Kaleden Fire District

FIRESMART COMMUNITY ASSESSMENT REPORT

January 2019

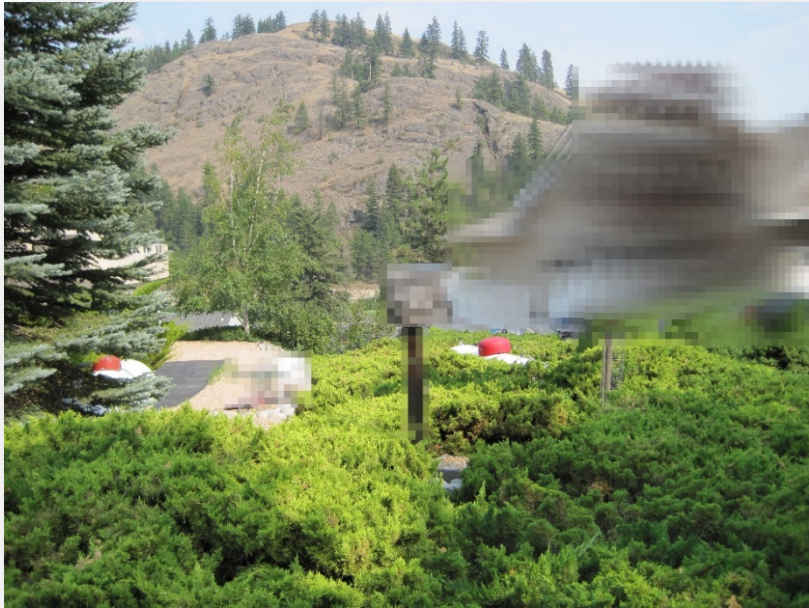
Arborvitae and juniper are members of the Cupressaceae (cypress) family and their foliage are rich in organic volatile compounds and terpenes, which have low flash points (Ubysz & Valette, 2010). Having a cedar or juniper shrub growing up against a house could very well be the source of a home ignition in the very likely event that these plants combust during a wildfire. Similarly, a long cedar hedge that leads up to a house can be viewed as a veritable wick of fuel waiting for a wildfire to light it. If removal is not an option, these fuels should be isolated by spacing and pruning so as to reduce the continuity and connectivity to adjacent structures (FIREsafe Marin, 2017).

Figure 14 An extensive clump of junipers in proximity to a home. These junipers have also surrounded a residential propane tank, identified by the red regulator cover on the white tank.

1. Substantially reduce the amount of highly combustible plants used in landscaping, such as cedar and juniper shrubs and hedges within Zone 1 (<10 m from the home).

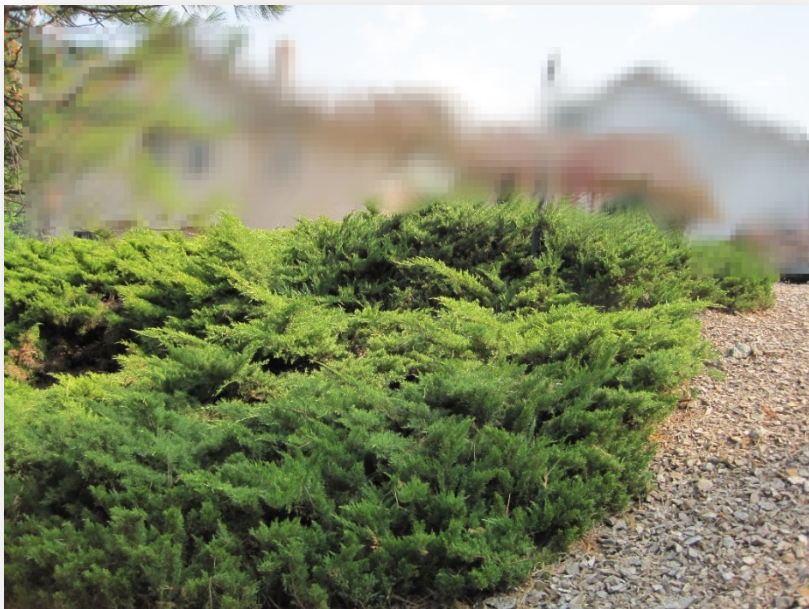
Figure 15 An extensive clump of junipers in proximity to a home.

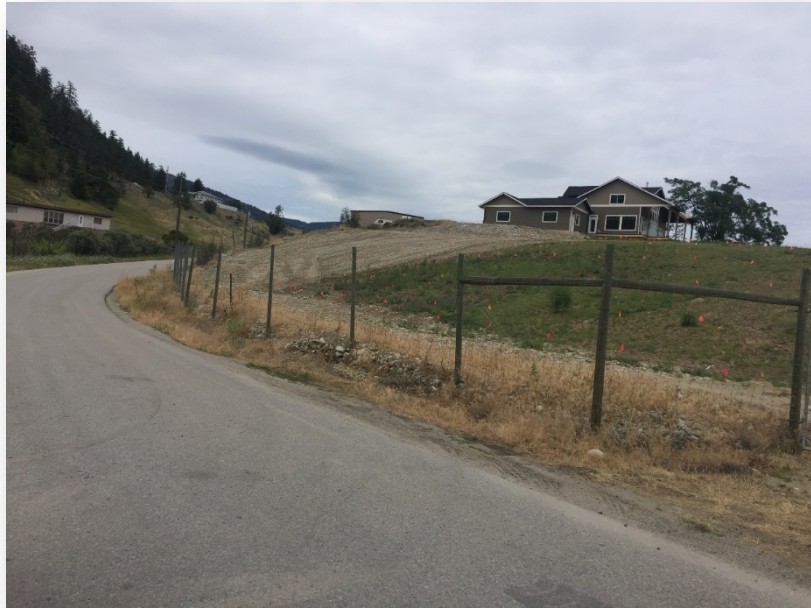
Figure 17 Cured grass along the shoulder of Linden Avenue, which is a summer maintenance class 5 road and included in the highway maintenance standards that are currently in effect. The cured grass on this shoulder would likely permit fire spread along the shoulder.

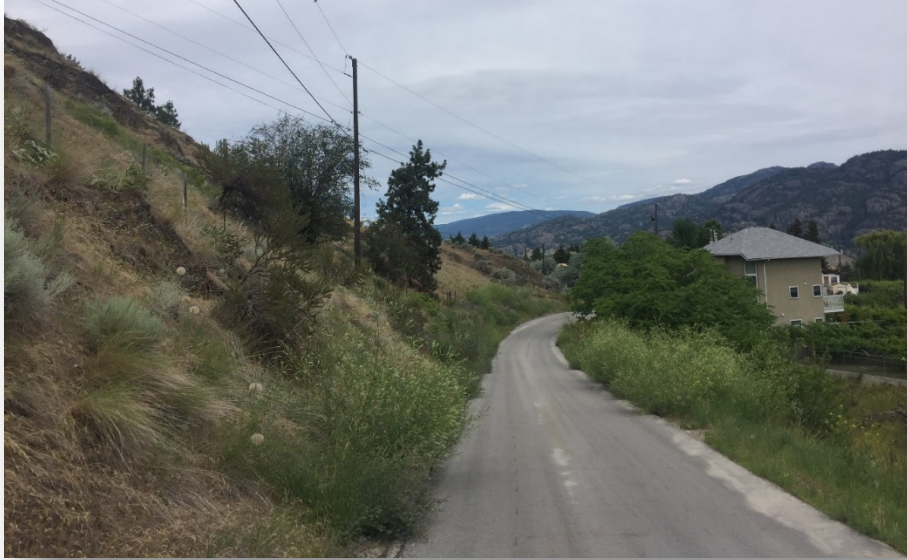
Figure 18 Looking north east down Dogwood Avenue. This road is summer maintenance class 6, which is not included for shoulder mowing in the highway maintenance standards that are currently in effect.

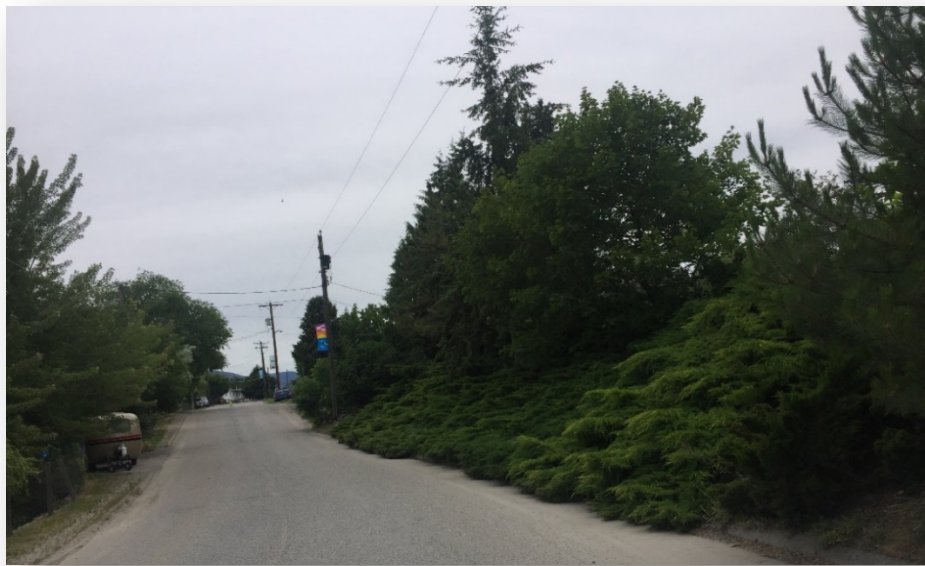
Figure 19 Looking south on Linden Avenue. This road is summer maintenance class 5, which is included for shoulder mowing in the current highway maintenance standards. This photo depicts an extensive clump of juniper that have spilled onto the road from an adjacent property.

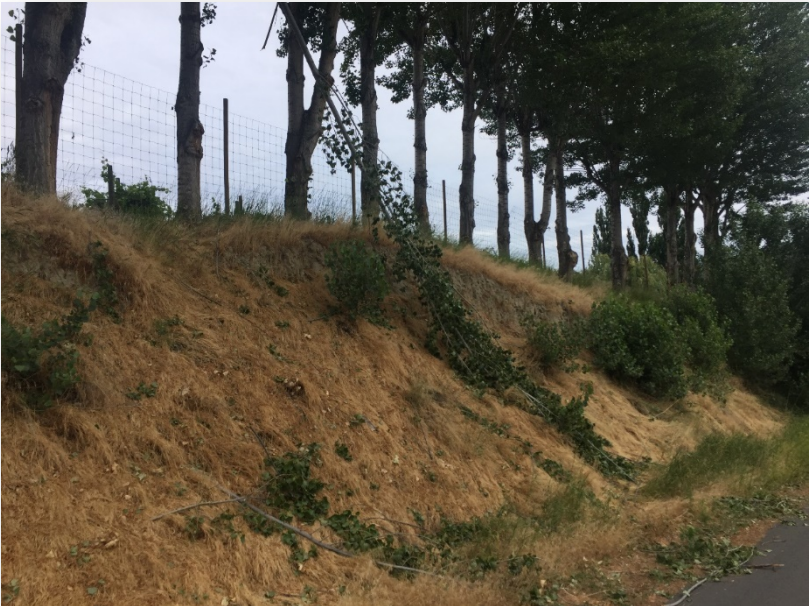
Figure 20 Shoulder vegetation along Spruce Avenue, a summer maintenance class 6 road, and as such not included for shoulder mowing in the current highway maintenance standards.

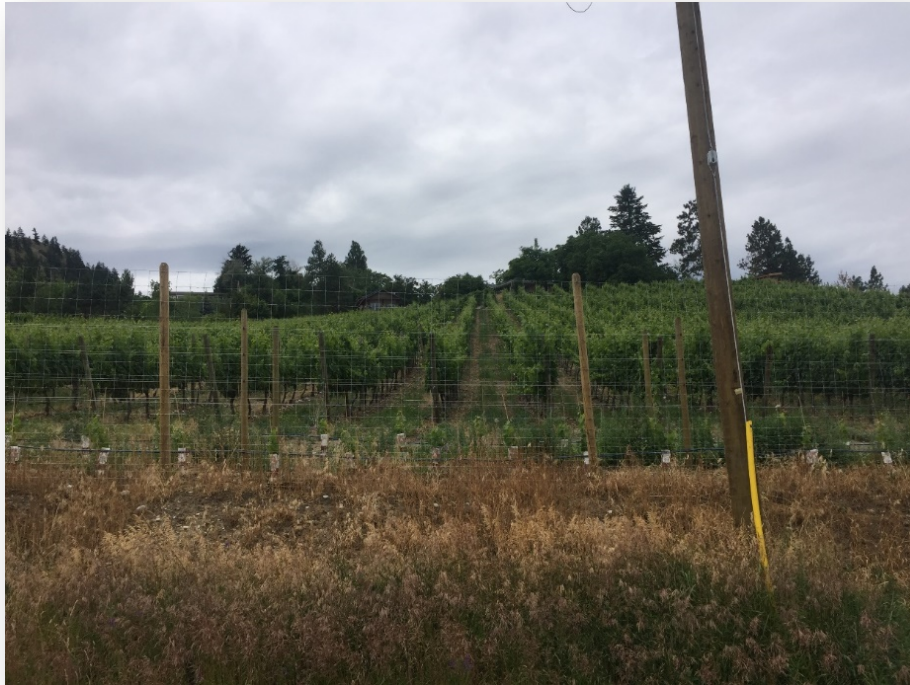
Figure 21 Vineyard with a green cover crop in the alleyway between rows. There is no concern of fire spread through the vineyard when the cover crop is green, however, as the cover crop goes dormant and becomes cured it becomes increasingly available to burn. Isolate long durable alleyways from adjacent fuels, such as the shoulder grass in the foreground.

5. Where grass is used as a cover crop in alleyways between grape vines, and the cover crop goes dormant during the dry season, ensure that the cover crop won't allow fire to spread into or out of vineyards.

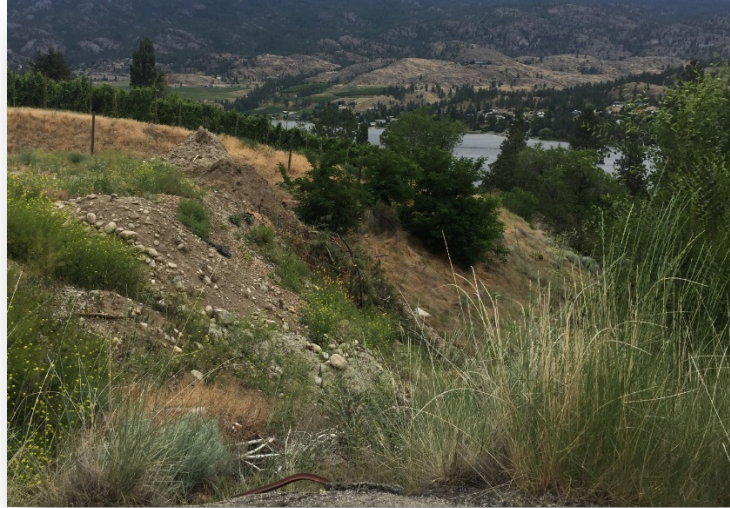
Several examples of yard waste dumped into gullies and over the edge of slopes were observed (see Figures 22 & 23). Yard waste, such as pruning debris, grass clippings, Ponderosa pine needles etc. need to be viewed as a fuel source for wildfire. While perhaps considered “out of sight, out of mind”, these yard waste fuel sources are often dumped into some of the worst possible places, where steep topography contributes to increased fire behaviour. At best, yard waste fuel accumulations are a stubborn mop-up problem for firefighters – at worst, they intensify upslope fire spread and concentrate energy up the length of gullies and at slope crests putting people and property at increased risk. A longtime Kaleden resident summarizes perfectly: “I strongly advise people not to discard yard waste into these draws and gullies, of which Kaleden has many. It’s just a huge fuel load,” (Richardson, 2017).

Figure 22 Yard waste vegetation is commonly dumped into gullies and over the edge of steep slopes, resulting in elevated fuel loads. This practice can contribute to increased fire intensity at slope crests and in gullies, making firefighting more difficult.

3. Remove highly-combustible plants and landscaping materials at the crest between a home and slope.
4. Stop dumping yard waste into gullies or over the edge of slopes, as this practice increases fuel loading in some of the worst possible places.

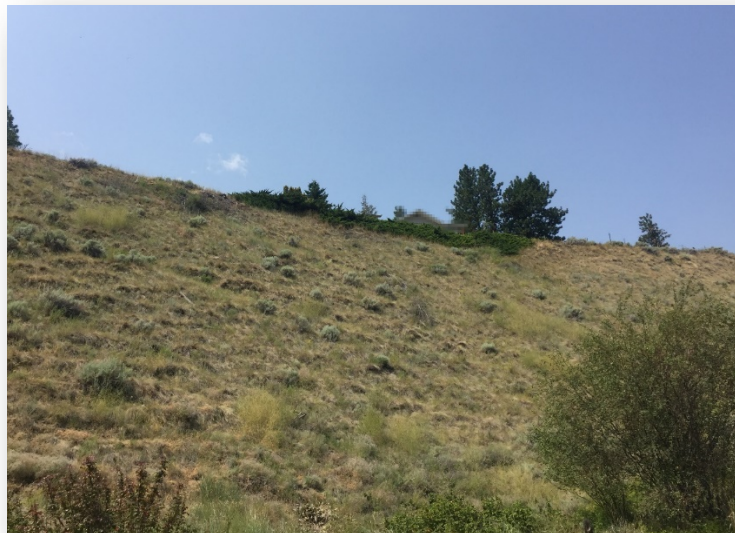
Figure 23 This home has junipers growing at the slope crest below the home, as well as a yard waste pile to the left of the junipers, at the slope crest. Both of these features would increase the intensity of a wildfire as it crested the slope below the home.

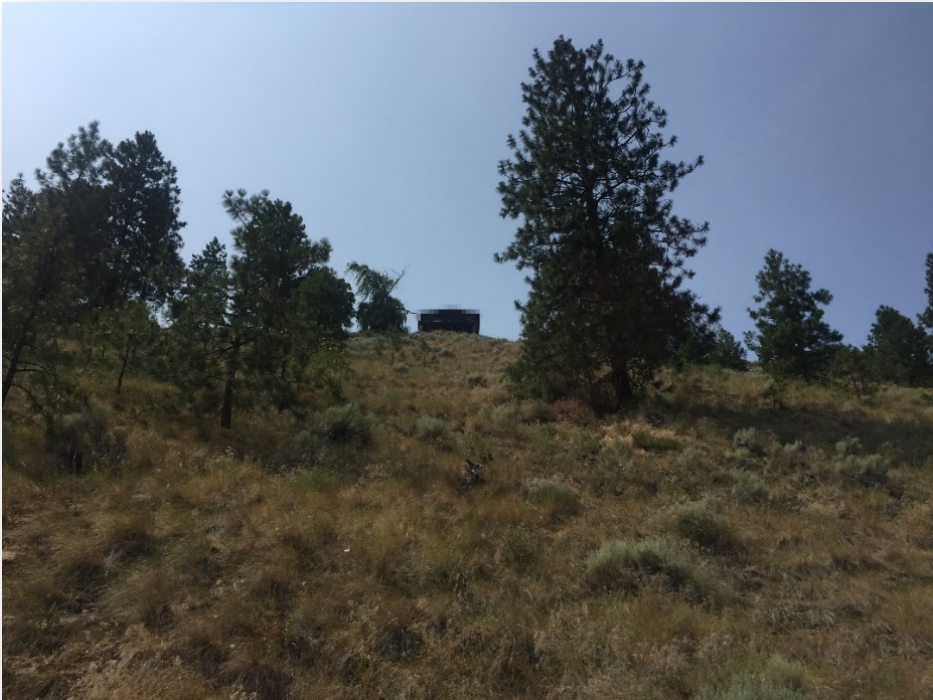
Figure 27 No set back between the home and a 70% slope below. In addition, an overhanging deck and home further exposes the home to upslope fire spread and direct flame contact.

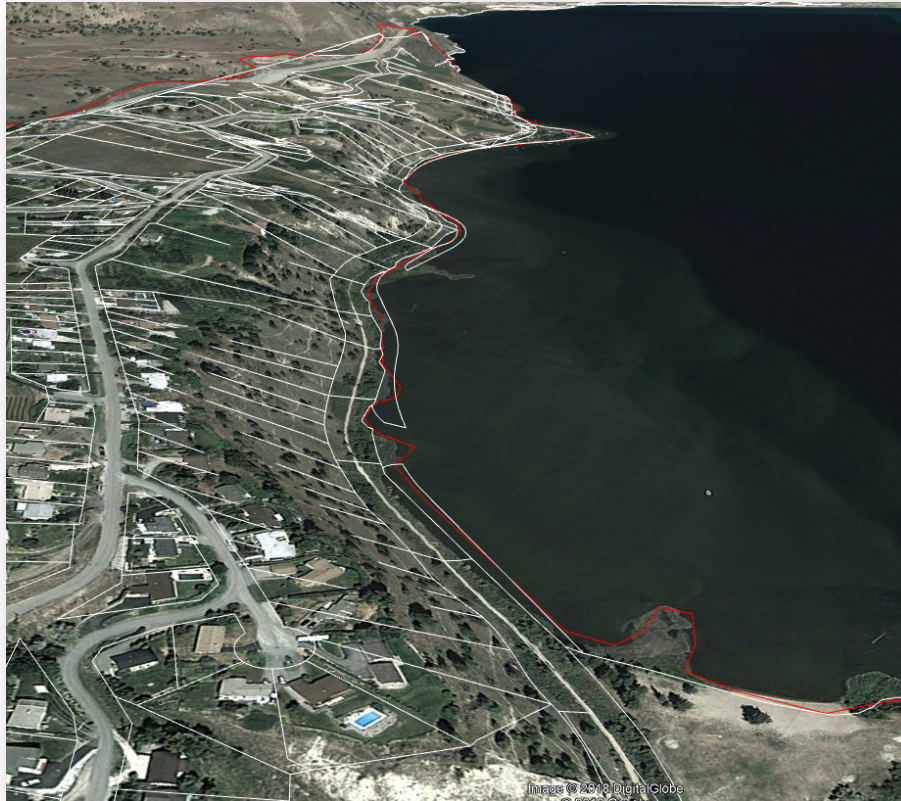
Figure 30 Three-dimensional Google Earth image of the area approximated in Figure 29. Significant portions of property lie downslope above the KVR trail where slopes are up to 70%. Fuel management on these slopes would be challenging.

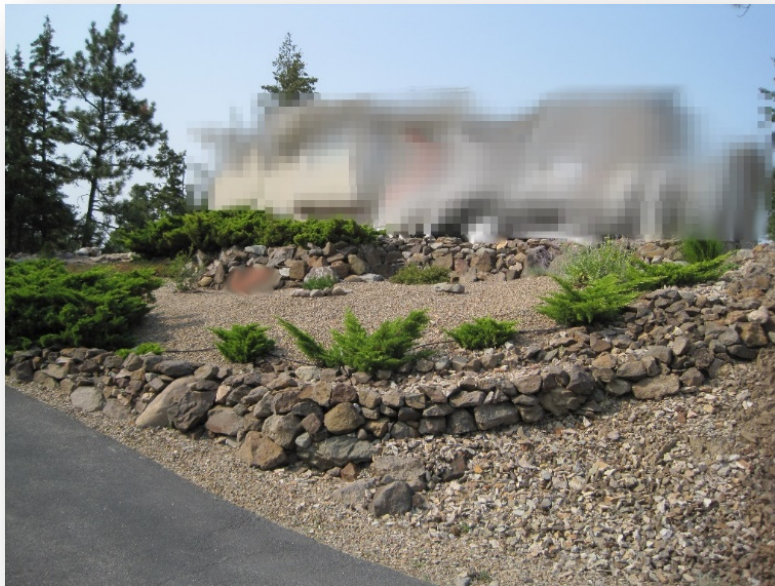
Figure 31 The landscaping materials used on this property help to increase the home's resilience to wildfire. Removal of the juniper shrubs within Zone 1 (<10 m from the house) should also be considered.

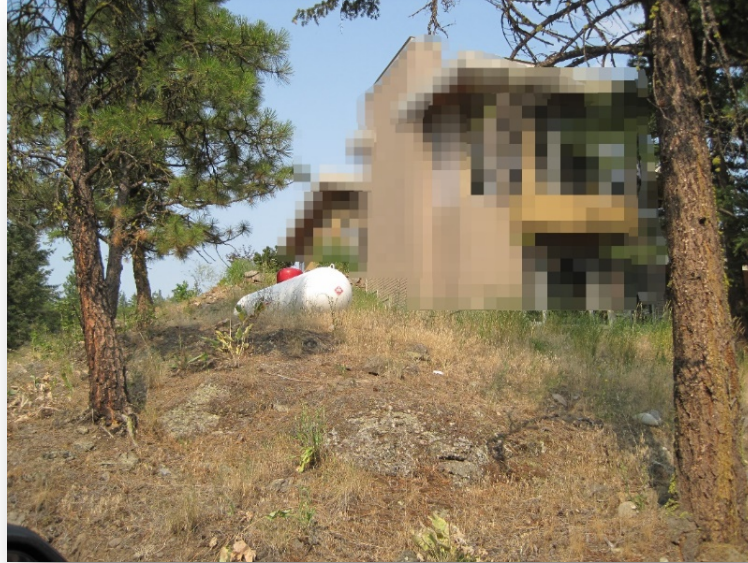
Figure 33 Although the natural grasses immediately adjacent to this home could use some mitigation, the rest of the Zone 1 (<10 m from the home) is generally free from heavy fuel accumulations and represents reasonably good defensible space.
