February 25, 2021

Big Meadow Lake Dam 2020 Dam Safety Review Report

For Regional District of Okanagan-Similkameen

H362819-00000-228-230-0002

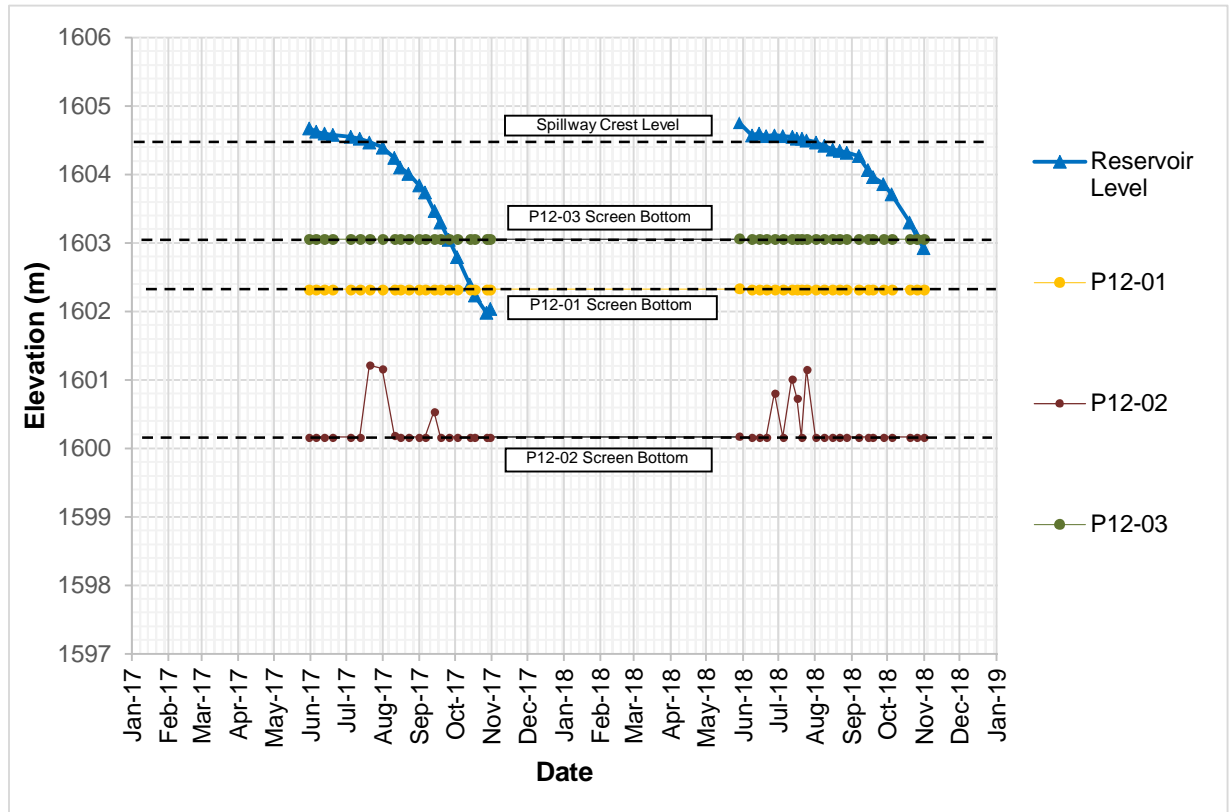
Figure 7-5: Big Meadow Lake Dam Piezometer Readings

Results of the instrumentation readings indicate that the screens of piezometers P12-01 and P12-03 were dry during all readings. These piezometers are located at higher elevations within the embankment and are downstream of the central concrete wall, indicating that the wall is acting effectively as a water barrier. Piezometer P12-02 was dry during the majority of the readings, however there were some fluctuations with water levels up to approximately 1601.25 m recorded. It is likely that the water in this piezometer is from seepage flows within the foundation passing around the bottom of the concrete core wall, which is consistent with seepage analysis results. The instrumentation readings reviewed are in line with the assumptions used in the seepage and slope stability assessments.

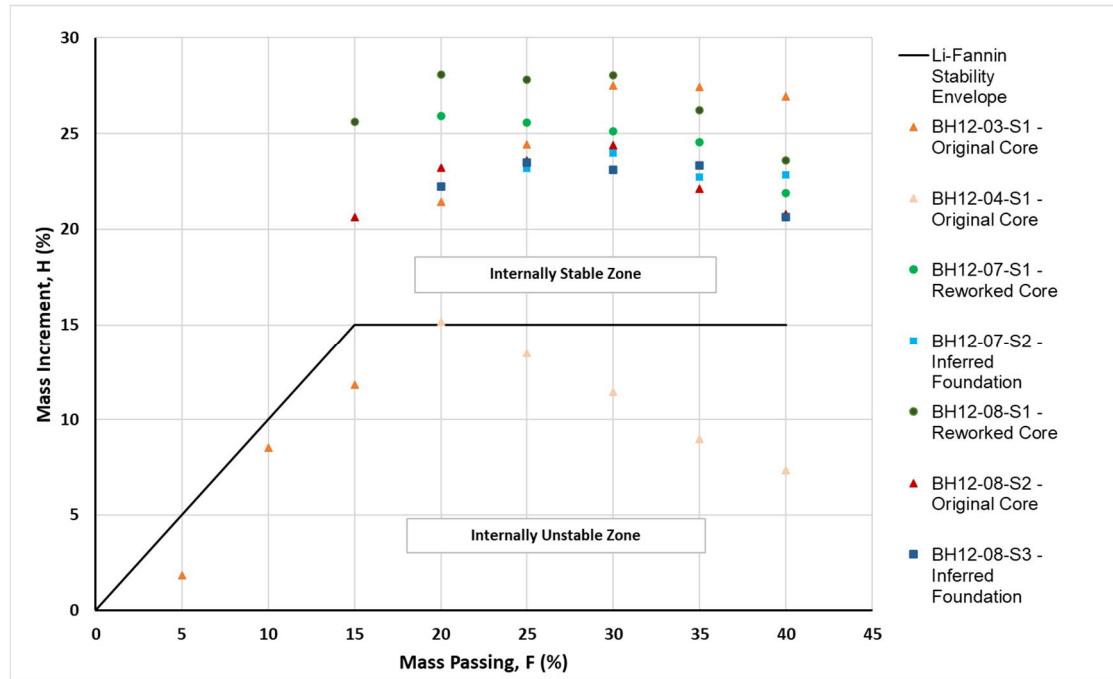
Figure 7-7: Plotted Internal Stability Results

Zone	Borehole ID	Depth (m)	Li-Fannin Stability Result
Original Core	BH12-03	2.5 – 2.7	Marginally Unstable
	BH12-04	2.0 – 2.2	Unstable
	BH12-08	3.7 – 4.0	Stable
Reworked Core	BH12-07	1.5 – 2.1	Stable
	BH12-08	1.5 – 2.1	Stable
Inferred Foundation	BH12-07	3.7 – 3.9	Stable
	BH12-08	5.6 – 6.0	Stable

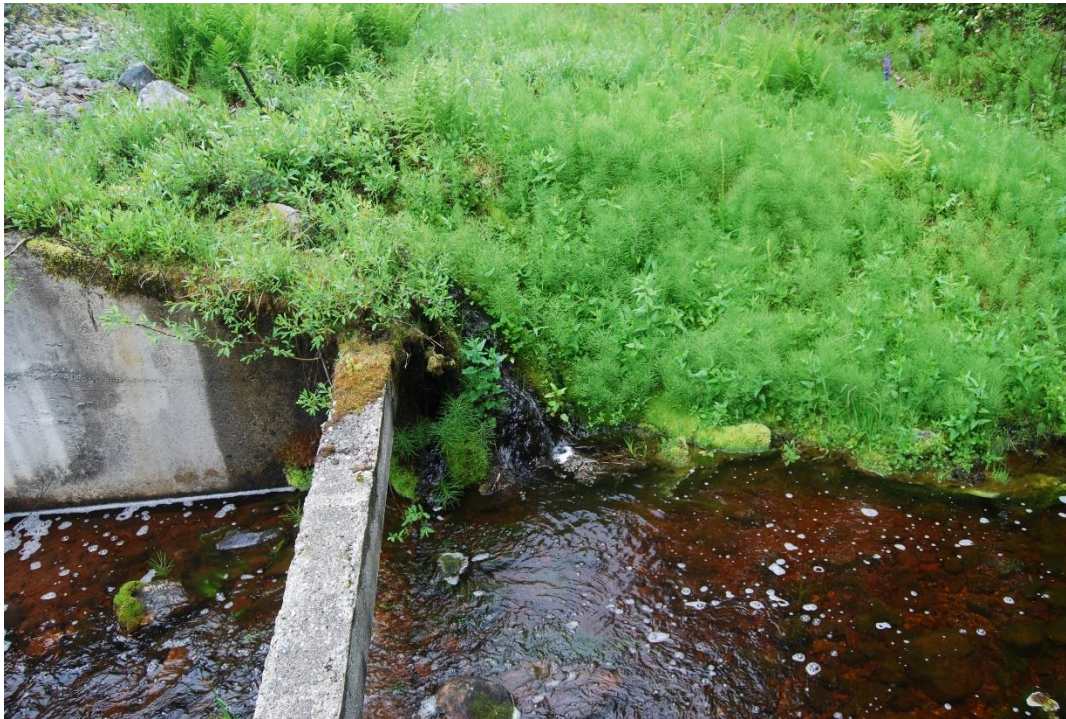
Photo A6: Big Meadow Lake Dam Outlet Works, Seepage from Left Wall Area

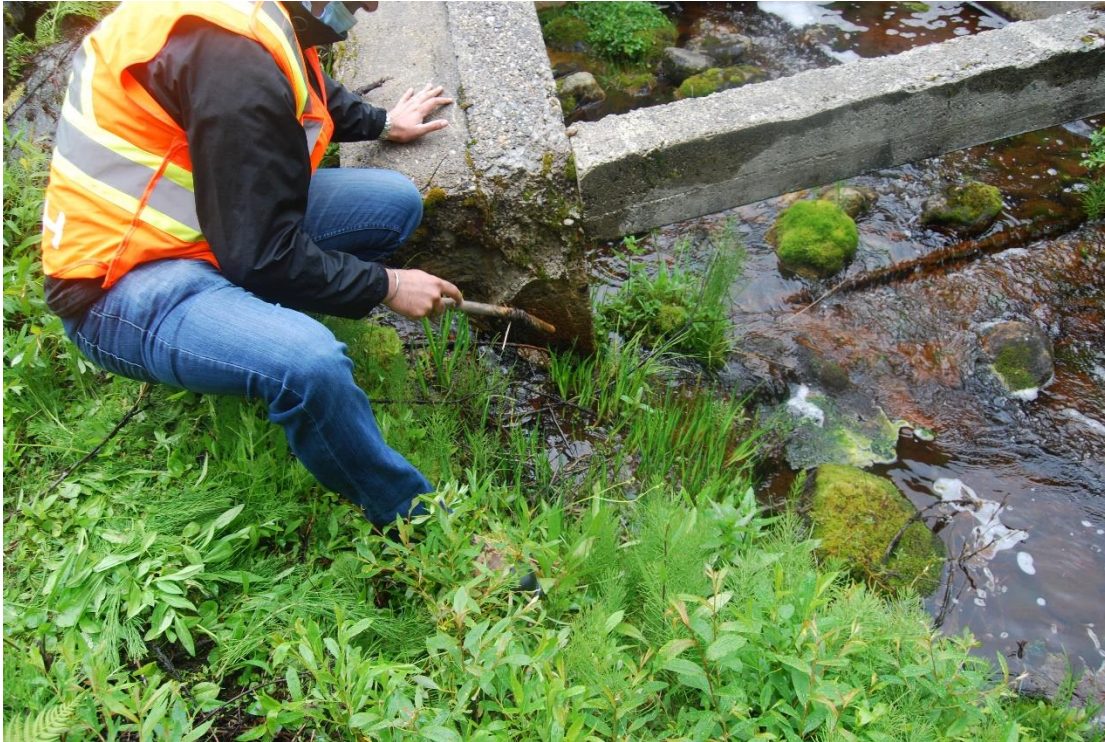
Photo A7: Big Meadow Lake Dam Outlet Works, Seepage from Right Wall Area

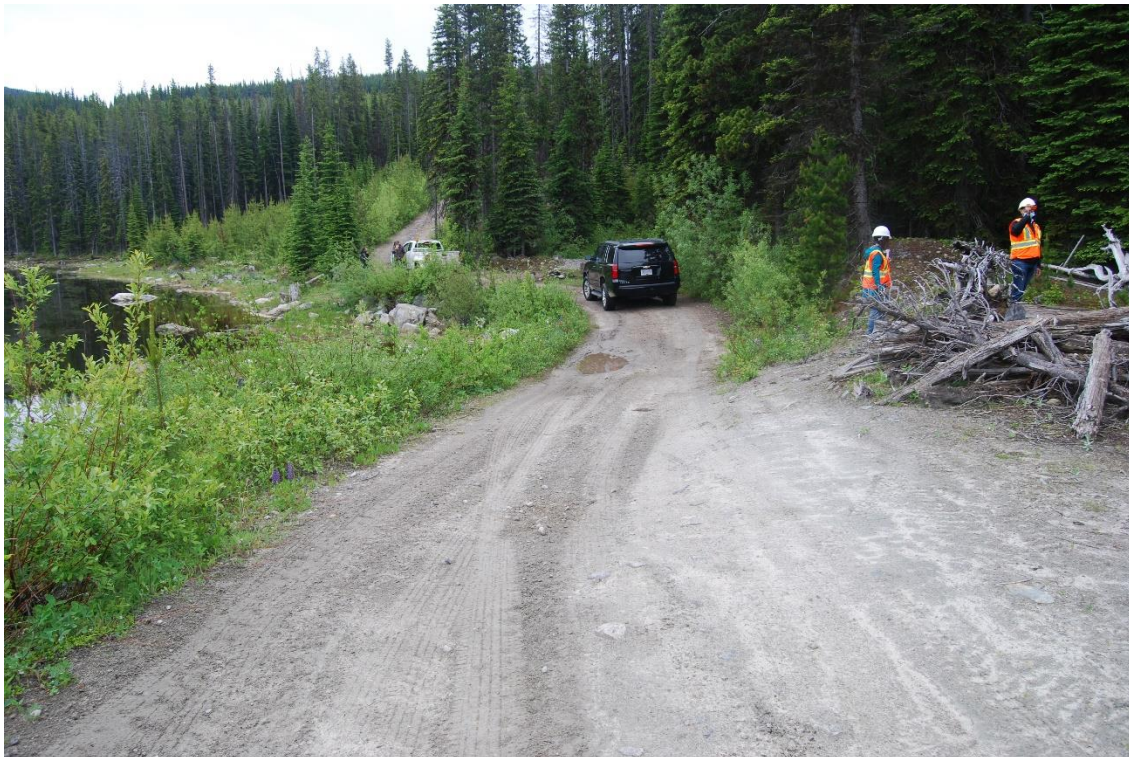
Photo A12: Big Meadow Lake Dam Low Crest Area close to Left Abutment

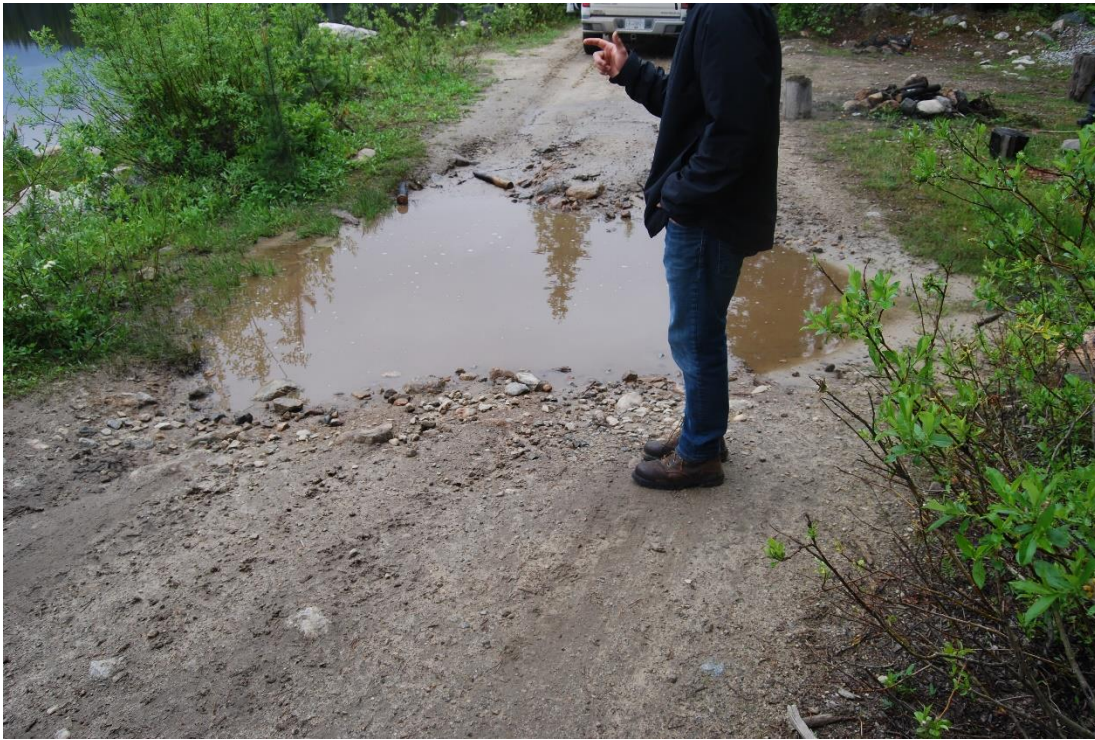
Photo A13: Big Meadow Lake Dam Low Crest Area close to Left Abutment

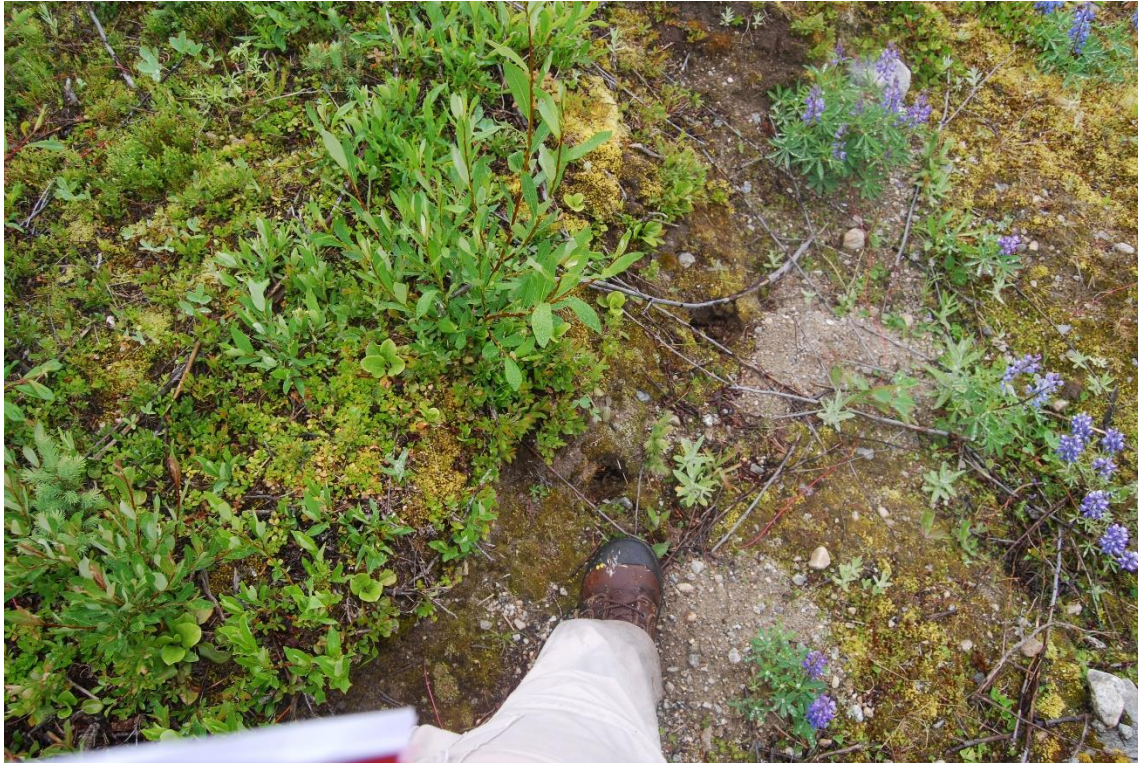
Photo A15: Big Meadow Lake Dam, Minor Animal Burrow on Dam Upstream Slope

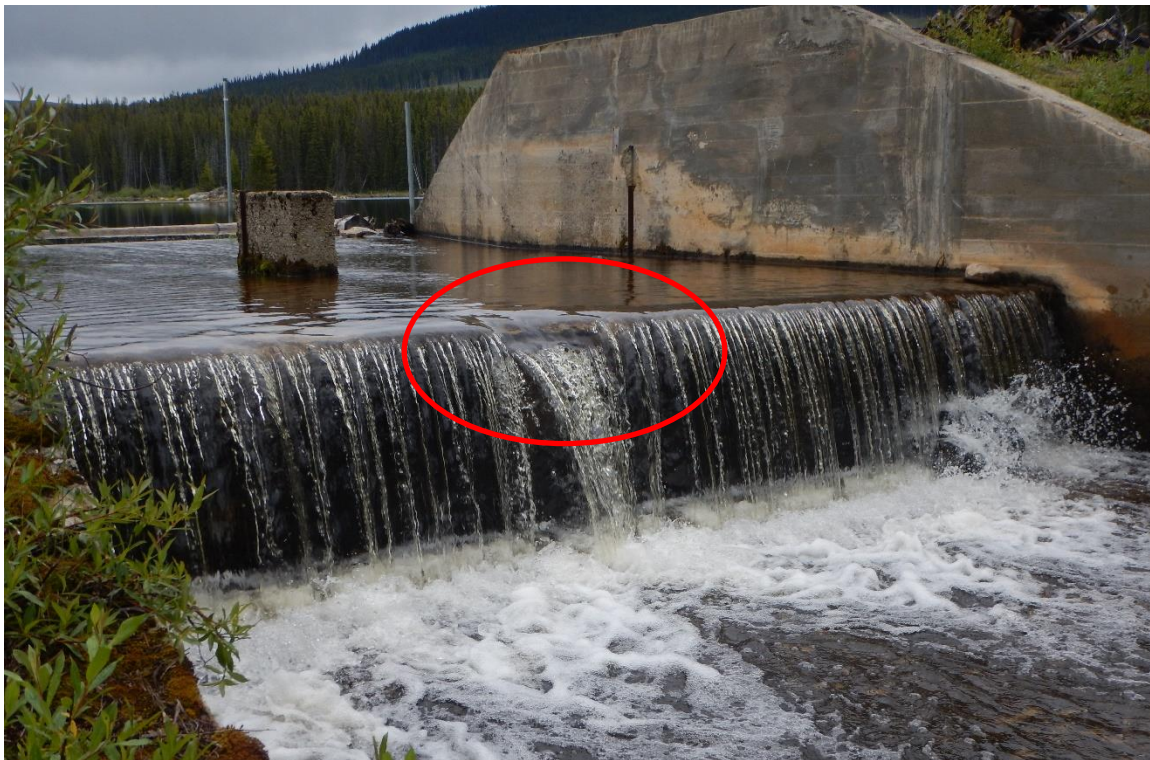
Photo A18: Big Meadow Lake Dam Spillway Crest Concrete Damage at Mid Span

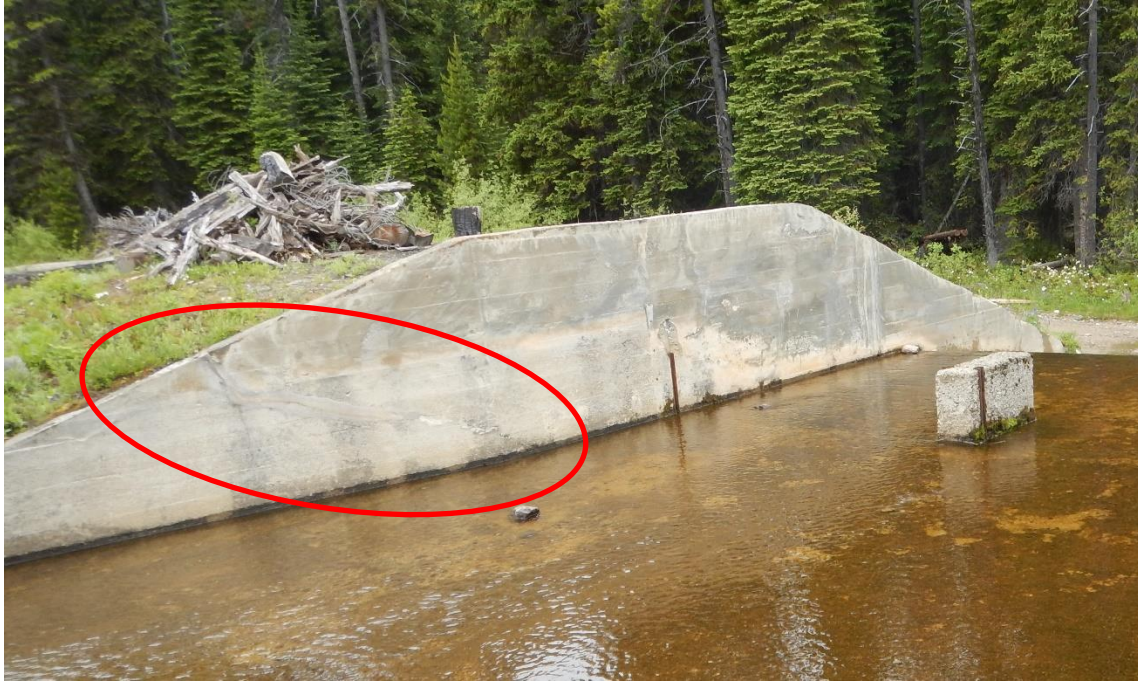
Photo A19: Big Meadow Lake Dam Spillway Repaired Crack in Left Retaining Wall
