## ***Geotechnical Report***

**File:** RGC-3624

**Subject:** ***Revised Geotechnical Assessment for Demolition of House and Backfilling  
At 811 West Bench Drive, Penticton, BC***

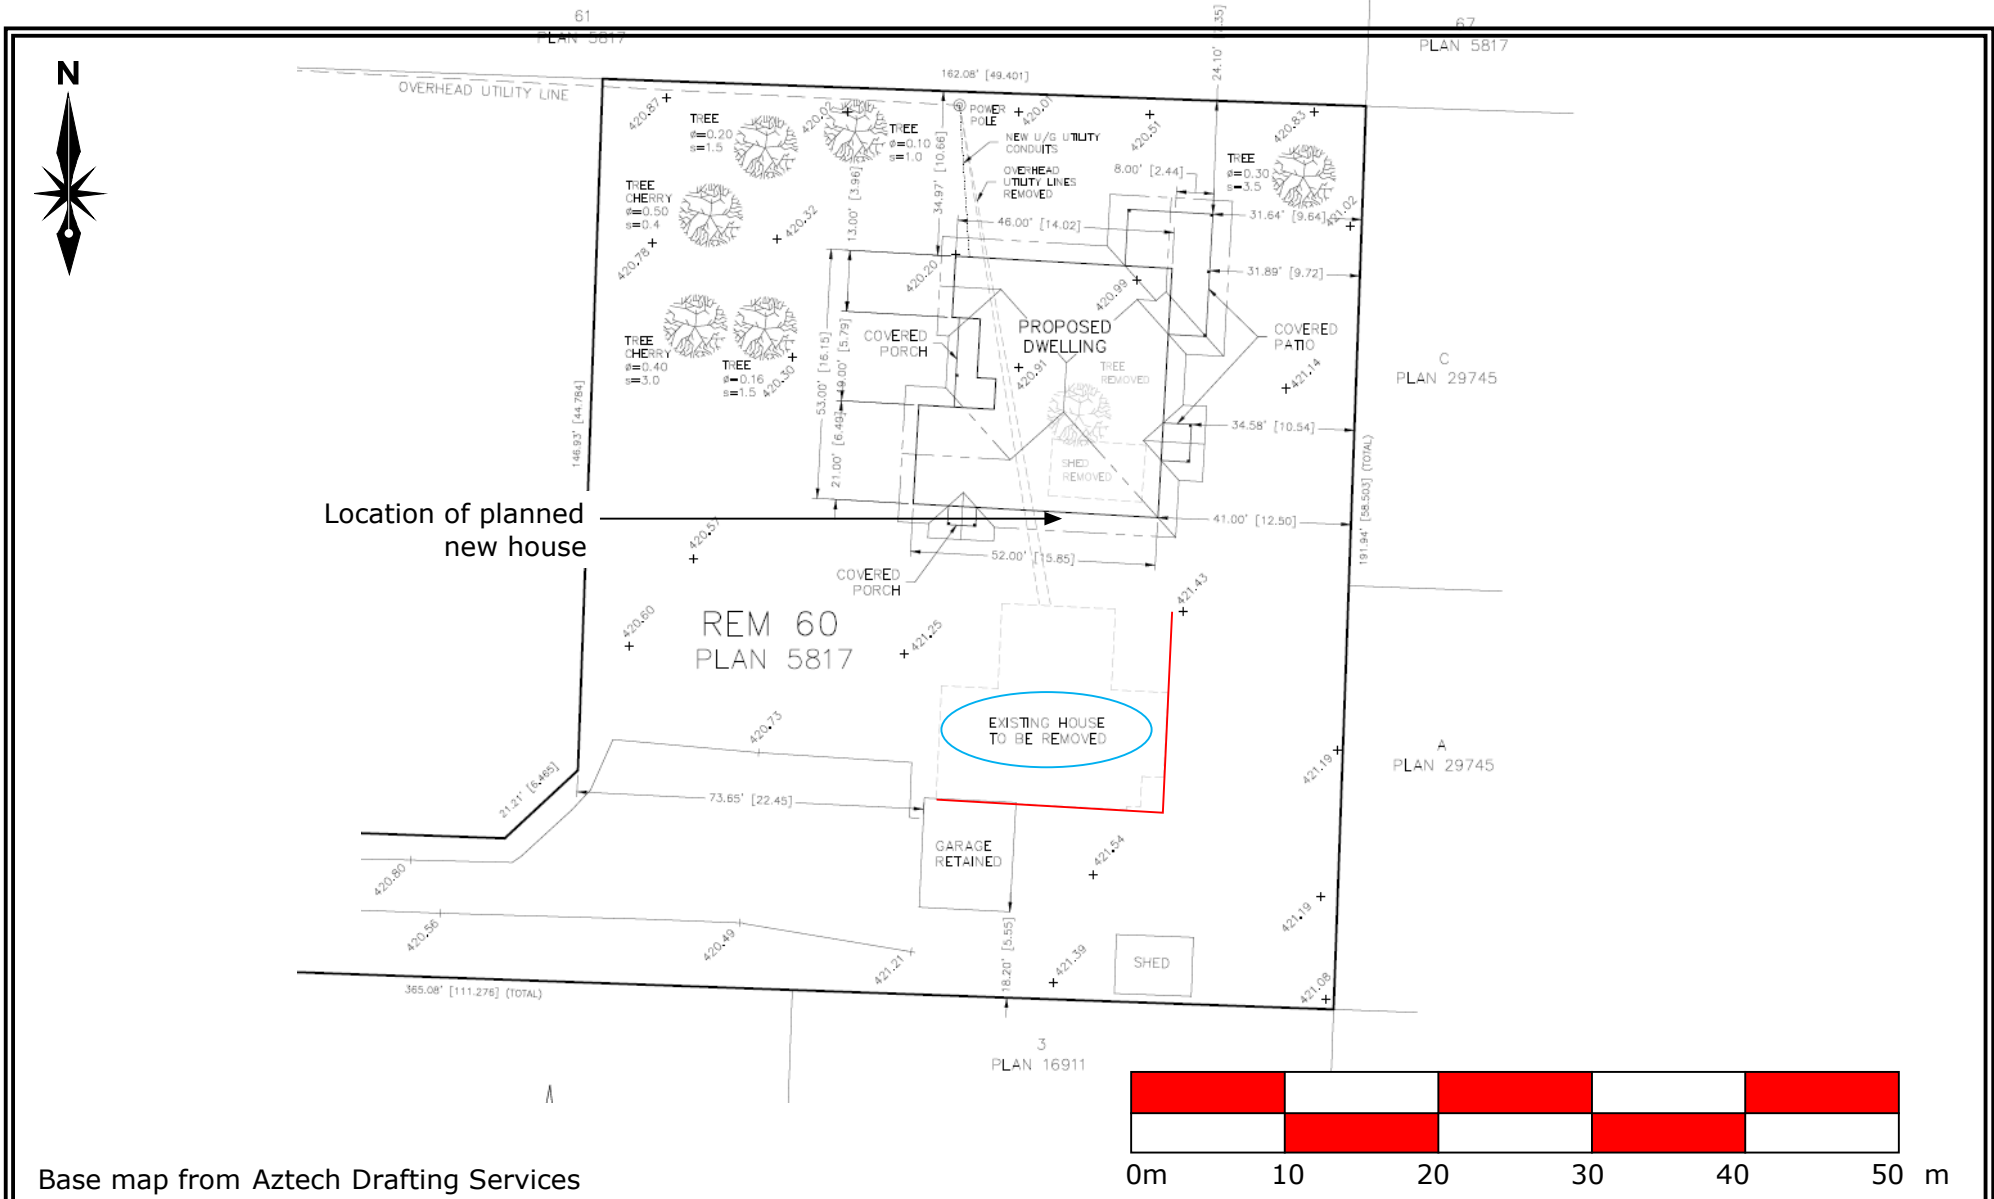
Figure 2: Site Plan  
811 West Bench Drive, Penticton, BC

The property is located about 350m from the nearest moderate landslide hazard area. A low landslide hazard classification is consistent with site observations. The subject property is flat to gently sloping, with an indicative elevation of 421m; gently sloping

northeast towards the lowest corner at elevation of 420.8m. See spot elevations across the property in Figure 2: Site Plan.

The arrangement of site structures was confirmed as shown in Figure 2: Site Plan. The property is access from West Bench Drive via a panhandle driveway, and is surrounded by developed residential lots. On the day site observations of site soils were limited to areas of recent disturbance. Review of previous RGC testpit logs and recent house construction photos also confirm presence of glaciolacustrine sediments. It is anticipated that construction backfill materials may be present near the old house but this will be confirmed further as part of demolition.

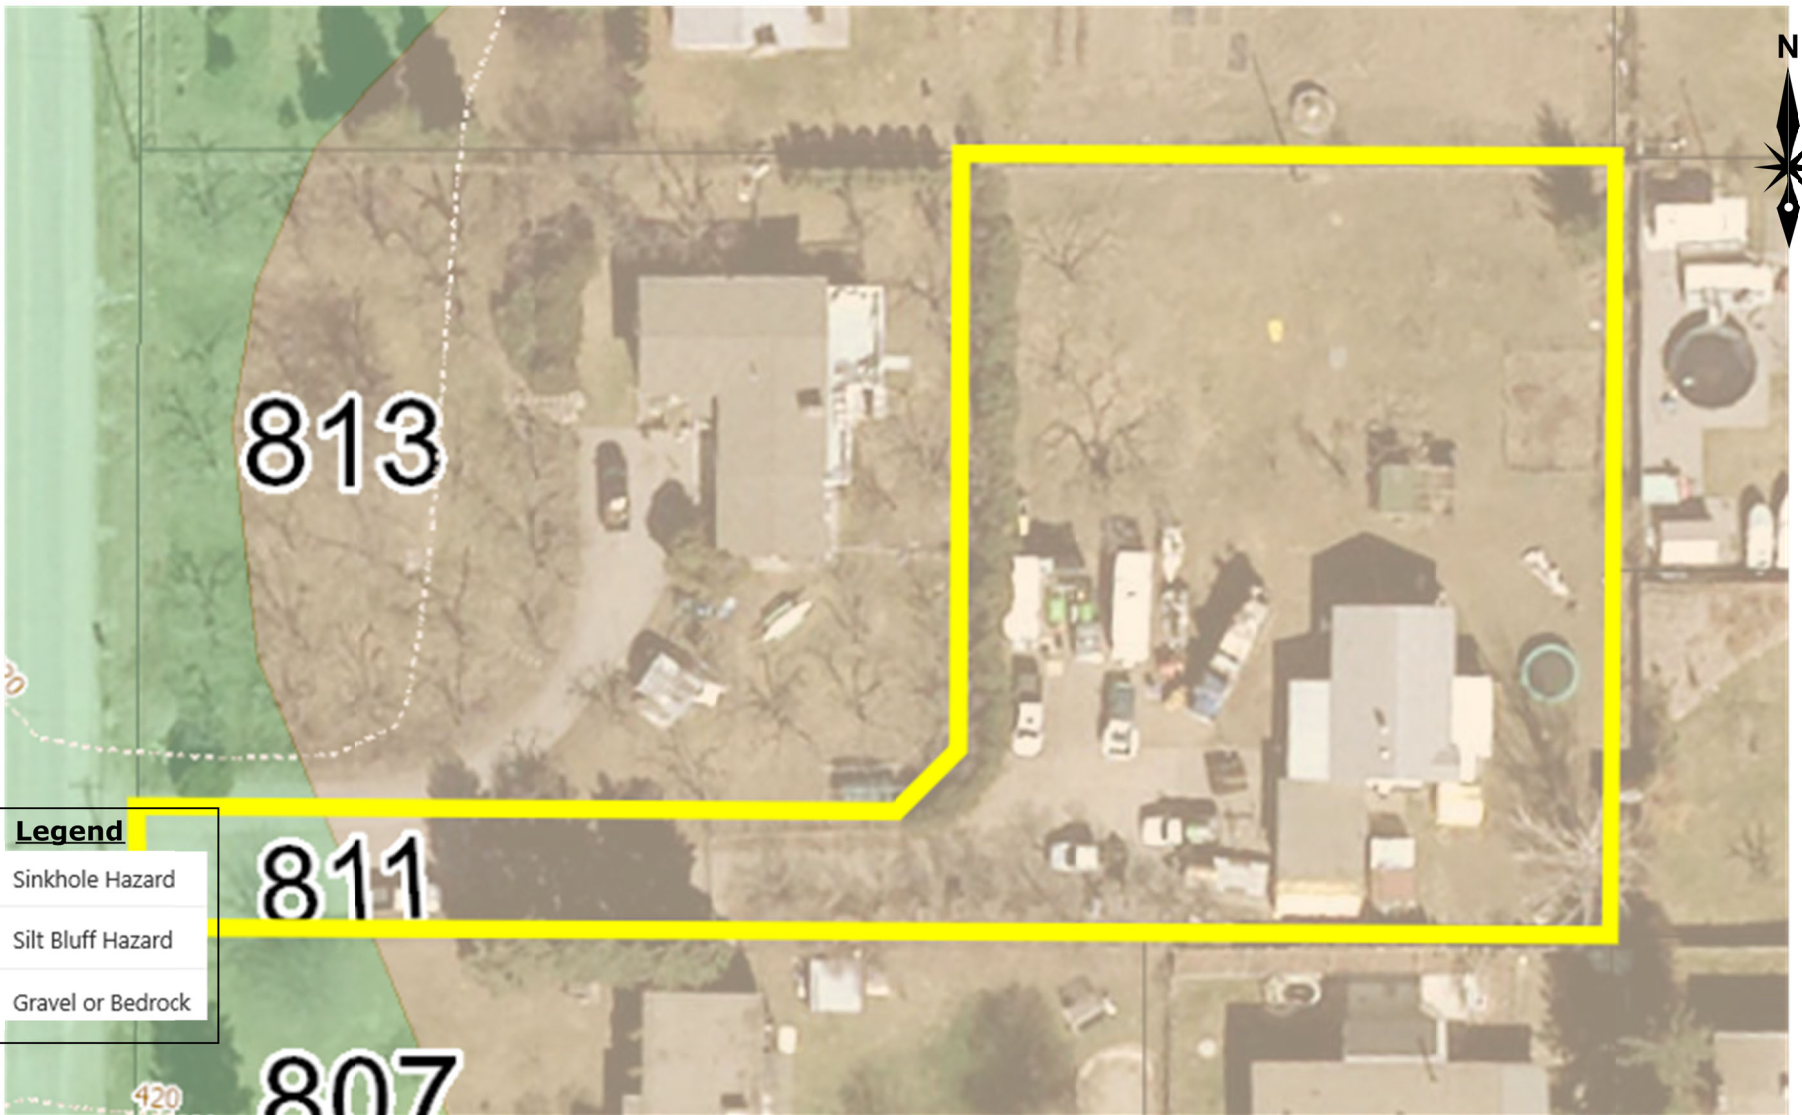
Figure 3: Hazard Map 9 (Leonoff, 1992)  
811 West Bench Drive, Penticton, BC

Klohn Leonoff Geological Mapping - As shown on Figure 3: Hazard Plan, area surrounding 811 West Bench Drive as "Silt Bluff Hazard Zone" with a low to moderate hazard classification.

Geotechnical Constraint Zones provide a cumulative assessment of the three unique hazards; whereby Zone B is indicative of land area with one of three hazards rated as moderate. For property at 811 West Bench Drive two hazards are mapped as moderate due the glaciolacustrine silt sediments. This consistent with site reconnaissance flat terrain and presence of glaciolacustrine sediments were observed.

Geotechnical conditions at 811 West Bench Drive are expected to consist of fine-grained glaciolacustrine SILT soils underlying the broader site, with backfill materials adjacent to the old house foundation. RGC confirms the property is considered Zone B (GWBG, 2022) with a moderate risk of a Sinkhole or Collapsed soils event, occurring with a 1 in 100-to-1000 year return period.
