# Geotechnical Assessment Report for Proposed Development at 1750 Highway 3, Osoyoos, BC

Presented To: **Steinar Johnsen**

Dated: November 2020

Ecora File No.: 201589

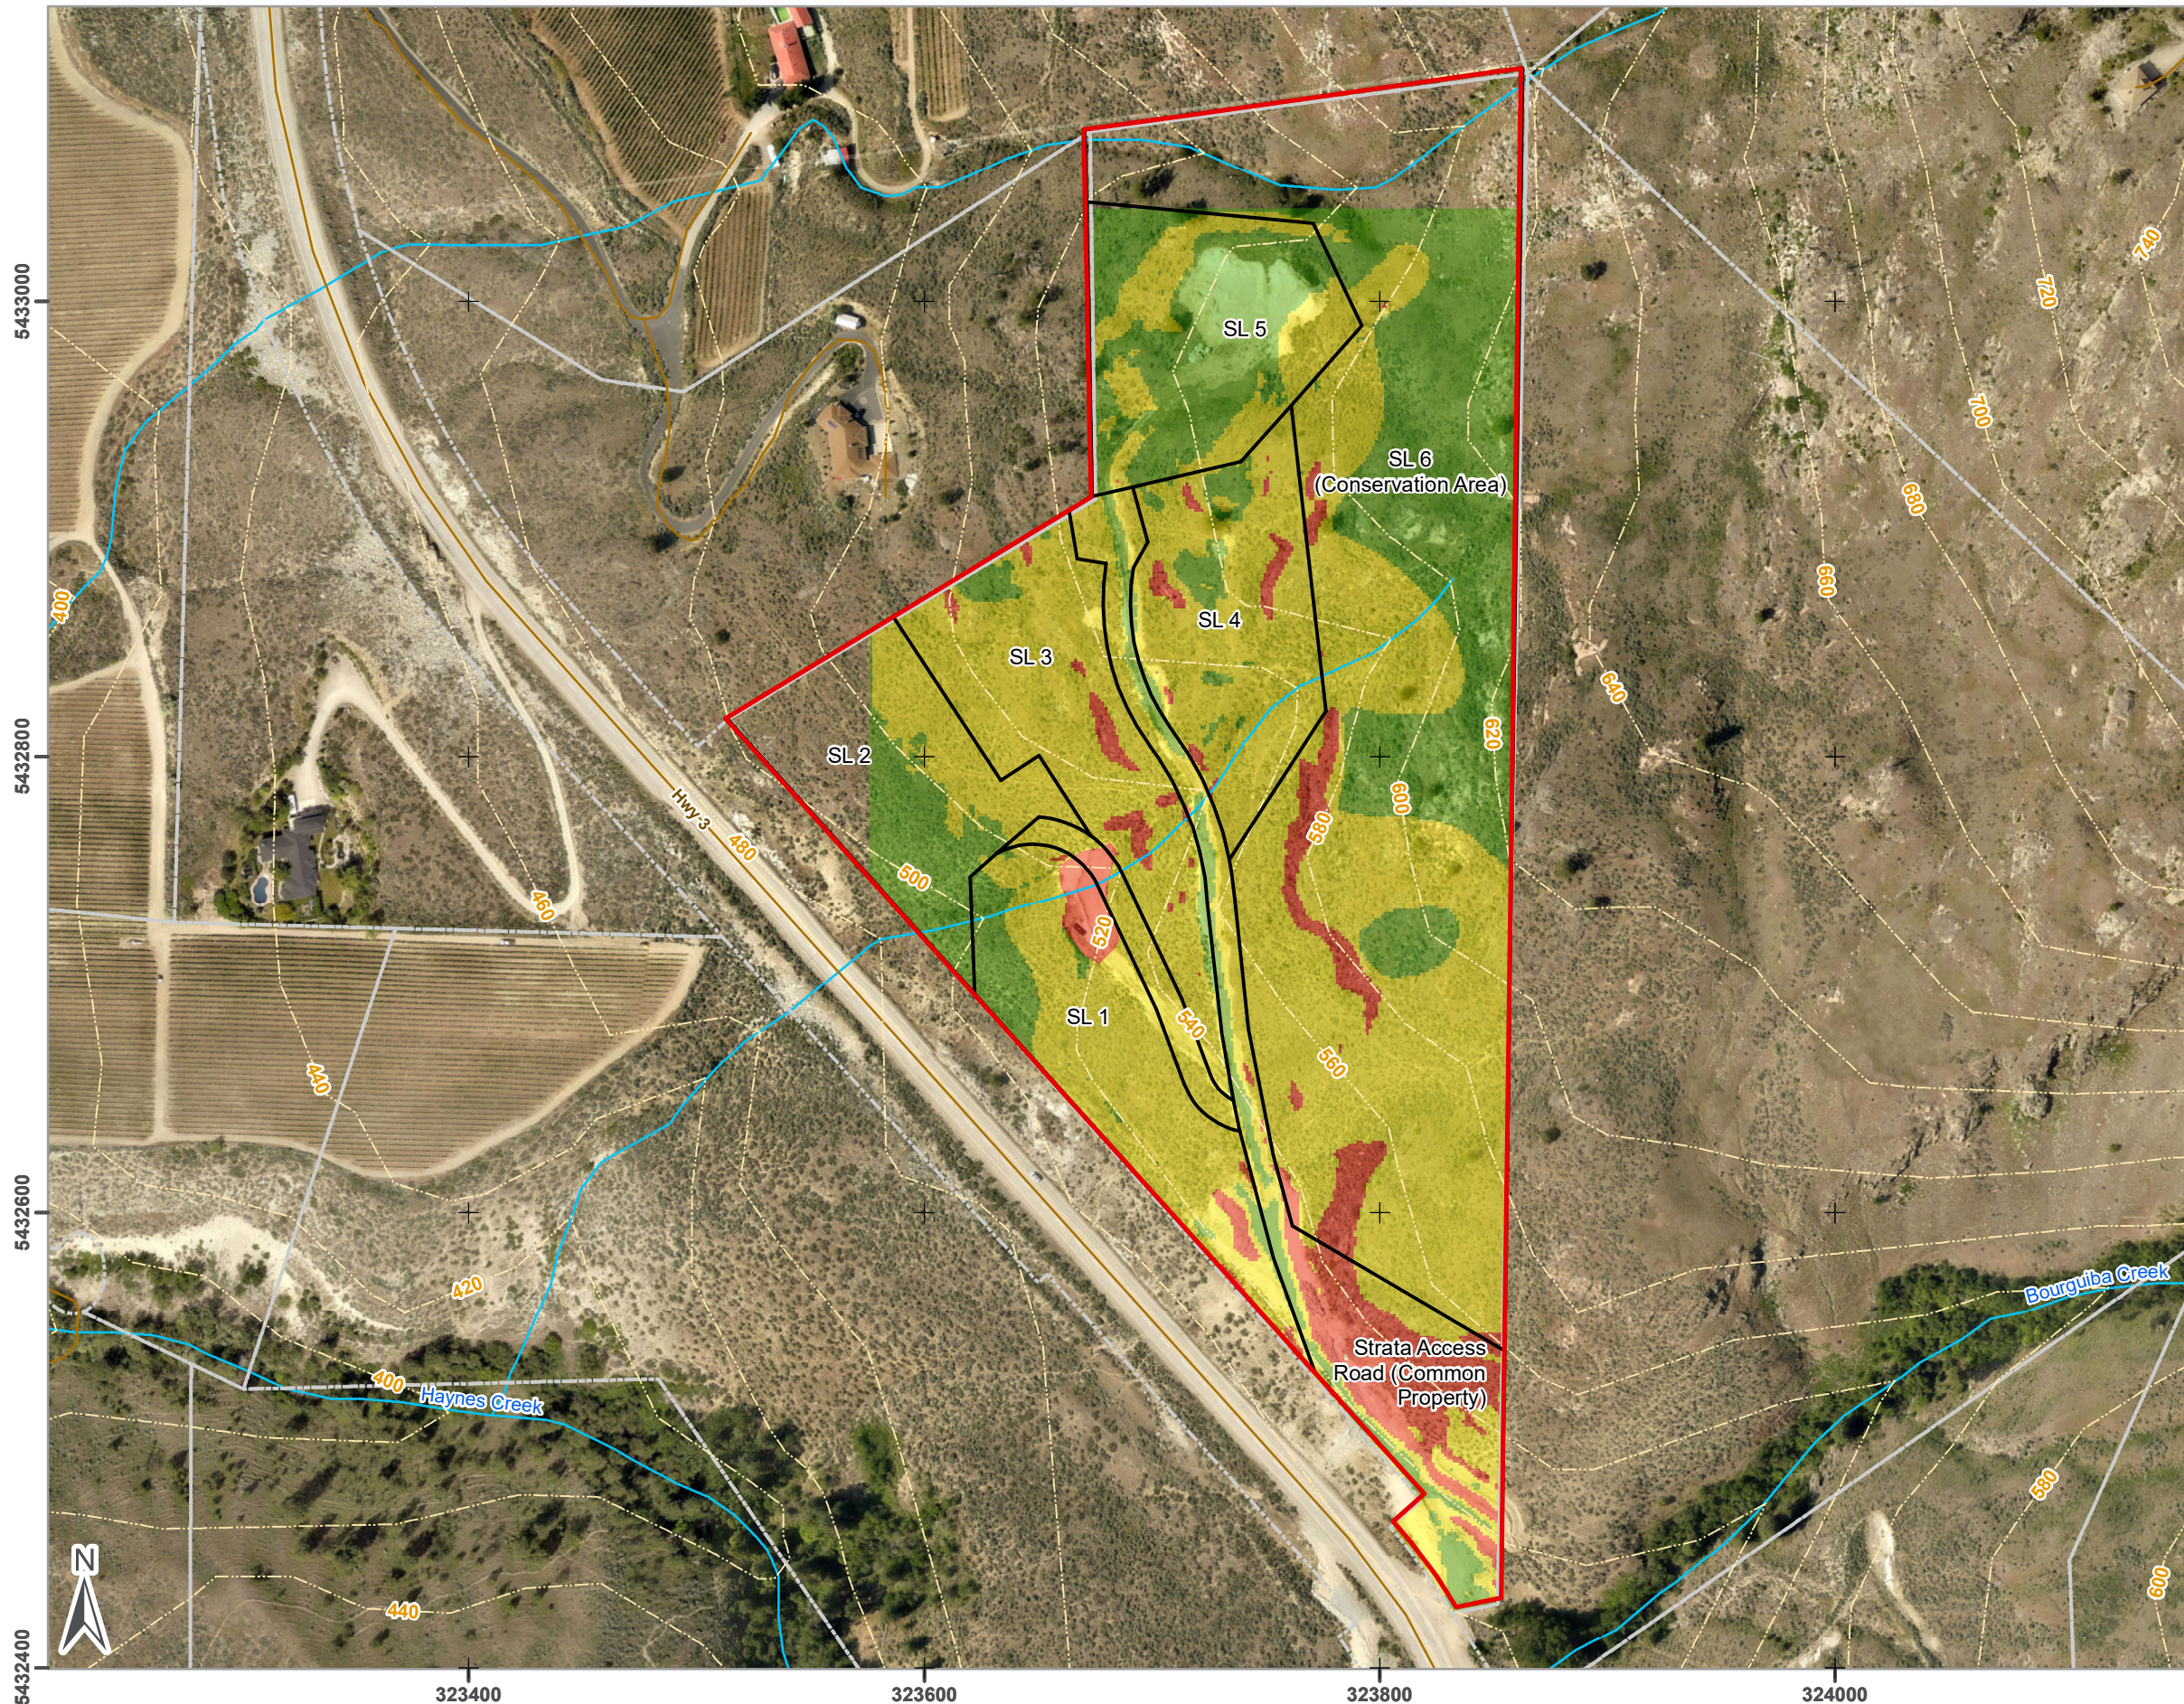
**Figure 3.0**

Ecora has divided the subject property into hazard areas based on the potential risk of geohazards. The majority of the constructable area of the subject property is considered to be a 'moderate' hazard corresponding to return periods of greater than 1 in 475 years for property damaging events and less than 1 in 10,000 for catastrophic events. 'Low' hazard areas were identified along the western side of the subject site (SL 2) and in SL 5, while the steep slopes located along the ephemeral stream gullies and the bedrock outcrops to the east of the access road are considered to be within a 'high' hazard risk class.

A rock fall hazard source zone with a moderate to very high return period and potentially property damaging events is located along the east side of the property, primarily through the middle of SL 6 (Conservation Area). The rock fall shadow from this source zone extends to the proposed SL 1, 3, and LCP access driveway for SL 1 and 2. Mitigation measures for this area are expected to be possible through a combination of site grading and protection measures (i.e. ditched berms) during development of the strata.

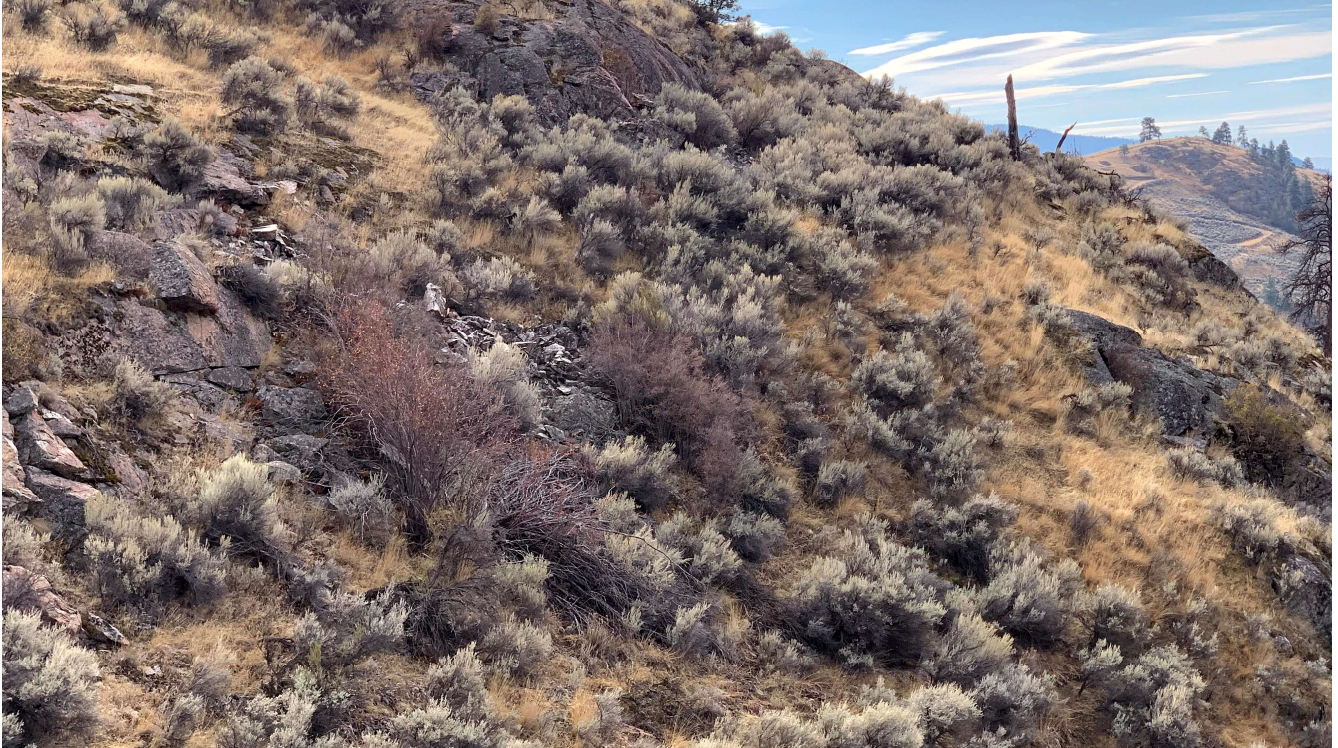
- Approximately 75% of the site is classified as having natural slopes of 15-30°. The slopes across the majority of site sloped east to west, with some areas having greater than 30° slopes. The slope surfaces generally contained tall grasses and shrubs. Bedrock outcrops were observed throughout the site (Photo 1).

**Photo 1** View of Northwestern portion of the site slope, looking south.

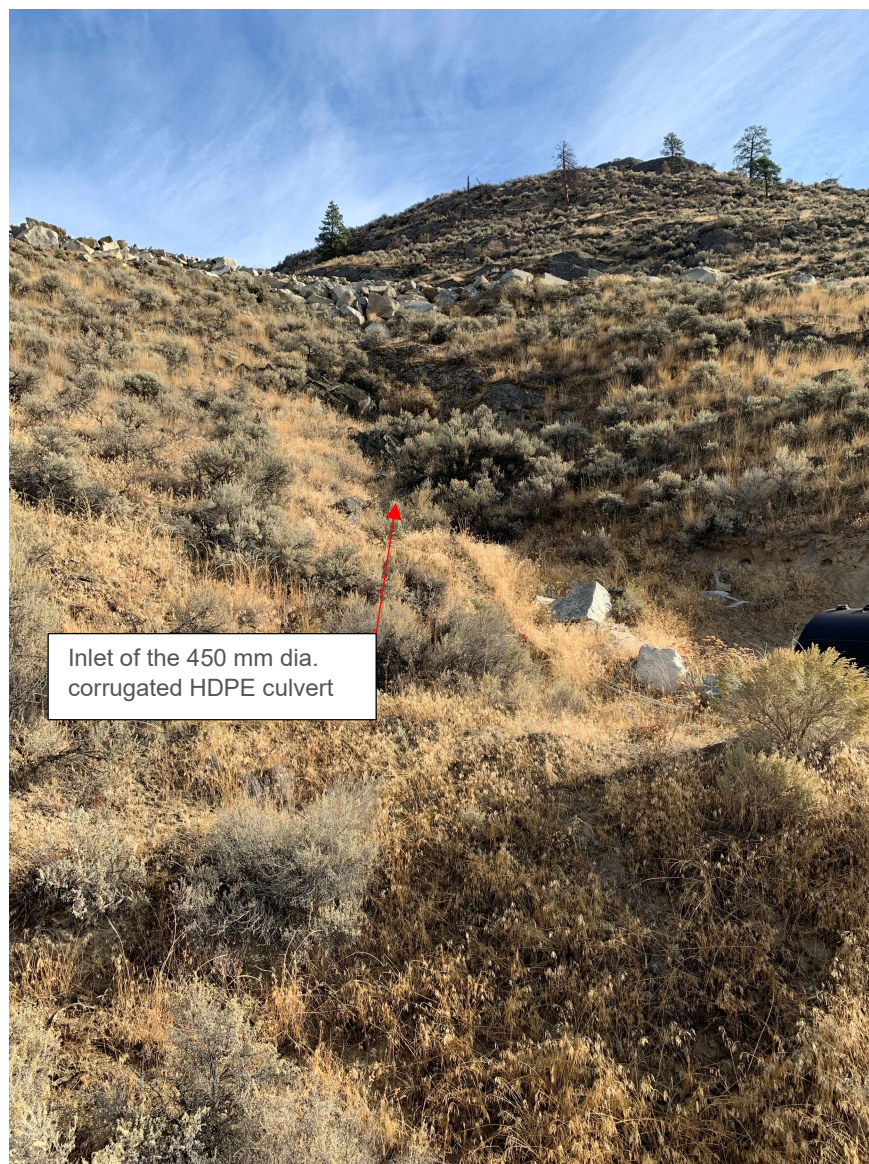
- Two unnamed, ephemeral streams were identified, one crossing midway through the property running northeast to southwest (Photo 2), and one across the north tip of the property from east to west (Photo 3). These streams were noted to be dry at the time of the site reconnaissance.

**Photo 2** View of Southern ephemeral stream looking east.

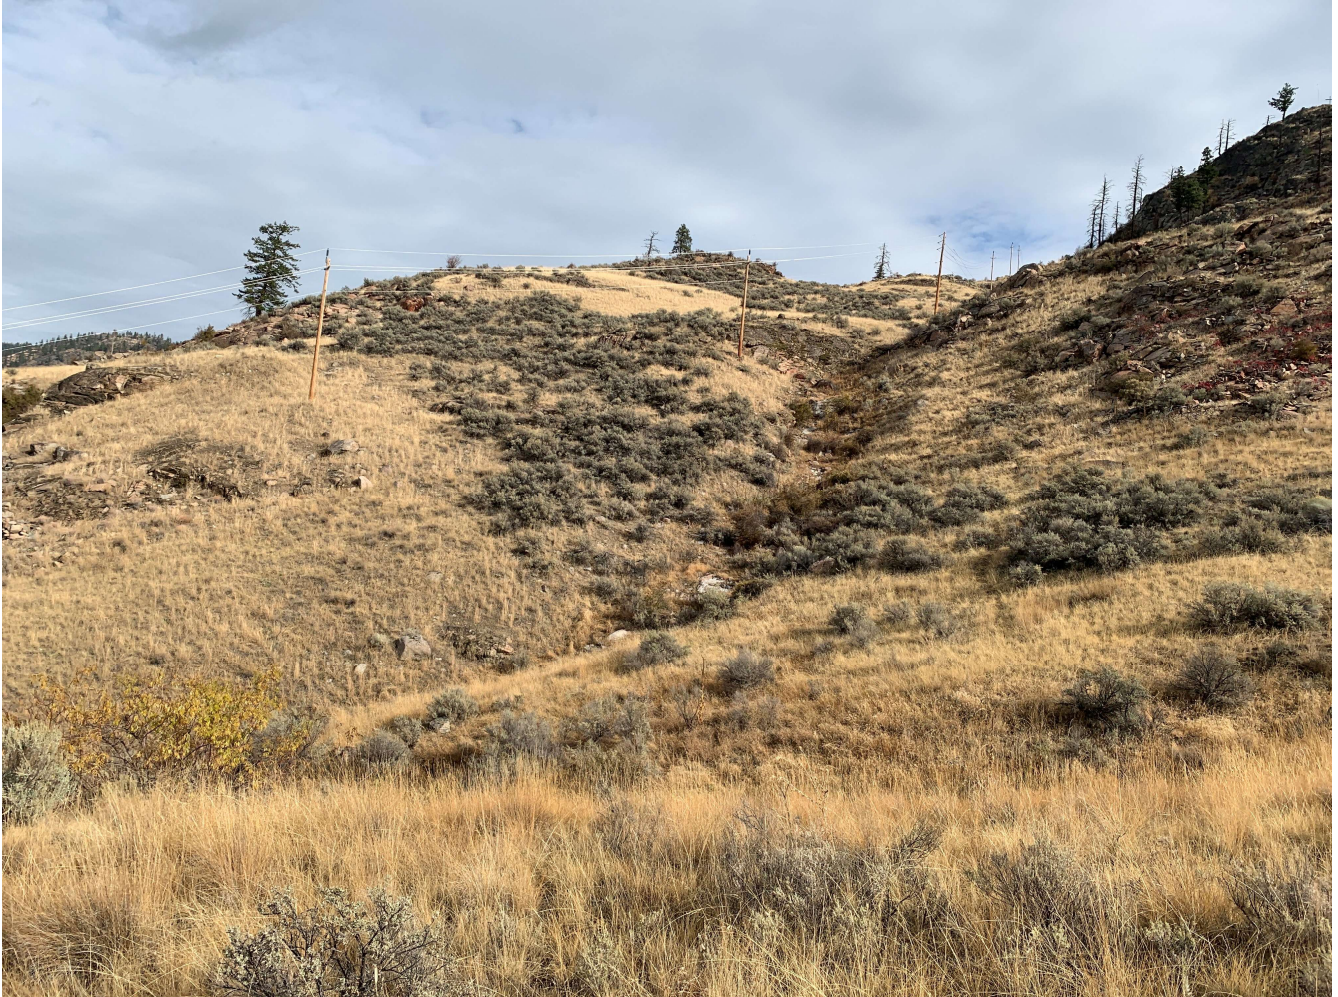
**Photo 3** View of Northern ephemeral stream looking east.

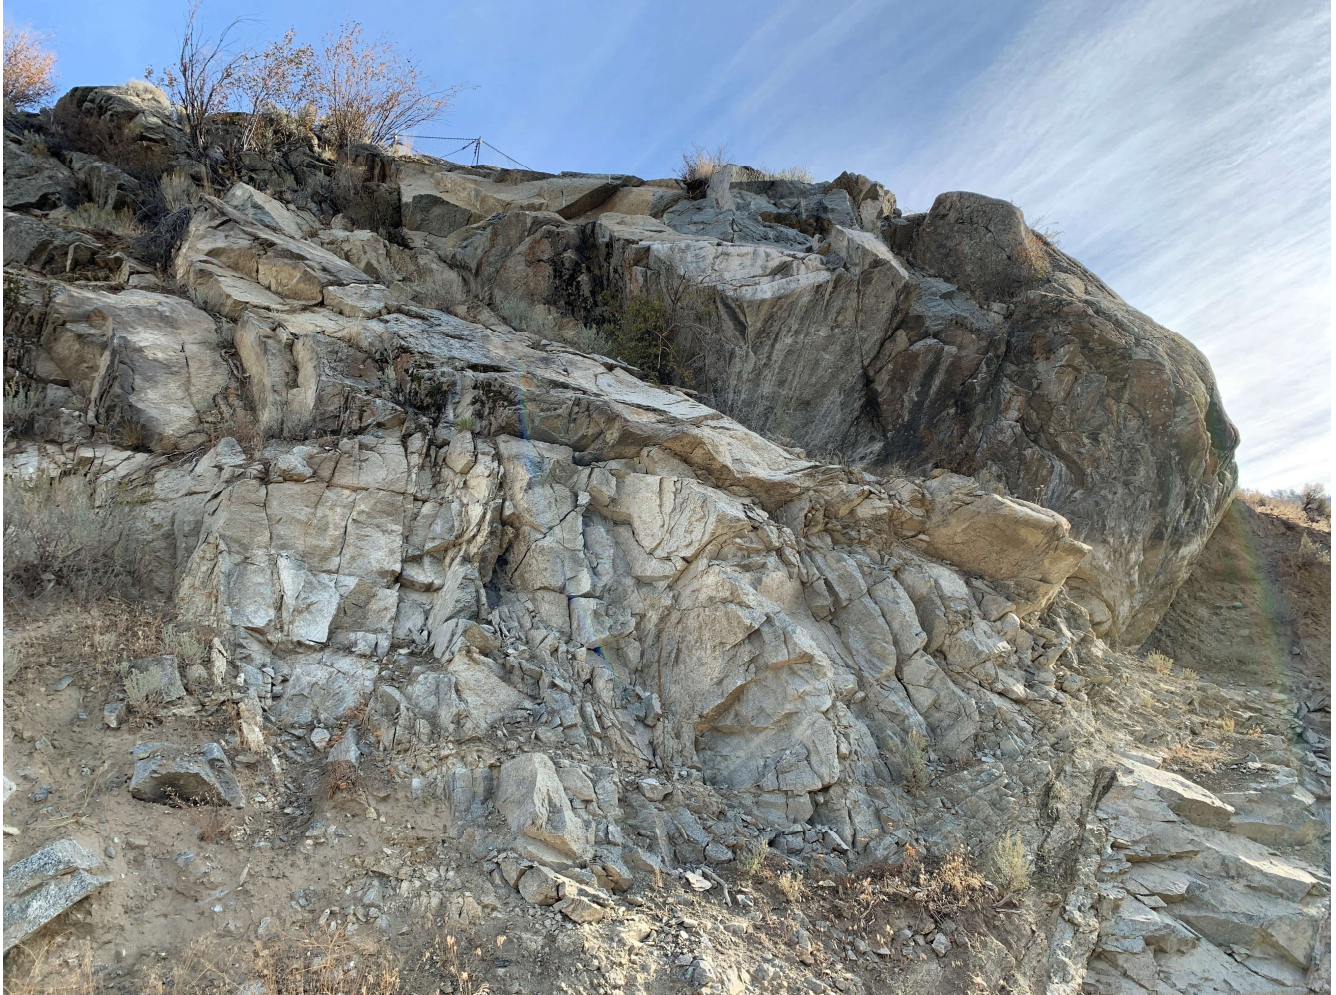
- The southern portion of the site was noted to have slopes exceeding 30° to the east of the access road. This area has rock fall mitigation in place consisting of catchment fences, and blasting to remove the highest risk areas has been undertaken (Photo 4).

**Photo 4** View of scaled and blasted bedrock east of the access road looking east. Rockfall mitigation can be seen at the top of the photo.

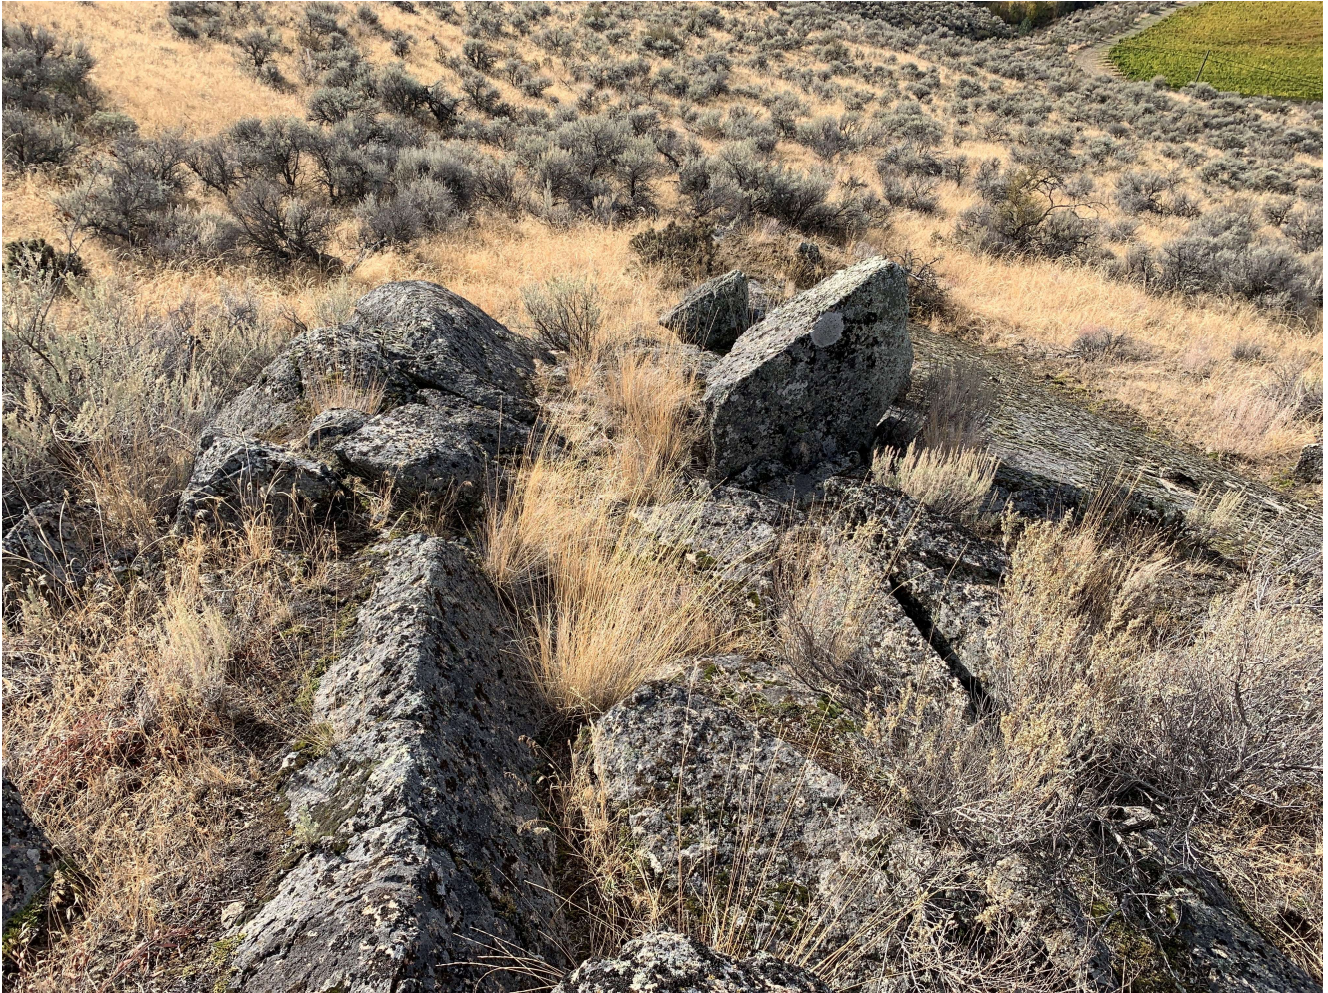
**Photo 5** View smooth bedrock outcrop with sub-angular boulders, west of access road. Photo looking southwest.

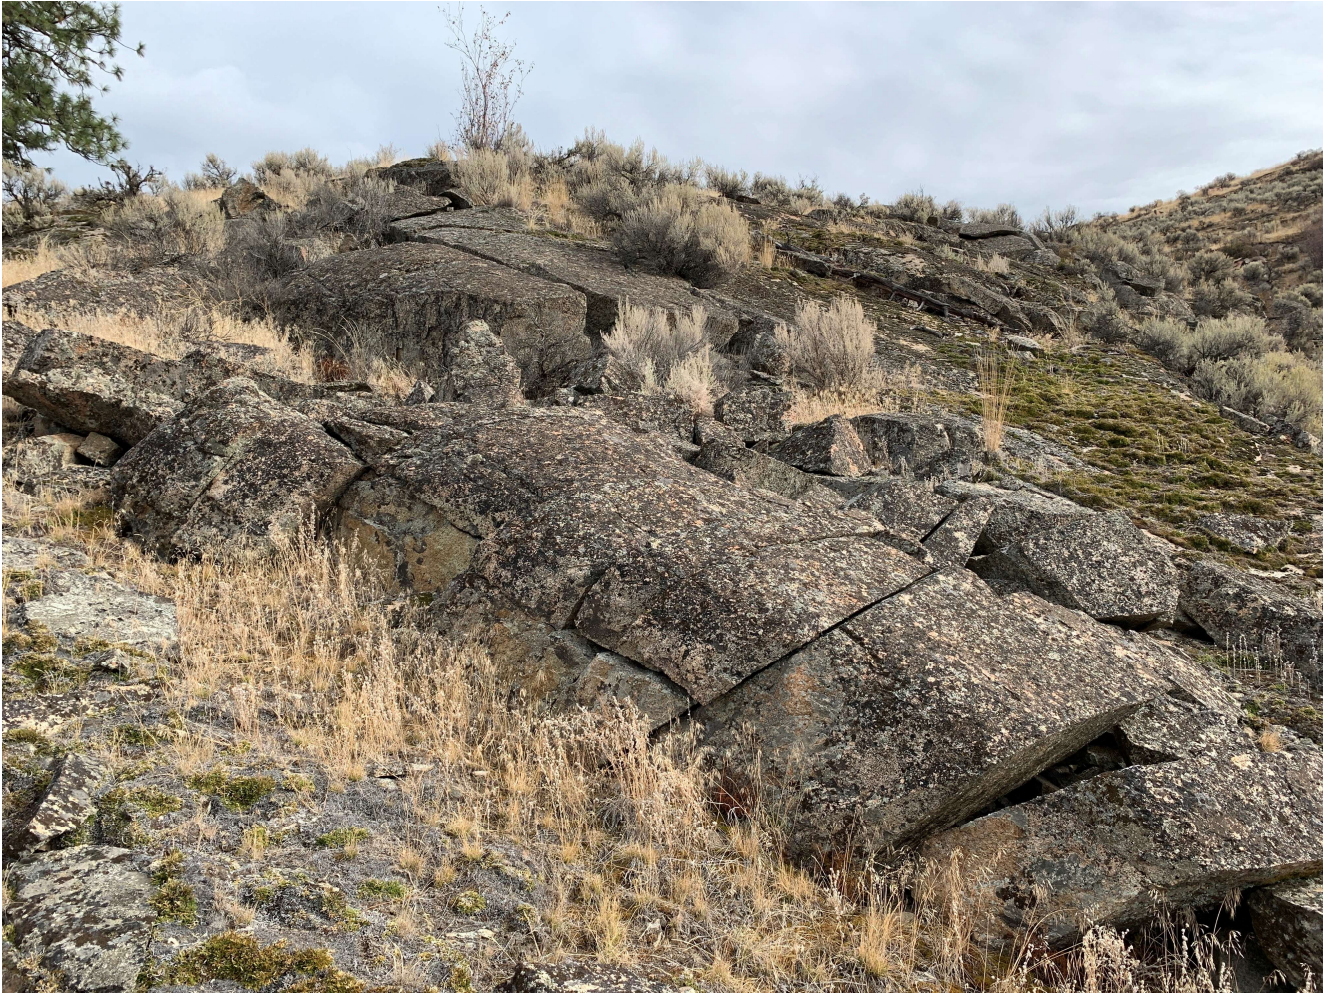
**Photo 6** View of smooth bedrock outcrop east of access road with planar failures visible. Photo looking east.

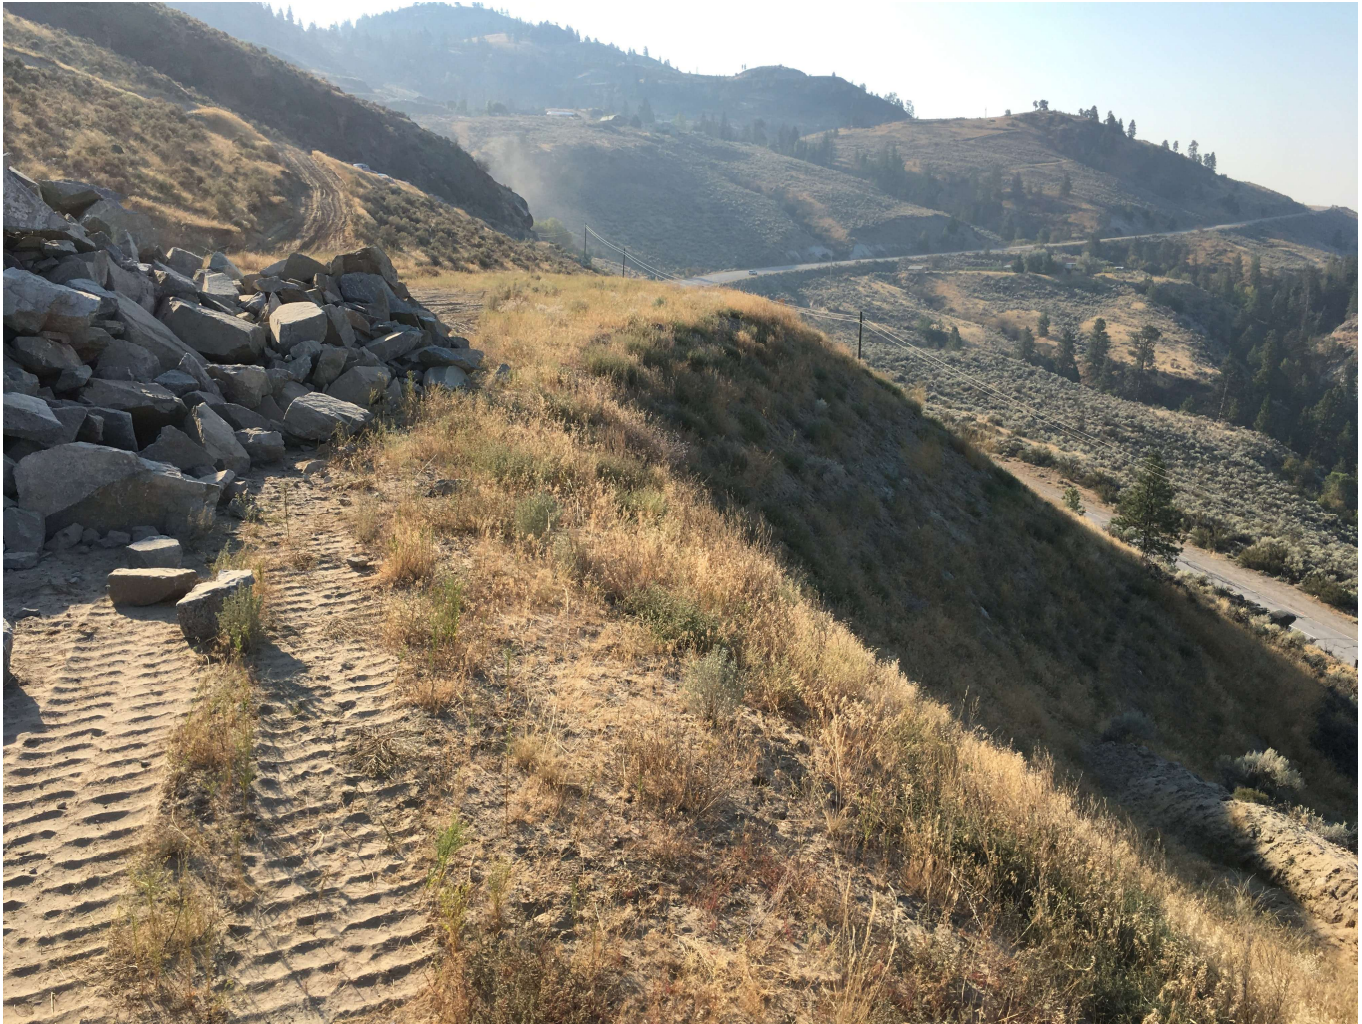
The infilled gully identified during the site reconnaissance and current site investigations, could pose a potential hazard in the form of instability, unacceptable settlement and/or development of sinkholes within that specific area. The approximate extent of the infill material is shown in Figure 3.0. Mitigation measures for this hazard consists of the removal of all uncontrolled fill. These areas may require the placement of engineered fill following the removal of uncontrolled fill to facilitate site development. The engineered fill would need to be placed under the supervision and direction of a qualified professional engineer.

**Photo 7** View of the uncontrolled fill, looking south. Blast rock is currently being stored in the area. The access road to the south portion of the fill can be seen in the top left corner of the photo.

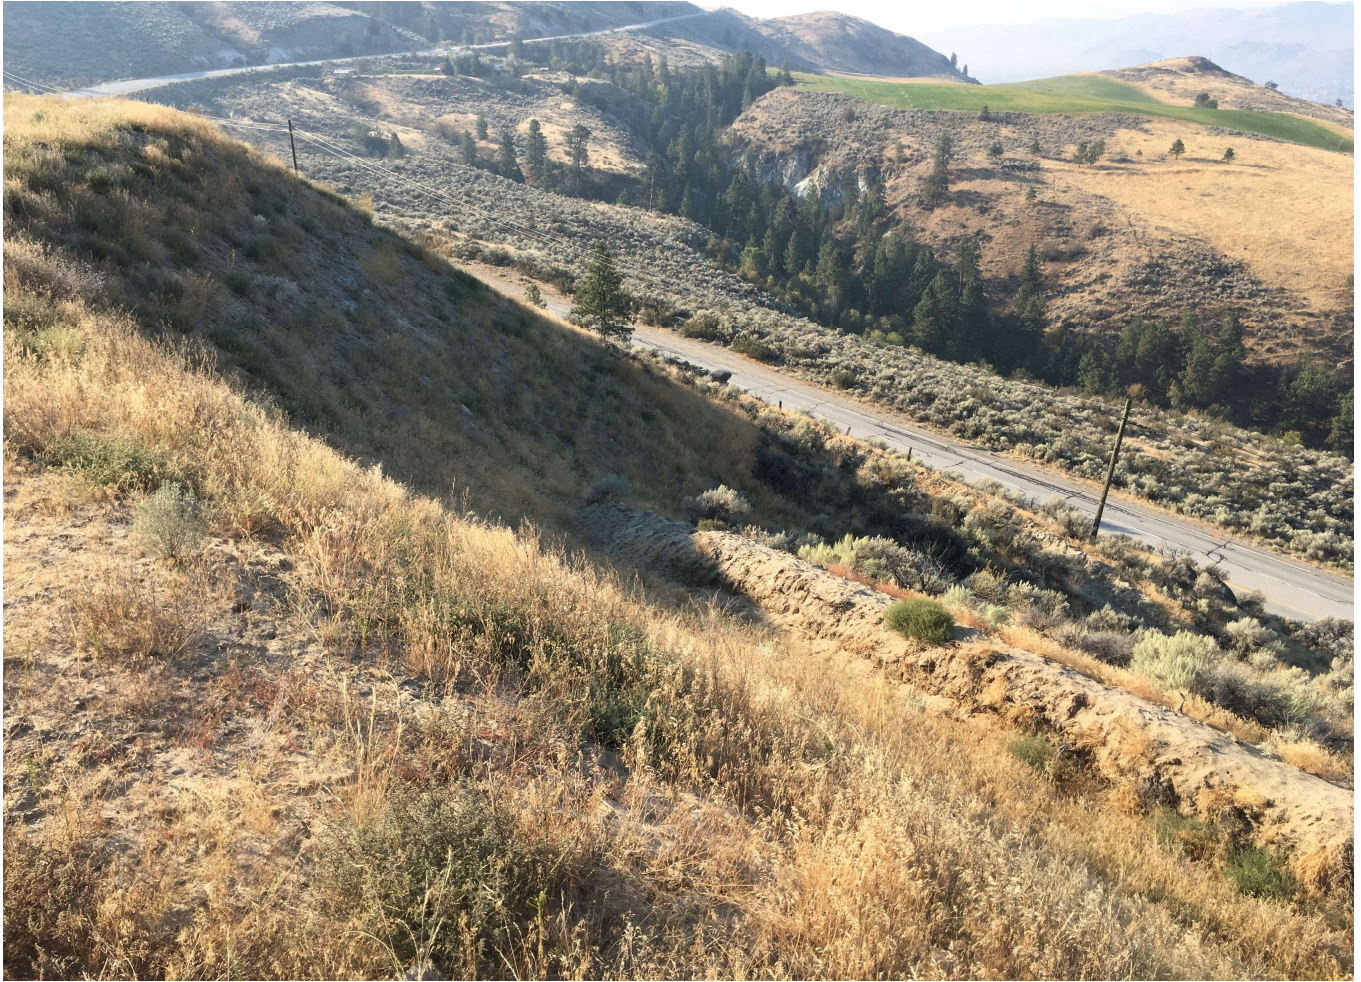
**Photo 8** Downslope view from northwest crest of the uncontrolled fill, looking southwest. A berm to stop material from rolling towards Highway 3 is located at various points around the area, but not around the complete area of uncontrolled fill.

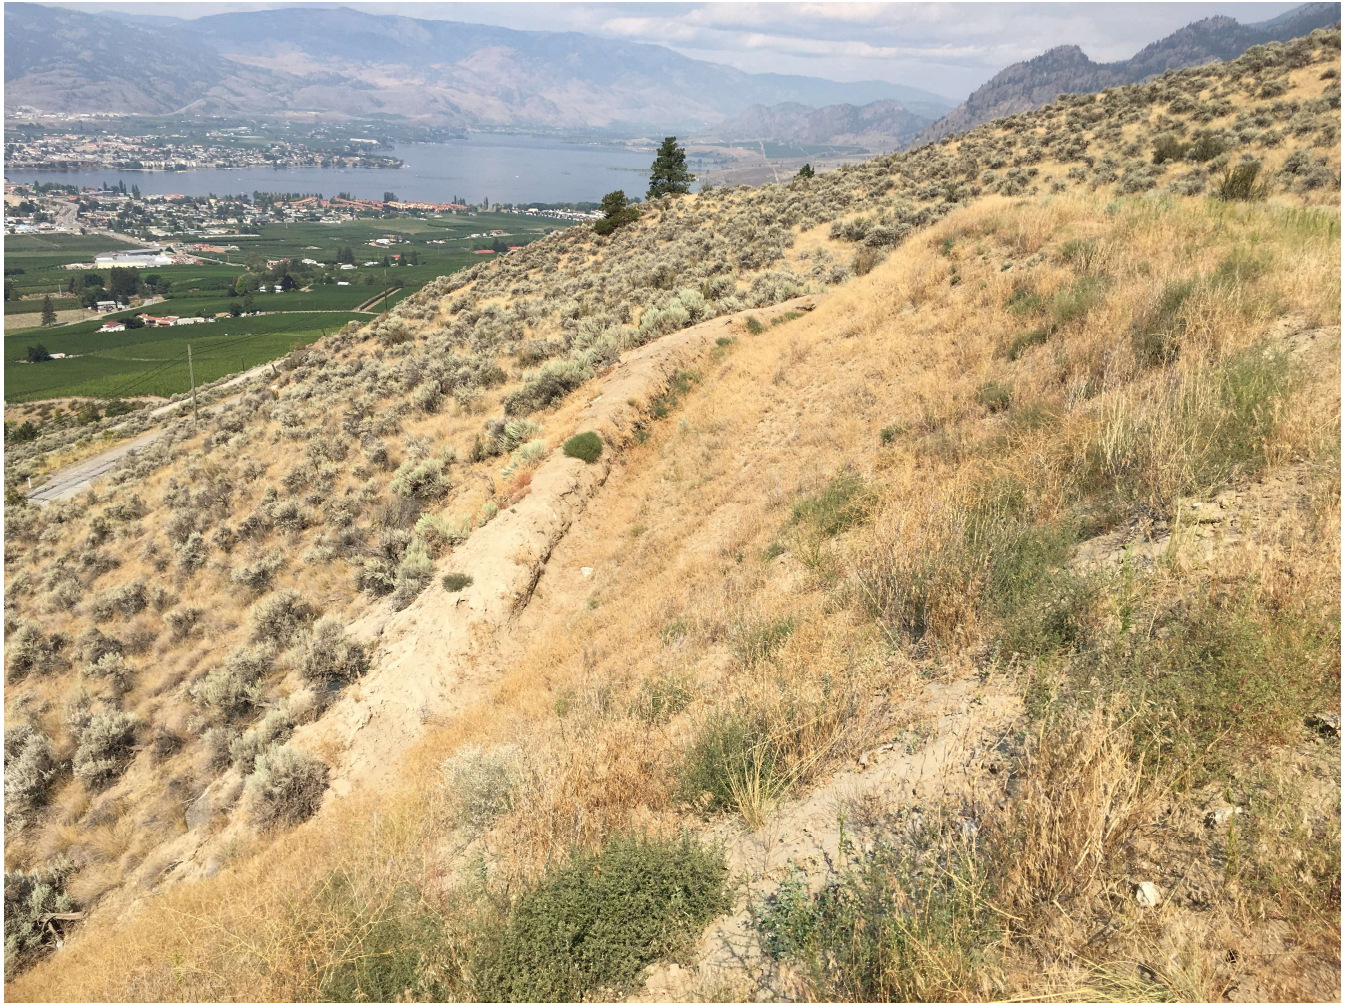
**Photo 9** View of the north side and slope of the uncontrolled fill prior to the stockpiling of blast rock, looking north.

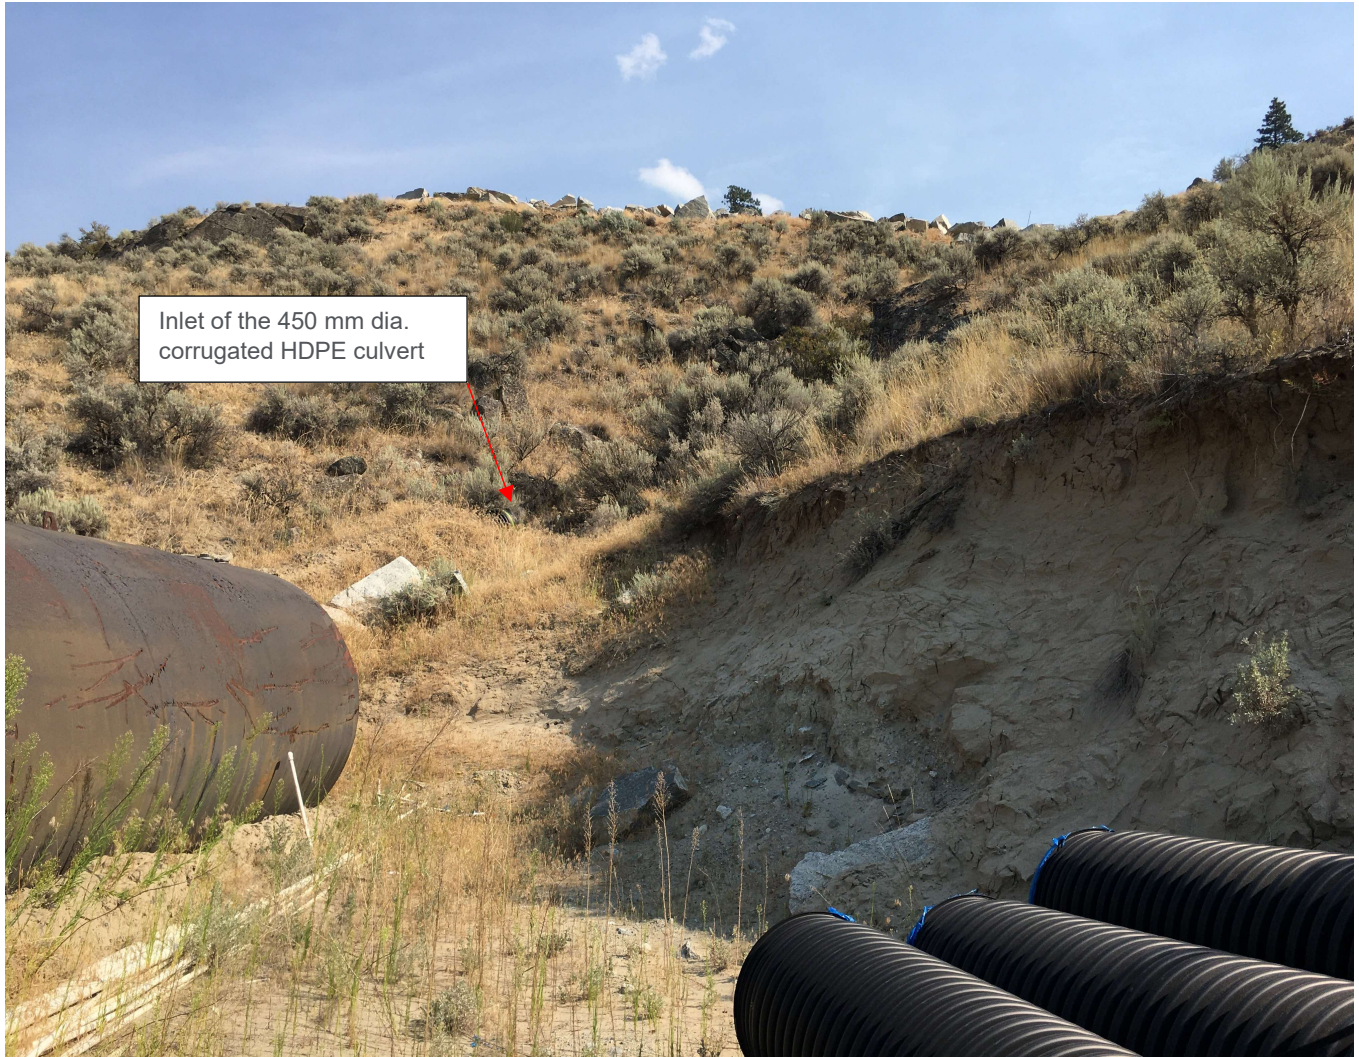
**Photo 10** Inlet of the 450 mm corrugated HDPE culvert running along the unnamed stream bed, below the uncontrolled fill. Photo looking east.

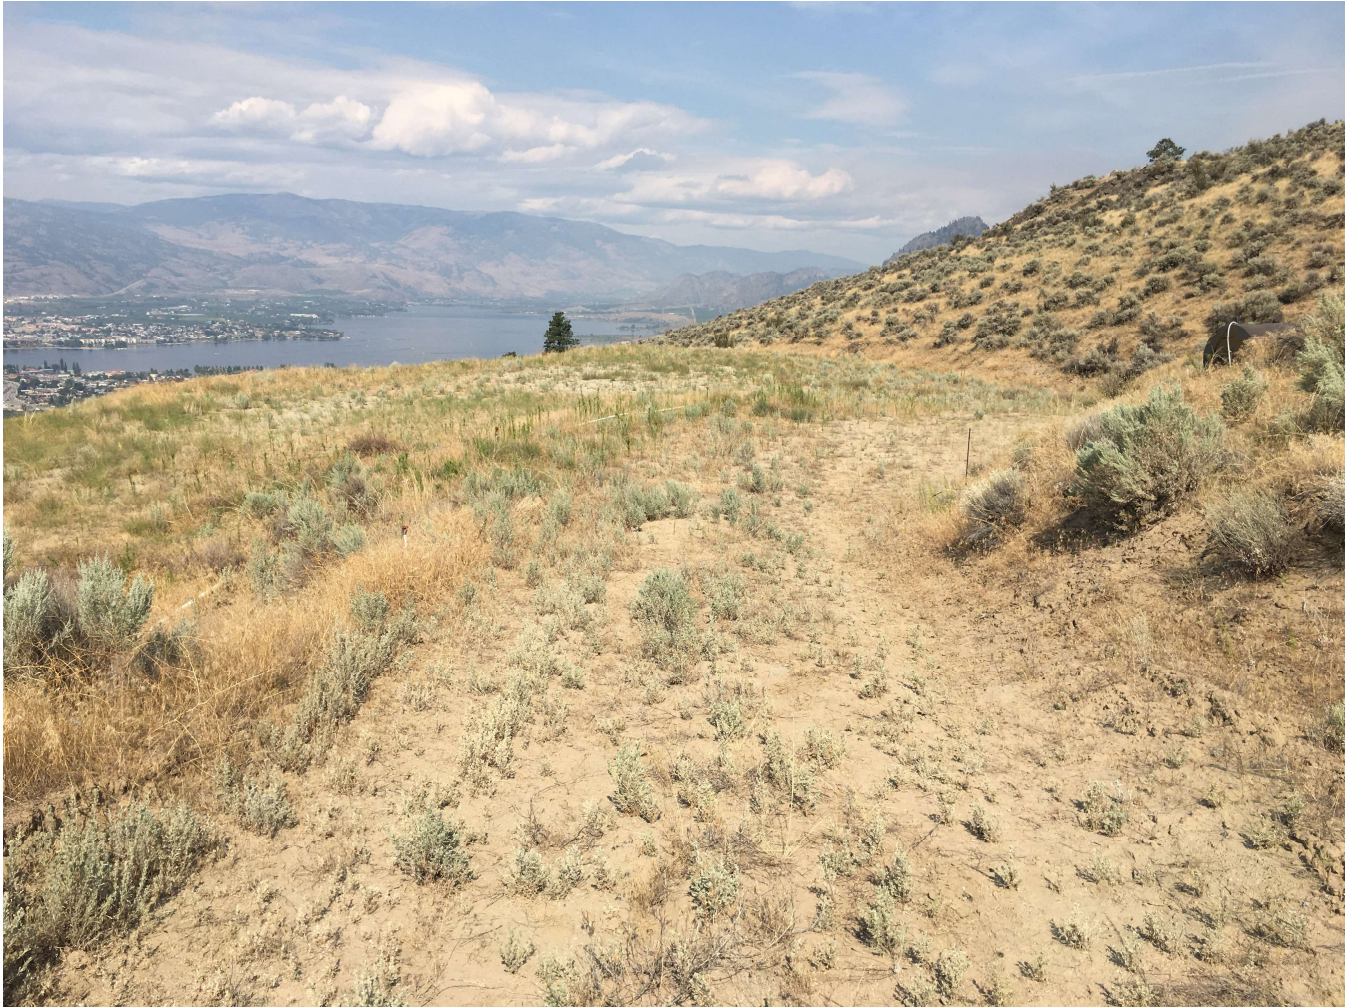
**Photo 11** View of the uncontrolled fill area looking north prior to the stockpiling of blast rock in this area, photo looking north.

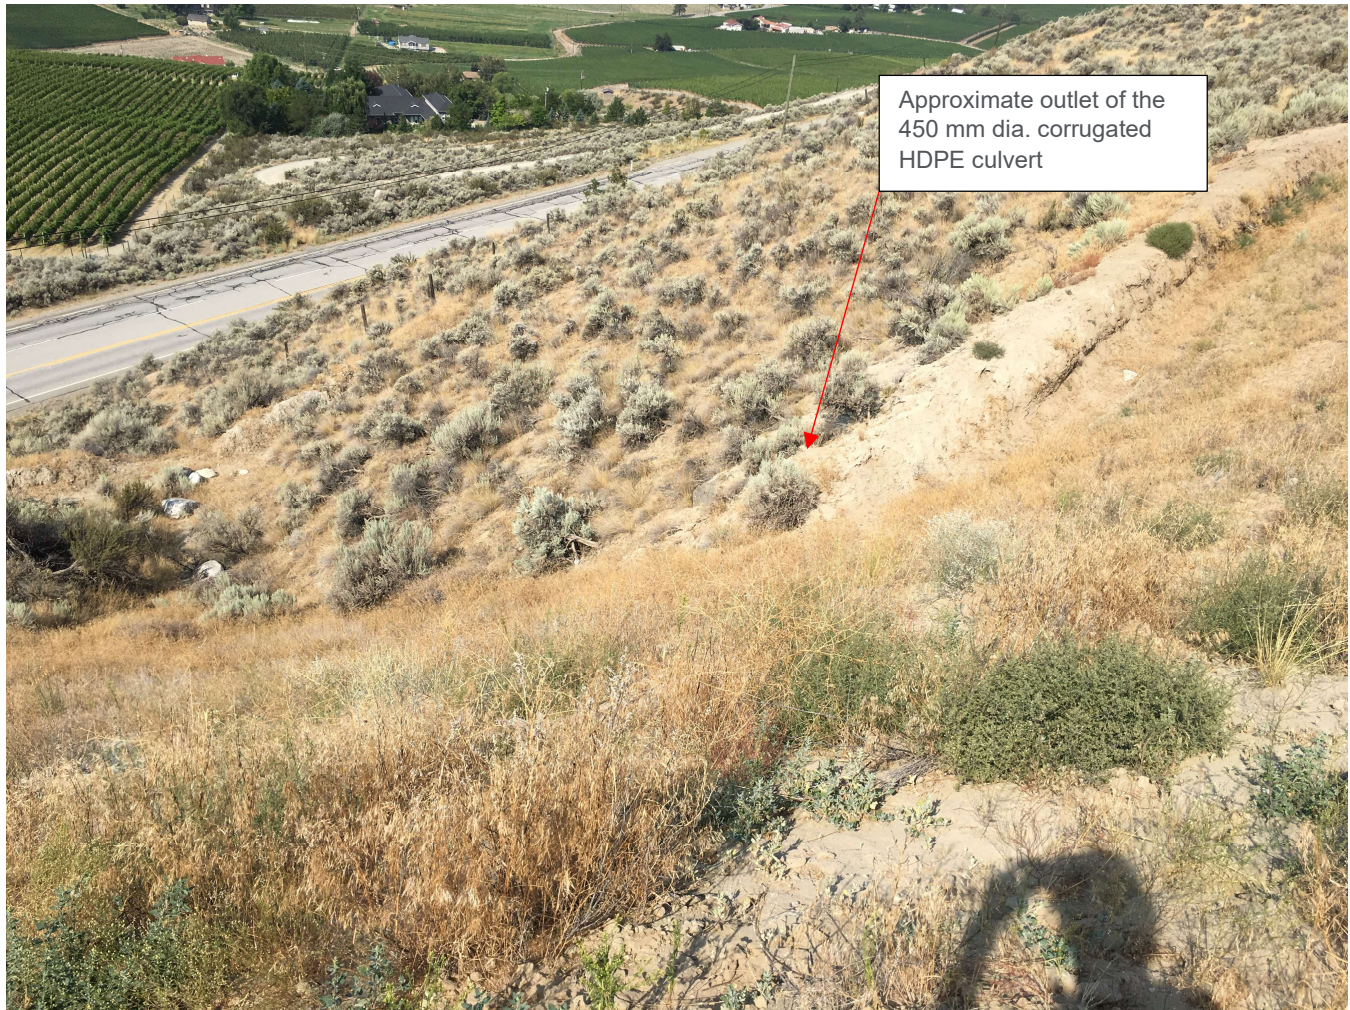
**Photo 12** Approximate outlet location downslope of the toe, of the 450 mm corrugated HDPE culvert running below the uncontrolled fill. Highway 3 can be seen running northwest-southeast in the background, photo looking west.
