Valley Environmental

July 15, 2022

**Re: Hazard Tree & Disease/Infestation Assessment at 4535 and 4545 Mill Road,
Adjacent to Okanagan Lake.**

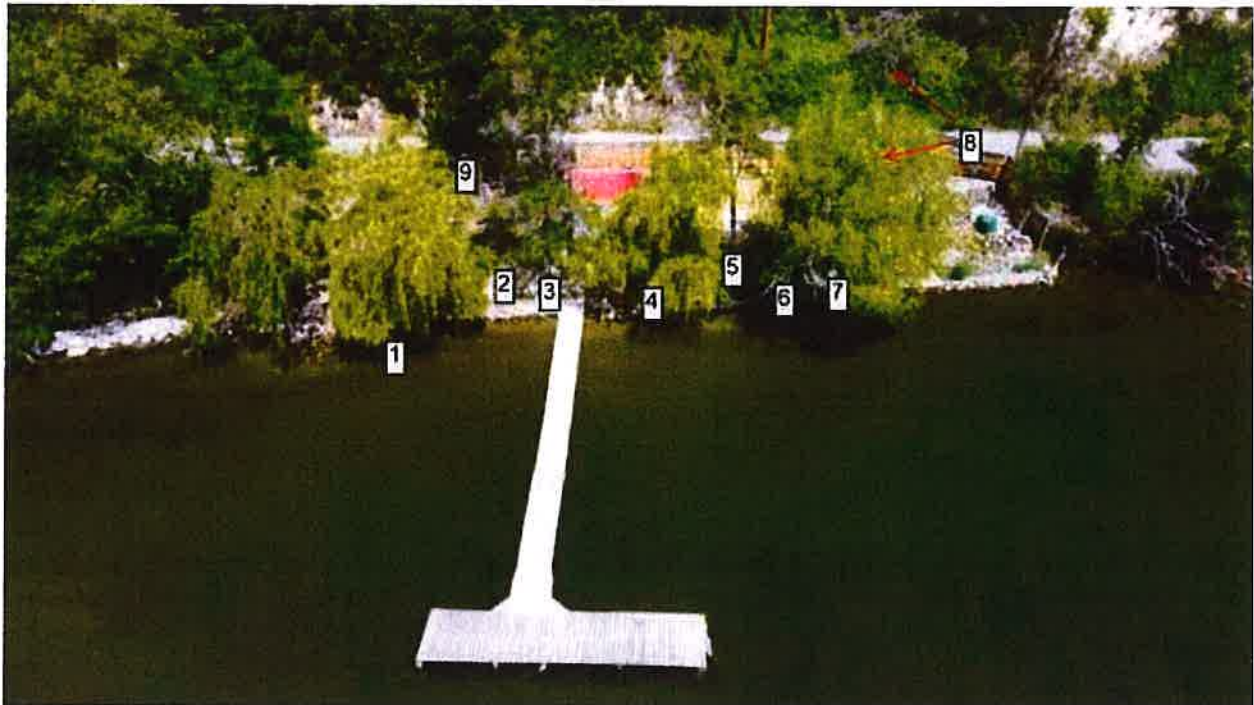
Pic 1 – June 11, 2022 – Drone view looking northward at the 4545 & 4535 Mill Road. Trees 1 – 4 & 9 are on 4545 Mill Rd and Trees 5-8 are on 4535 Mill Rd.

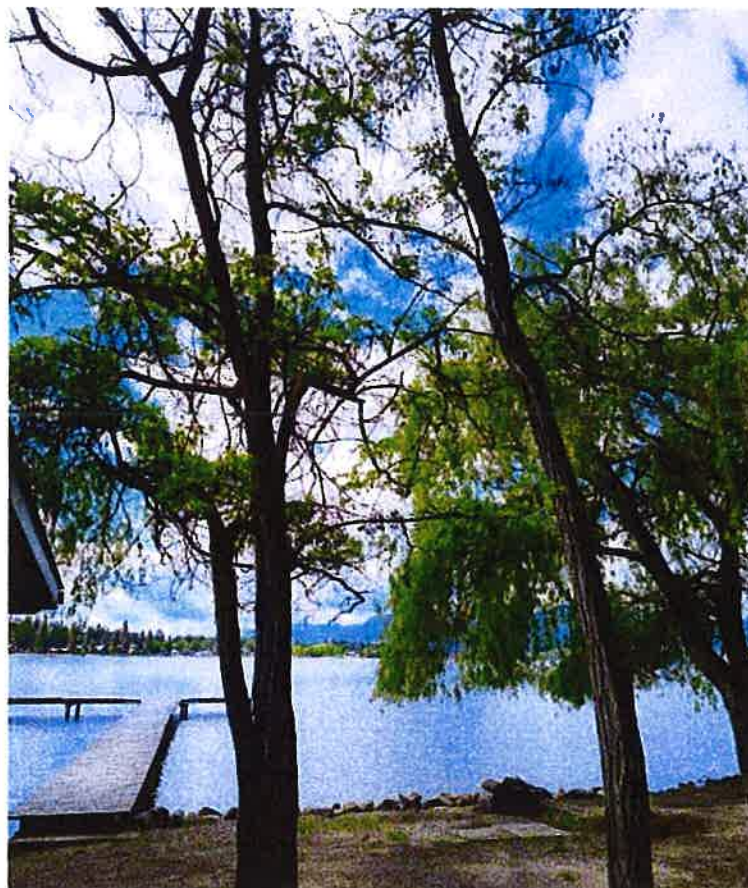
All four Black Locust trees appear to be in significant stress and are either dying, have numerous dead limbs or the leaves are wilted and there was no significant growth. VE estimates that the trees with partial growth will not likely survive the next two years. In addition, the Pine tree is also dead. It should be noted that Black Locust trees are considered invasive and the seeds, leaves and bark are all considered neurotoxins which are poisonous to humans, pets and livestock.

Pic 2 – June 11, 2022 – View looking at trees 2 & 3 which are Black Locust and need to be removed. Both of these trees are partially dead and have several large limbs that could fall on the existing cabin or dock area. Tree 1 on the far right is a weeping willow and is currently healthy.

Given the above VE has classified 6 trees as hazardous and should be removed prior to further use of the properties as an amenity space. The four Black Locust trees (trees 2, 3, 5 & 8) will need to be removed as they are dead or dying and could fall on cabins, the dock or residents using the amenity space. The Pine tree (tree 6) is also dead and should be removed. The Pacific Willow (tree 7) is in danger of splitting where it could fall on a proposed new dock, swimmers or the main stem could snap and fall back and injure residents within the amenity area.

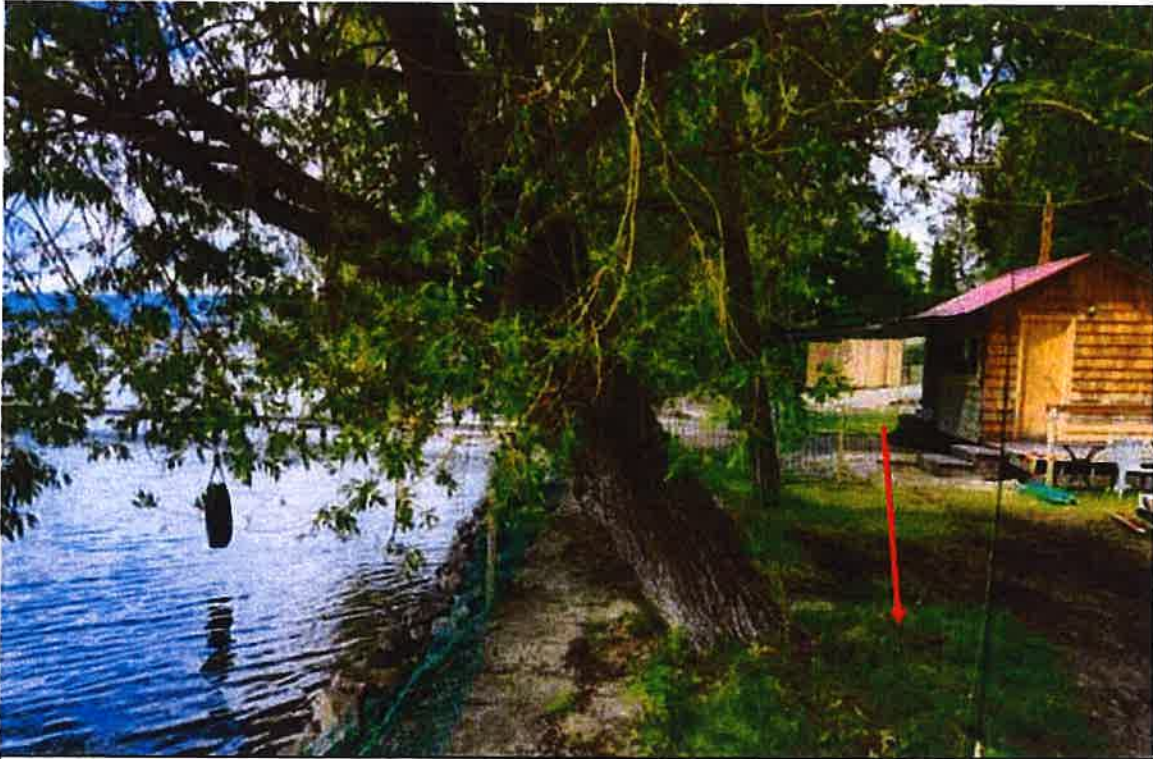
The Pacific Willow appears to have significant growth however, this tree has significant lean, has a significant stress fracture in its main stem (likely from the extensive lean) and has several large dead branches. The root mass was also lifting due to the extensive tree lean.

Pic 3 – June 11, 2022 – View looking at the Pacific Willow on 4535 Mill Rd. The root wad on the base of the tree on the right is lifting due in part to the tree lean; several large roots are exposed. This tree is in danger of falling over from the tree lean alone. A large stress fracture was also observed (see photo below).

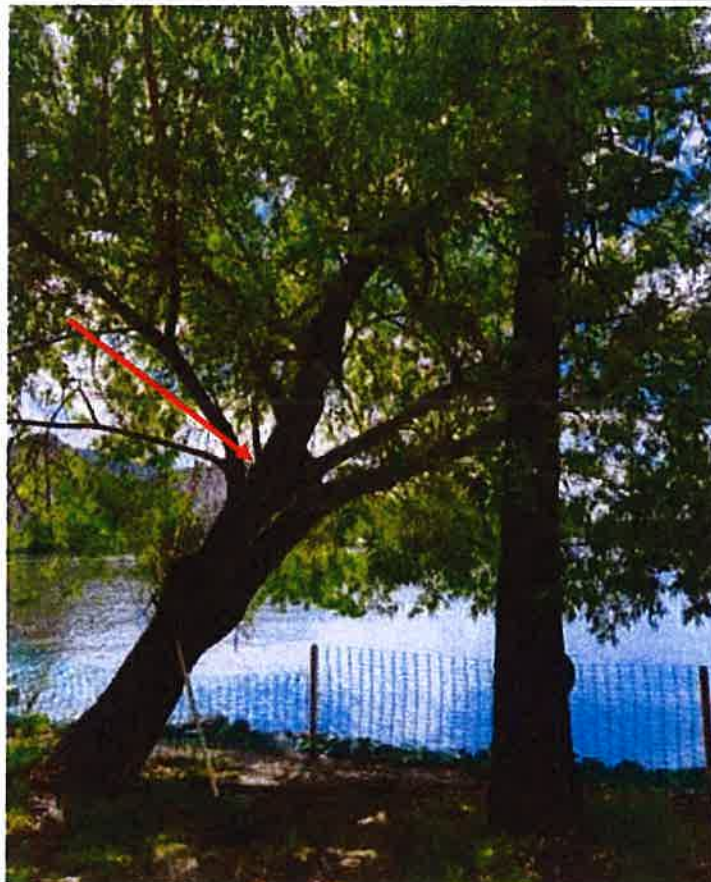
Pic 4 – June 11, 2022 – View looking at the dead pine (right) and the Pacific Willow (left). The willow has a large stress fracture in the main stem noted in the location of the red arrow.
