Geotechnical Report

File: RGC-2960

Subject: ***Geotechnical Assessment for Demolition of House and Backfilling
At 811 West Bench Drive, Penticton, BC***

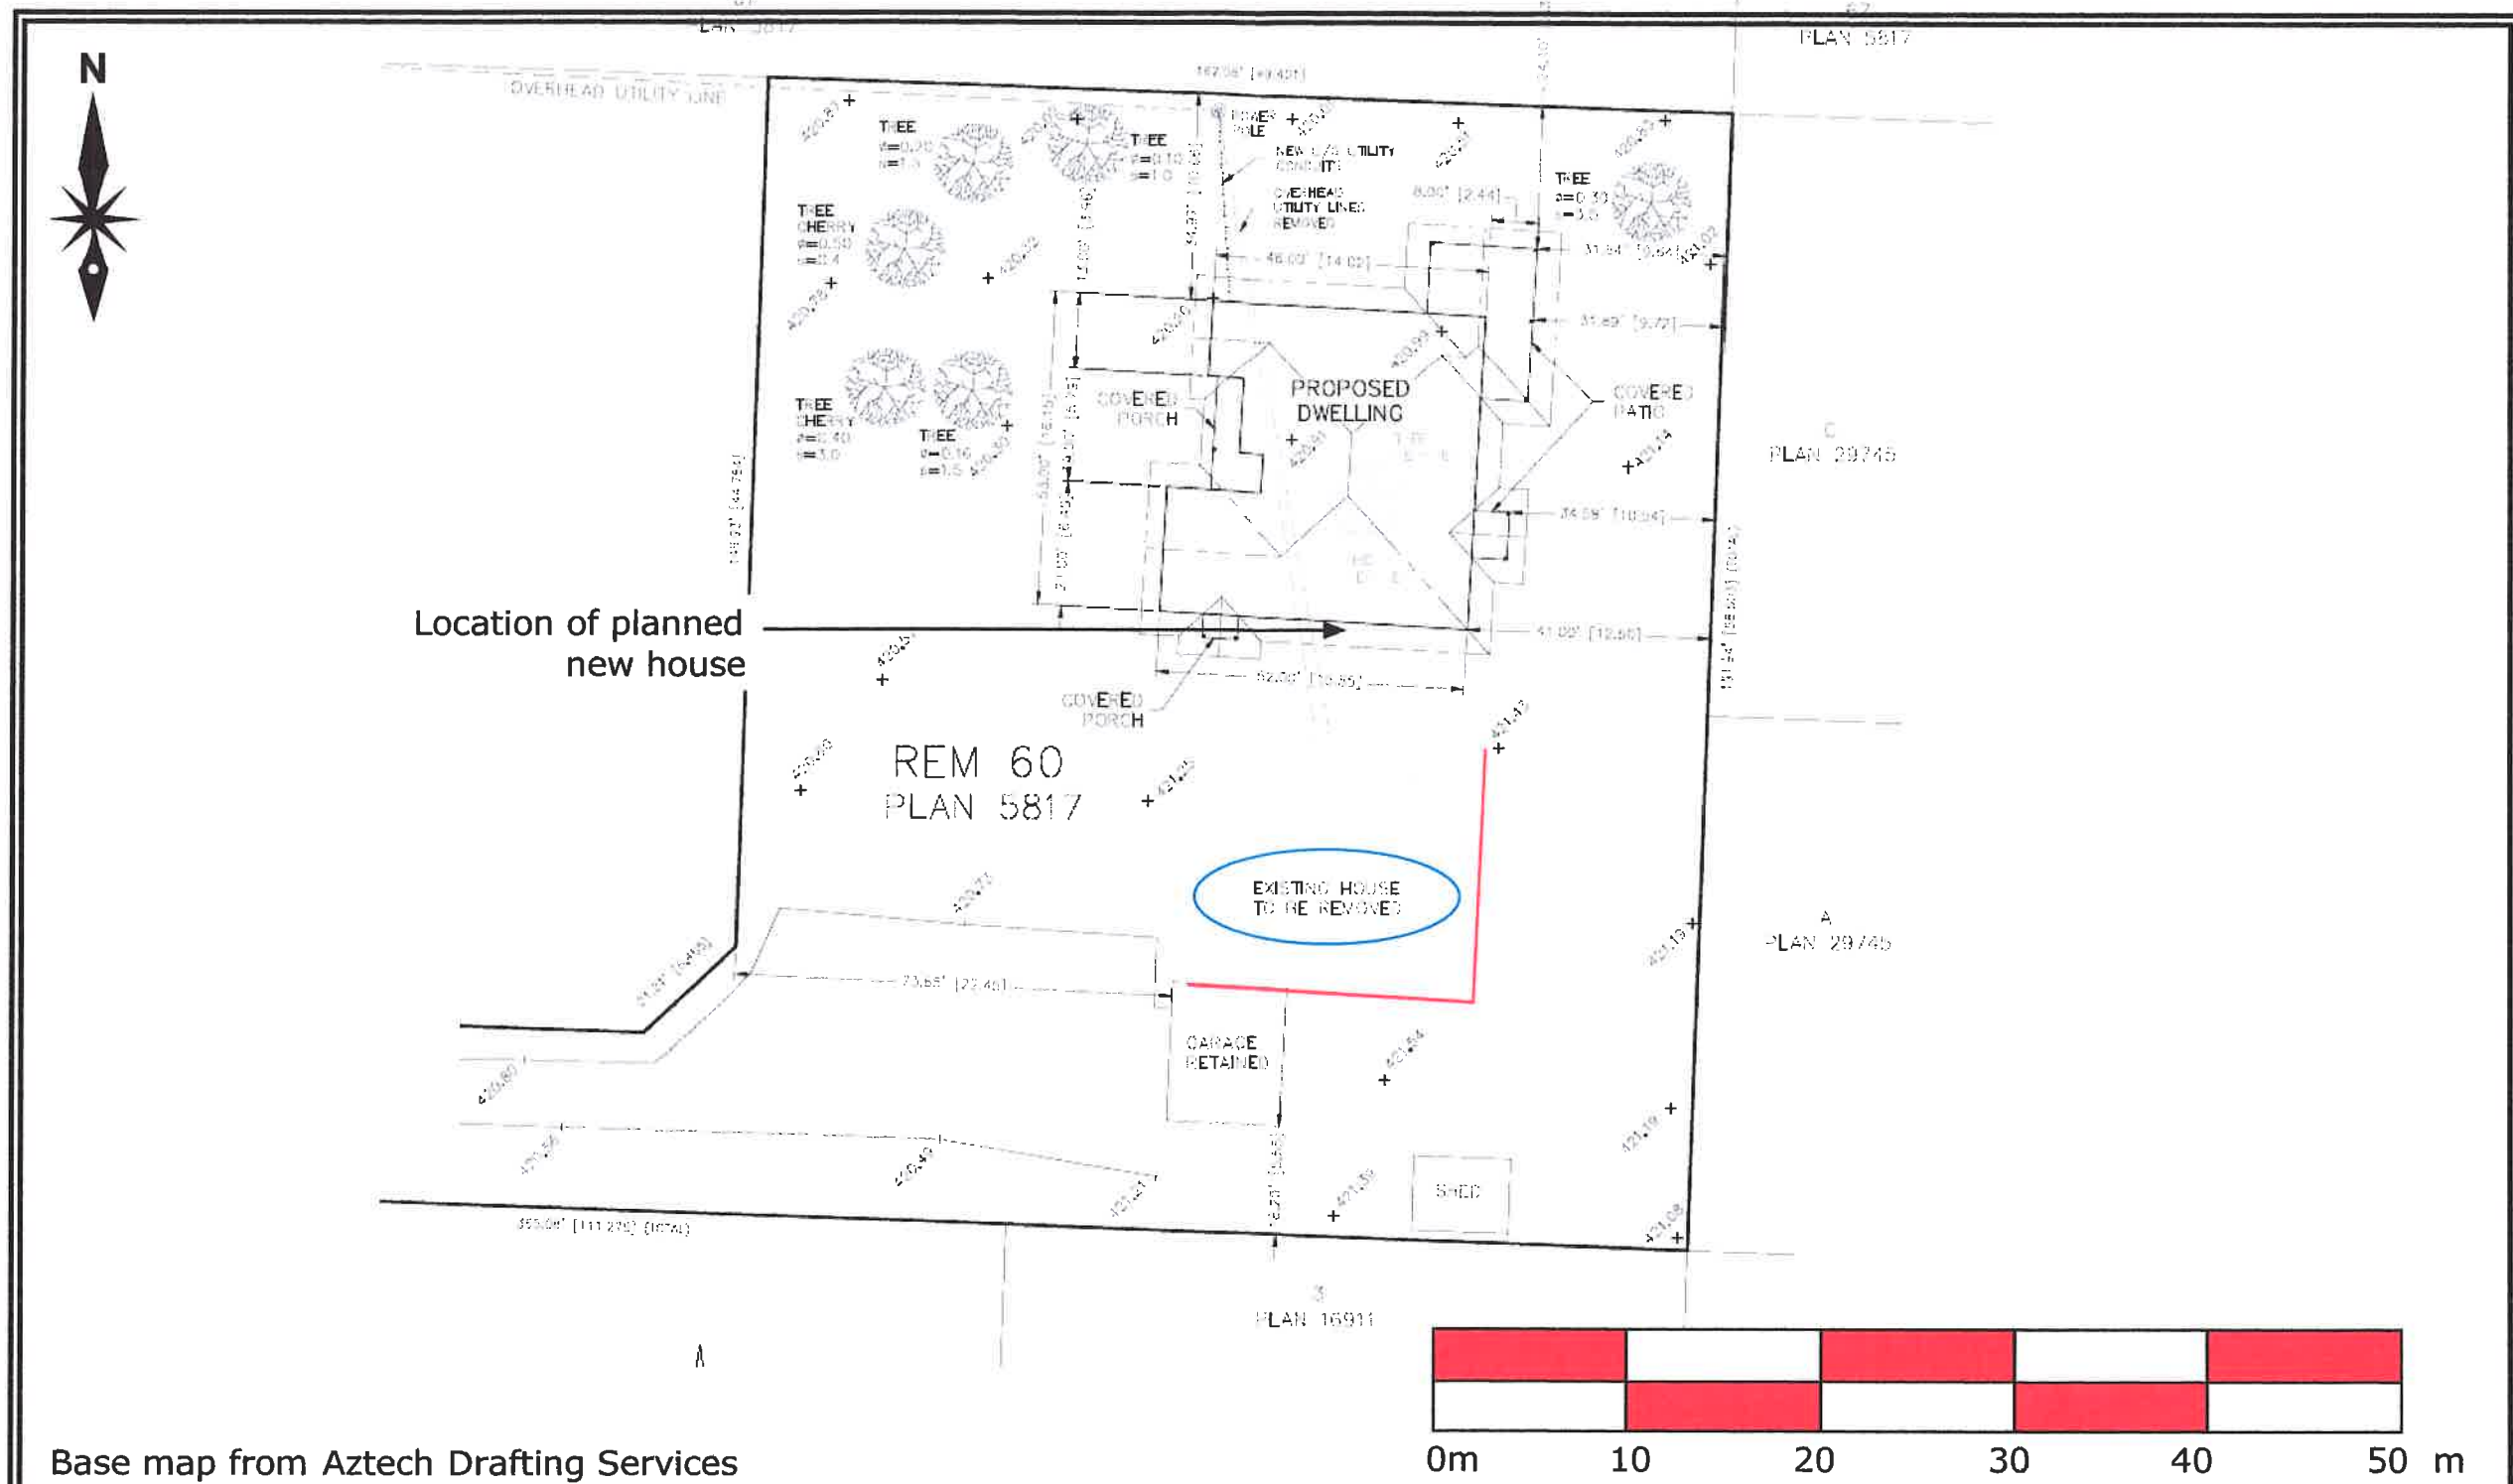
Figure 2: Site Plan
811 West Bench Drive, Penticton, BC

The property is located about 350m from the nearest moderate landslide hazard area. A low landslide hazard classification is consistent with site observations. The subject property is flat to gently sloping, with an indicative elevation of 421m; gently sloping

northeast towards the lowest corner at elevation of 420.8m. See spot elevations across the property in Figure 2: Site Plan.

The arrangement of site structures was confirmed as shown in Figure 2: Site Plan. The property is access from West Bench Drive via a panhandle driveway, and is surrounded by developed residential lots. On the day site observations of site soils were limited to areas of recent disturbance. Review of previous RGC testpit logs and recent house construction photos also confirm presence of glaciolacustrine sediments. It is anticipated that construction backfill materials may be present near the old house but this will be confirmed further as part of demolition.

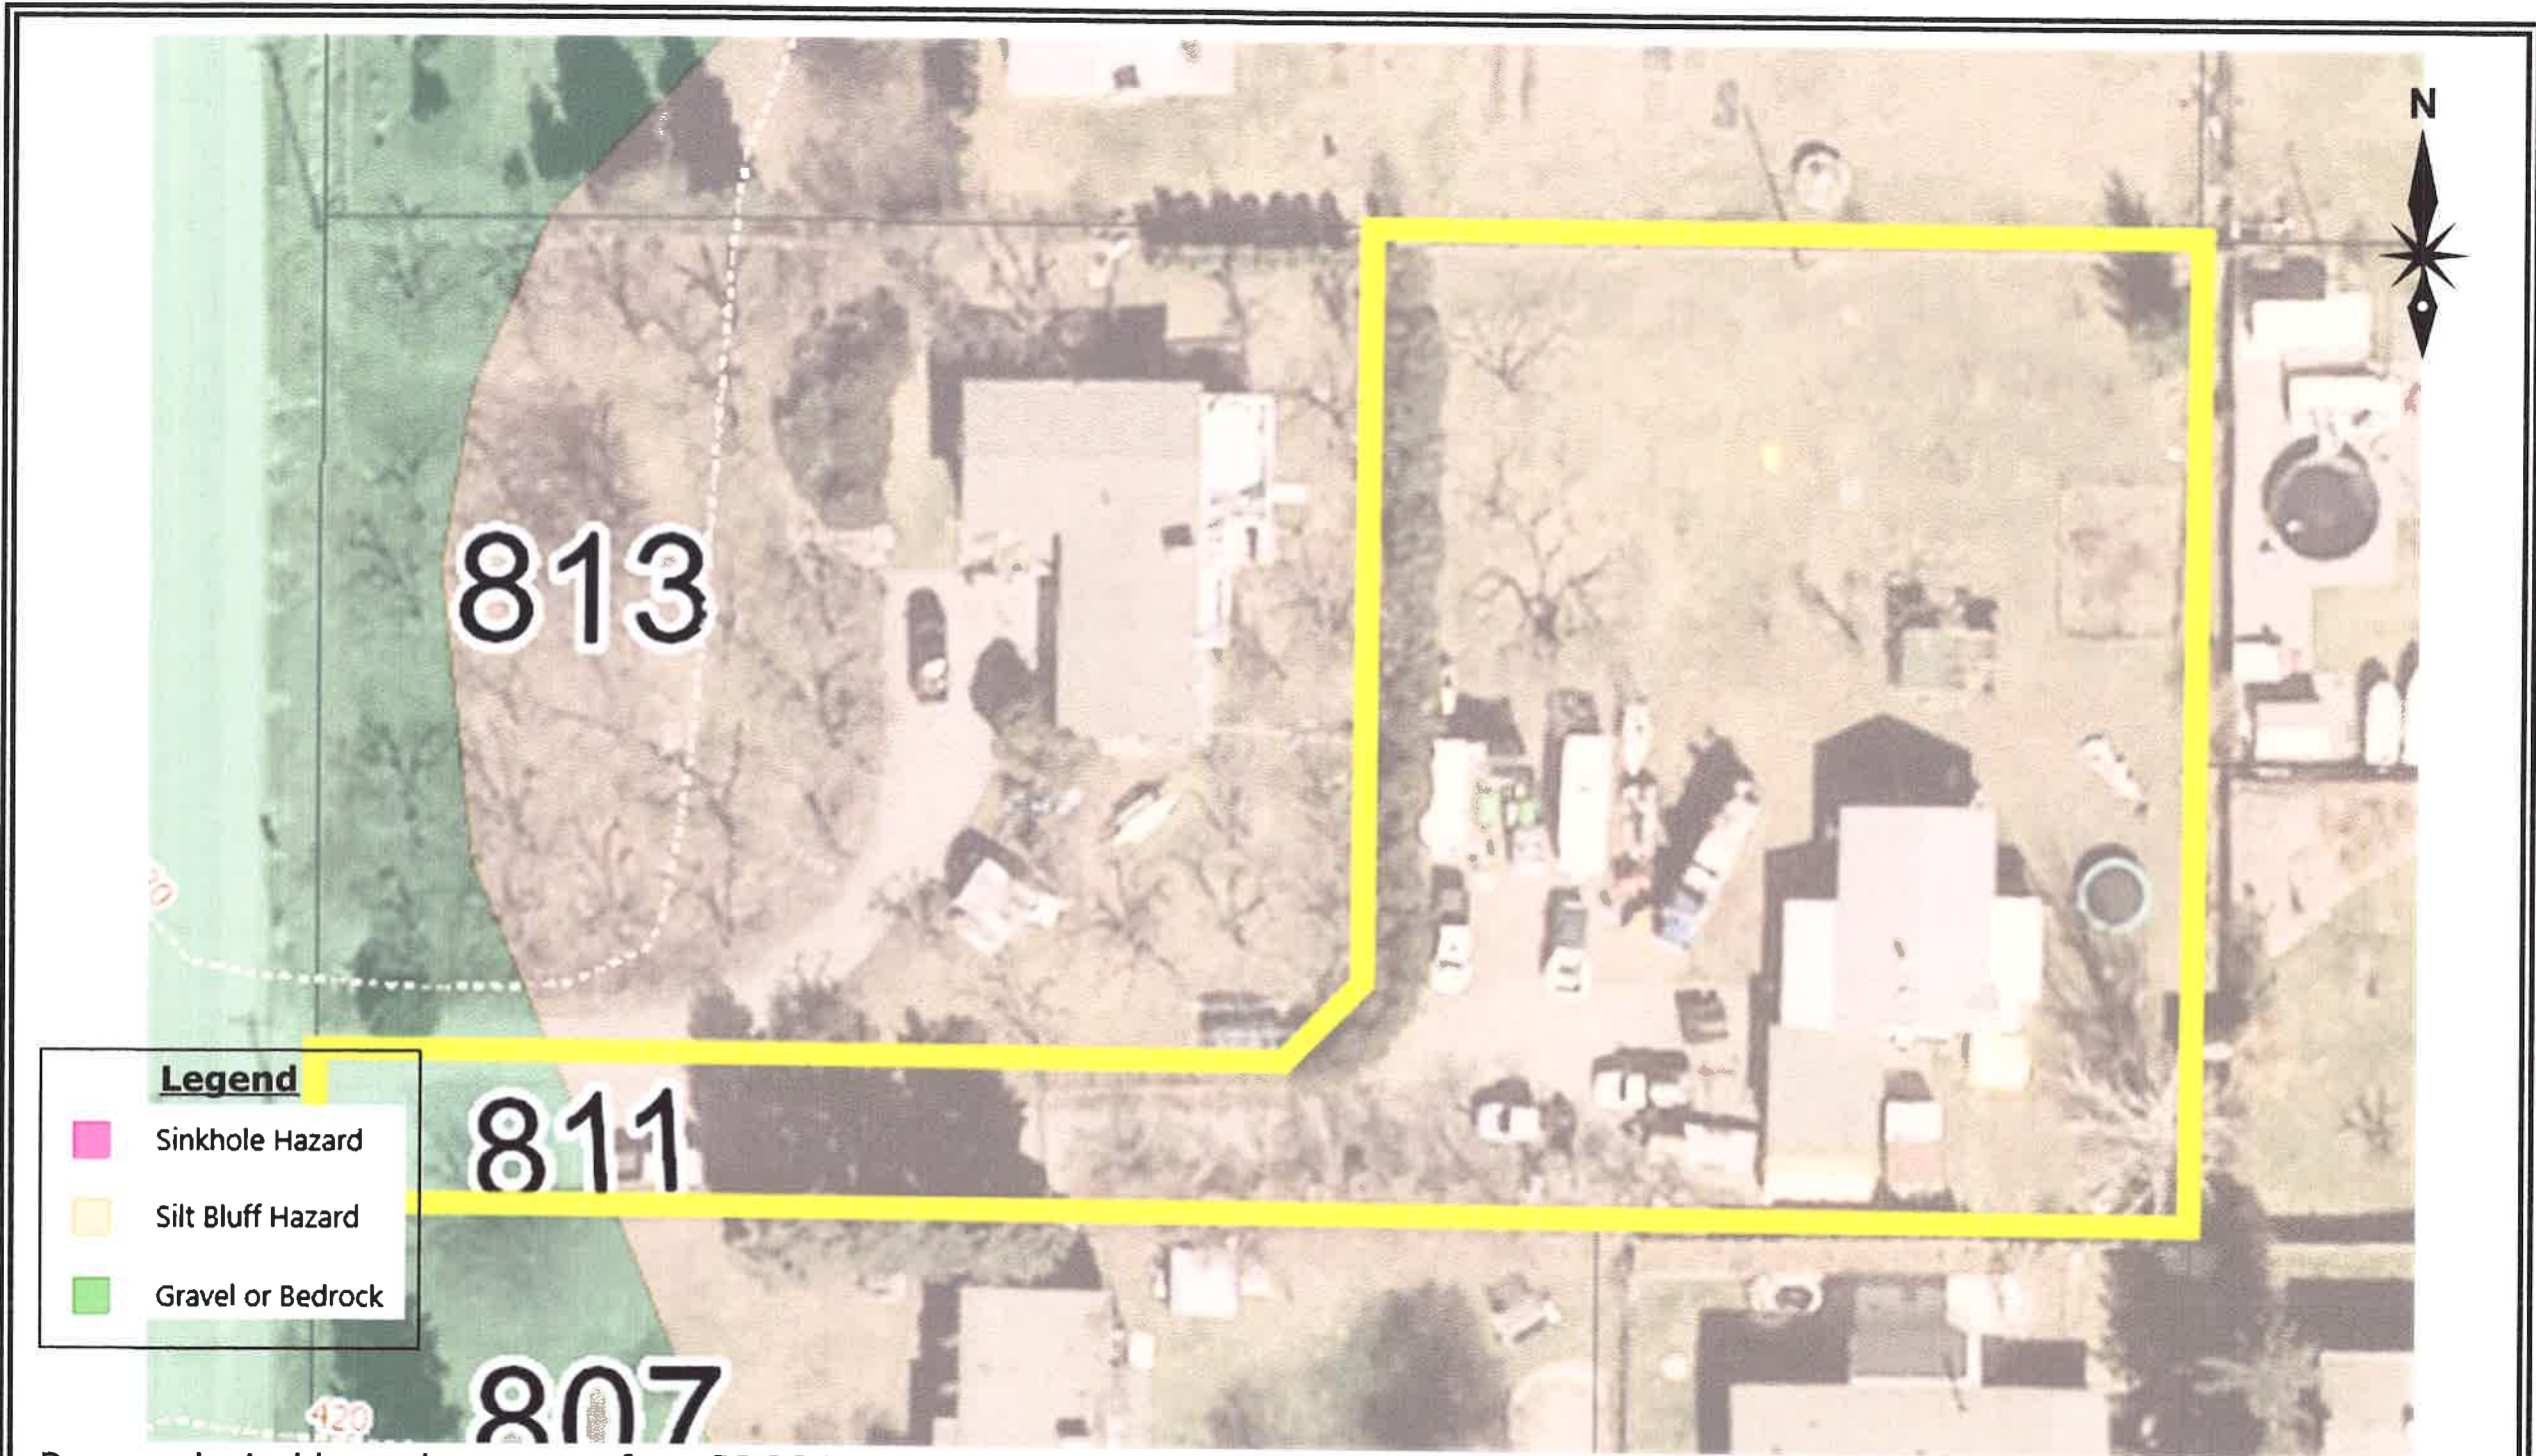
Figure 3: Hazard Map 9 (Leonoff, 1992)
811 West Bench Drive, Penticton, BC

Klohn Leonoff Geological Mapping - As shown on Figure 3: Hazard Plan, area surrounding 811 West Bench Drive as "Silt Bluff Hazard Zone" with a low to moderate hazard classification.
