September 25, 2023

GFX-1068

Geotechnical and Geohazard Assessment for Existing Swimming Pool – **AMENDED in RED**
2636 Forsyth Drive, Penticton, BC

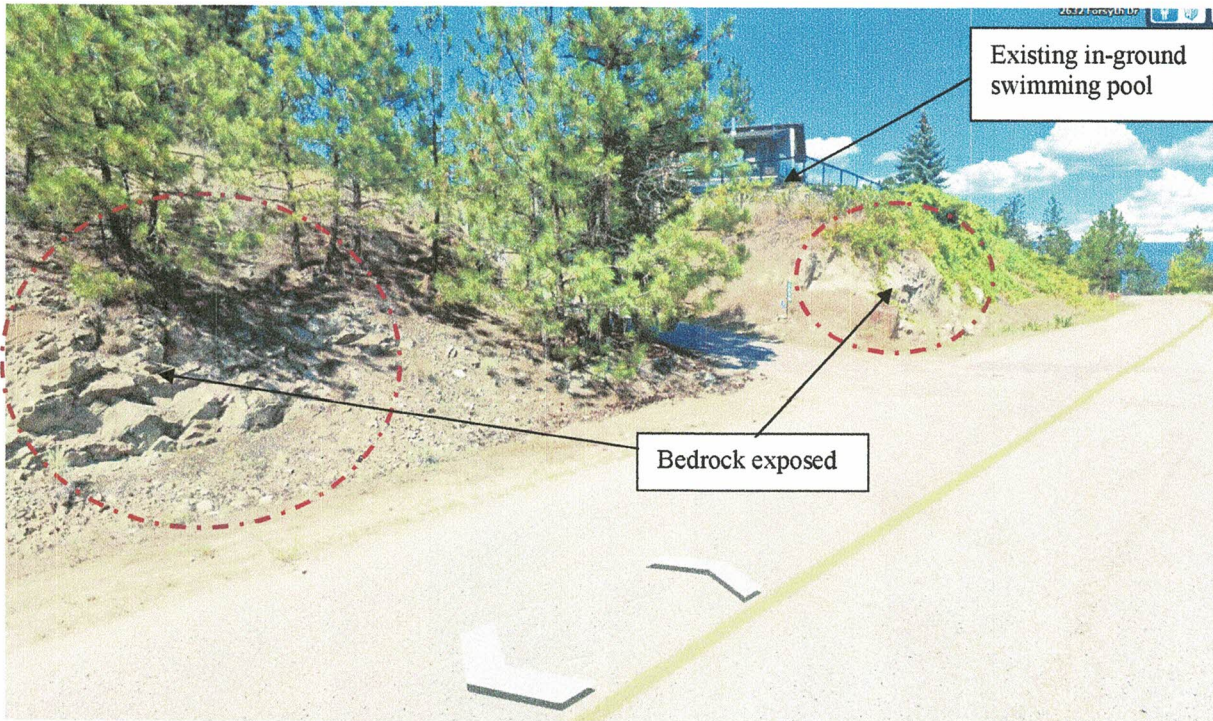
Through discussions with the property owners, as well as a visual assessment of the property, it is understood that the swimming pool was constructed on bedrock. Bedrock can be seen in the roadway cut slopes, as shown in Photos No. 1 and 2 from Google Earth.

Photo No. 1 (Google Earth): Street view looking east up Forsyth Drive
Note bedrock exposed in cut slopes below pool and just below property.

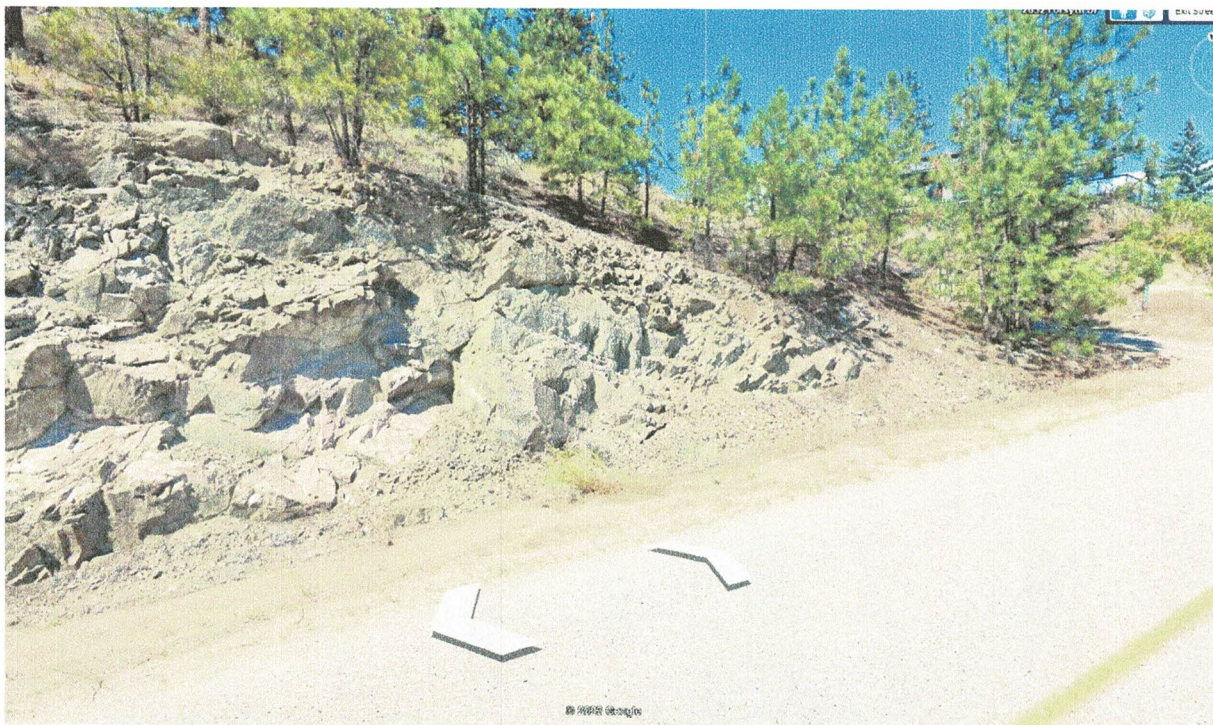
- The primary geohazard of note near the swimming pool is potential rockfall. The bedrock cut slope below the existing swimming pool is only approximately 8 feet high at the most and is presently stable.

Photo No. 2 (Google Earth): Street view looking northeast up Forsyth Drive
View of bedrock cut slope just below property.

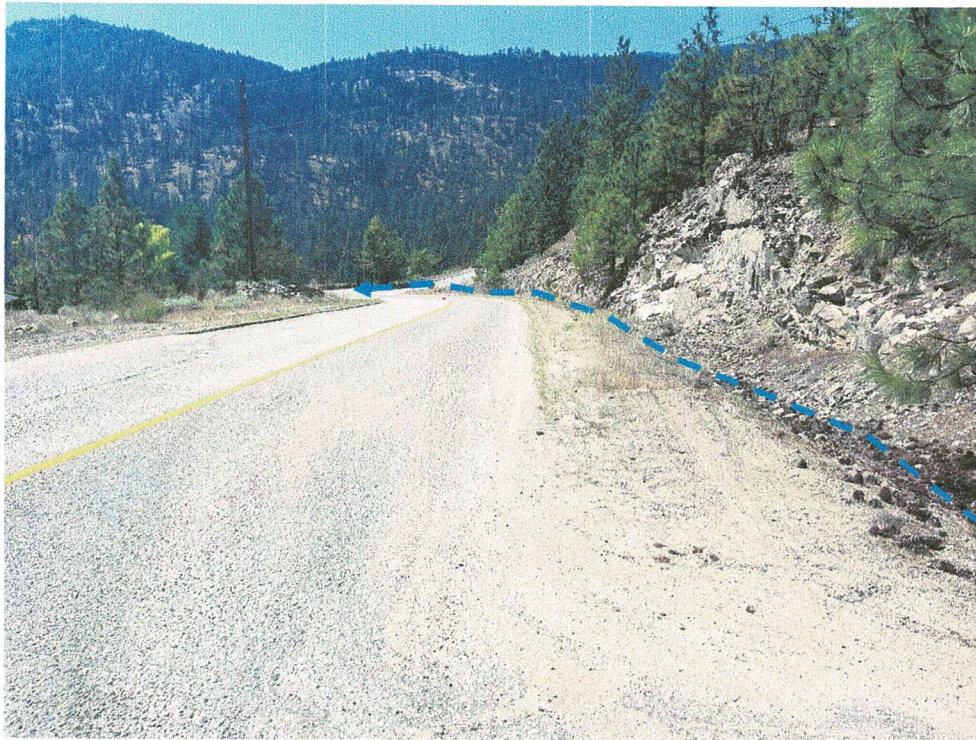
It is understood that when the swimming pool is drained, the water is discharged to the Forsyth Drive ditch. In addition, if the swimming pool were to fail, the water from the swimming pool would exit the swimming pool and drain directly to the Forsyth Drive ditch. From the ditch on Forsyth Drive, any pool runoff or leakage would eventually infiltrate into the soils and eventually make its way to Madeline Lake (See Photo No. 3 and Figure 3 – Drainage Route).

- The existing swimming pool is located approximately 75 m from the nearest downstream house. In the event of a swimming pool leak, the ditch along Forsyth Drive would convey the pool water as shown on the attached *Figure 3 – Drainage Route*. Any pool runoff or leakage would eventually infiltrate into the soils or make its way to Madeline Lake (See Photo No. 3).

Photo No. 3 : View looking west down Forsyth Drive towards location where any pool leakage or runoff water would infiltrate into the soils along the ditch and eventually make its way to Madeline Lake. (2023 07 31).
See attached Figure 3 – Drainage Route for approximate runoff path.

Any drainage from the swimming pool should be carefully controlled and not allowed to discharge a concentrated flow that could cause soil erosion.

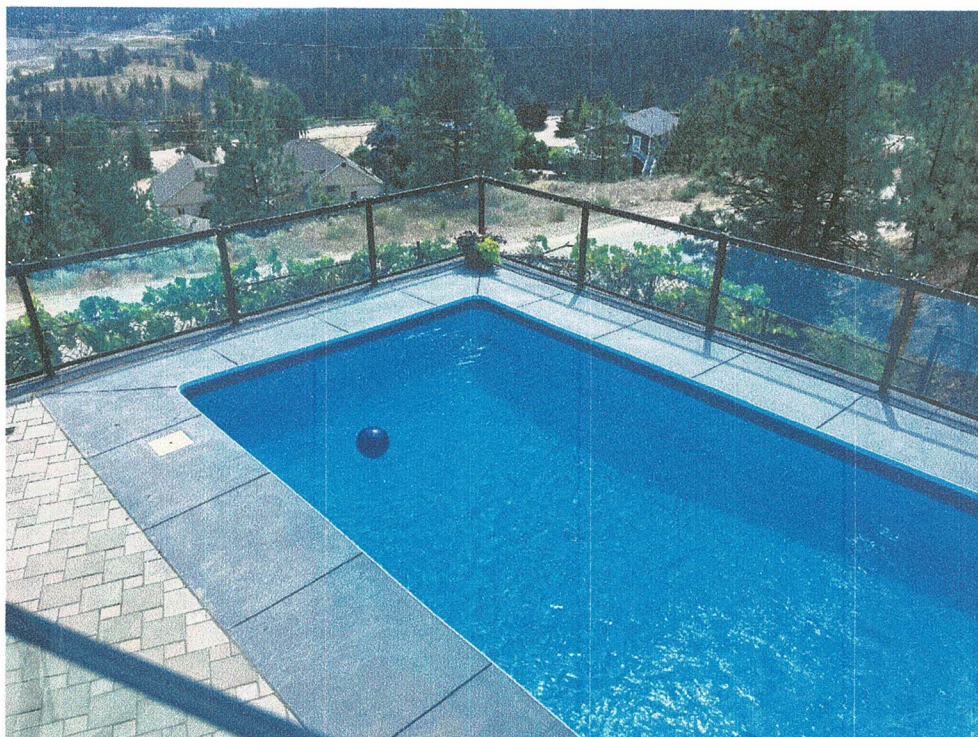
The property at 2636 Forsyth Drive is located in the West Bench area of Penticton. The property is surrounded by residential lots, with access along a driveway from Forsyth Drive. The subject property slopes down to the south with the swimming pool located at the south end of the property (See Photo No. 4), as shown on the attached *Figure 2 – Site Plan*.

Photo No. 4: View looking south from house through swimming pool location.
Forsyth Drive below (2023 07 06).
