May 10, 2022

Our File: RGC-3511

**Subject: Geotechnical Pre-Purchase Assessment
2204 Forsyth Drive, Penticton BC**

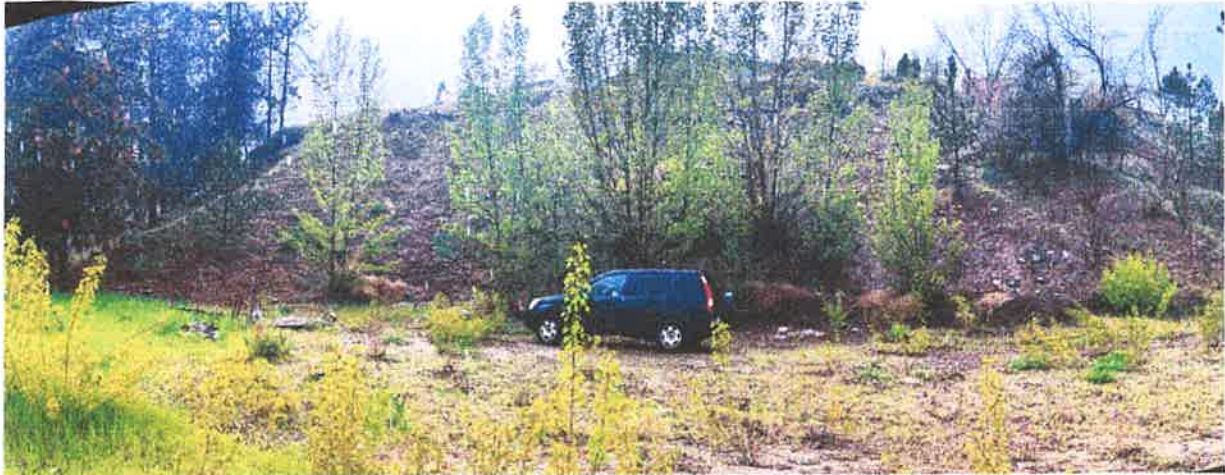
The slope above the terrace consists of fine to medium-grained sand with some gravel and is capped by about 2 m of fill. The fill is composed of fine-grained sand and silt with some gravel, cobbles, and boulders. The sand section of the slope is approximately 30° and the upper fill is 50-55°.

Under normal, dry conditions, cobbles and boulders can be seen to have ravelled from the fill capping the slope. Further analyses indicate that the top of the slope has a safety factor less than 1 for a small, ~1 m deep landslide. Under wet conditions the slope is unstable and possible slope failures 3 to 6 m deep may occur. Under seismic conditions, using a Peak Ground Acceleration (PGA) of 0.139, the slope is also unstable.

Photo No. 1 – Steep slope above north side of building area

- In reviewing the rockfall and landslide risk, RGC recommends that a concrete or block retaining structure be constructed to protect any house at the base of the slope from ravelling material and landslides.

- Rockfall protection fencing could also be considered to intercept ravelling and rolling cobbles and boulders.
- In lieu of free-standing concrete or block walls, the foundation walls on the north side of any house at the base of the slope shall be structurally engineered to withstand a landslide.

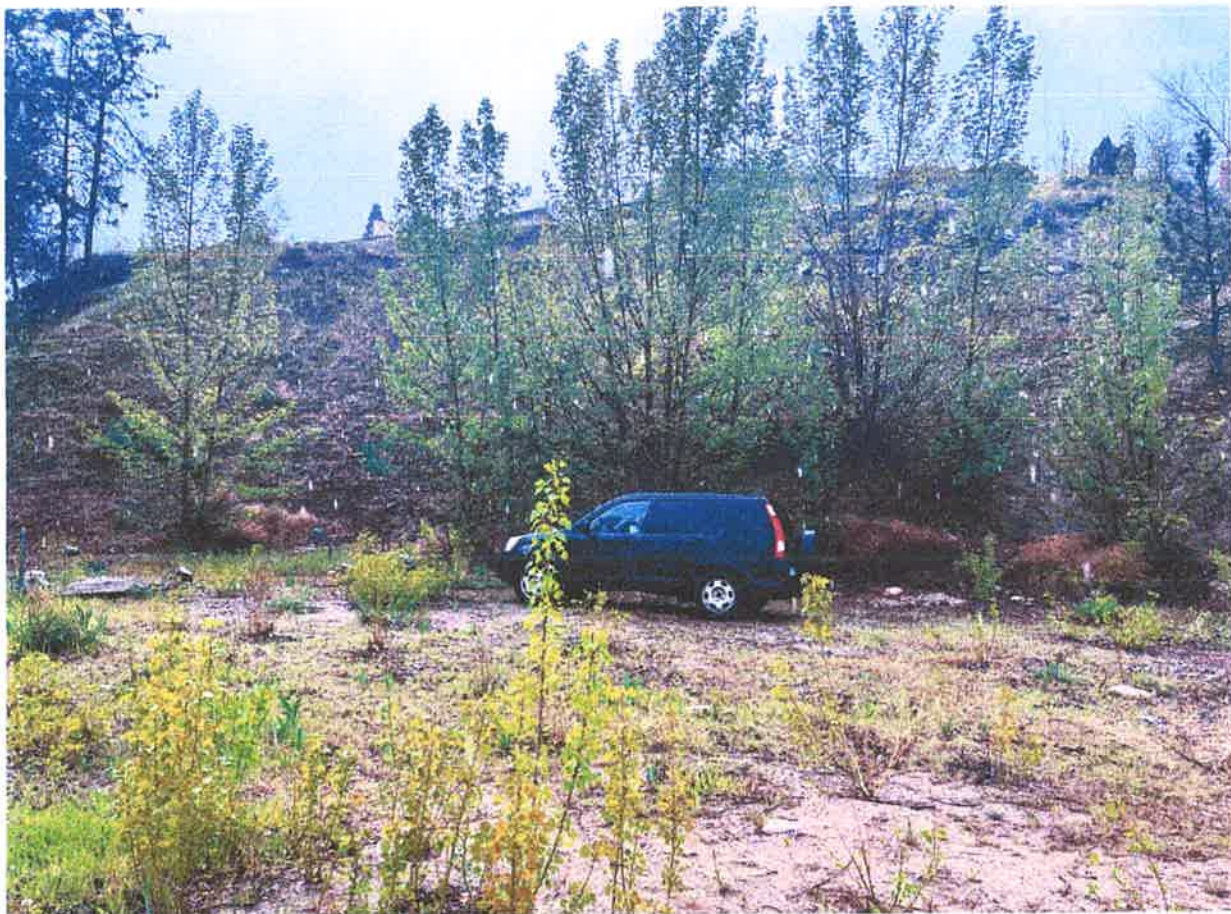
The slope is approximately 15 m high and sparsely vegetated. Boulders, approximately 30-50 cm in diameter were observed at the toe, indicating they had been eroded from the fill at the top of the slope.

Photo No. 2 – Steep north slope. Note boulders on slope and at toe of slope

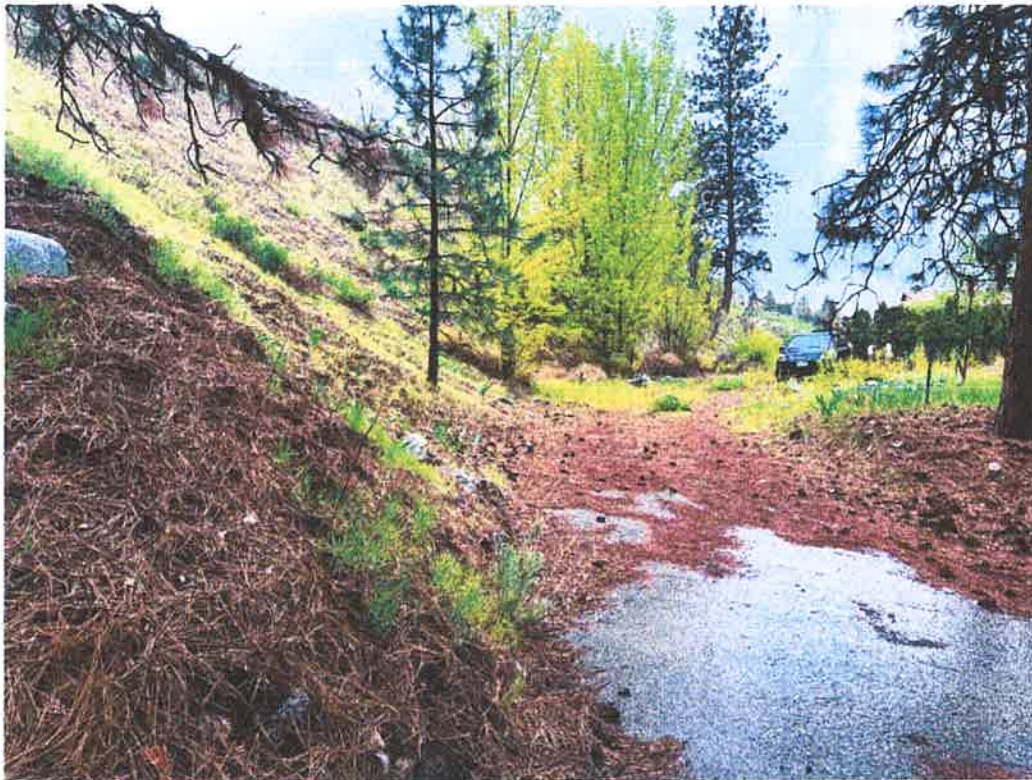
Photo No. 3 – View across steep north slope.

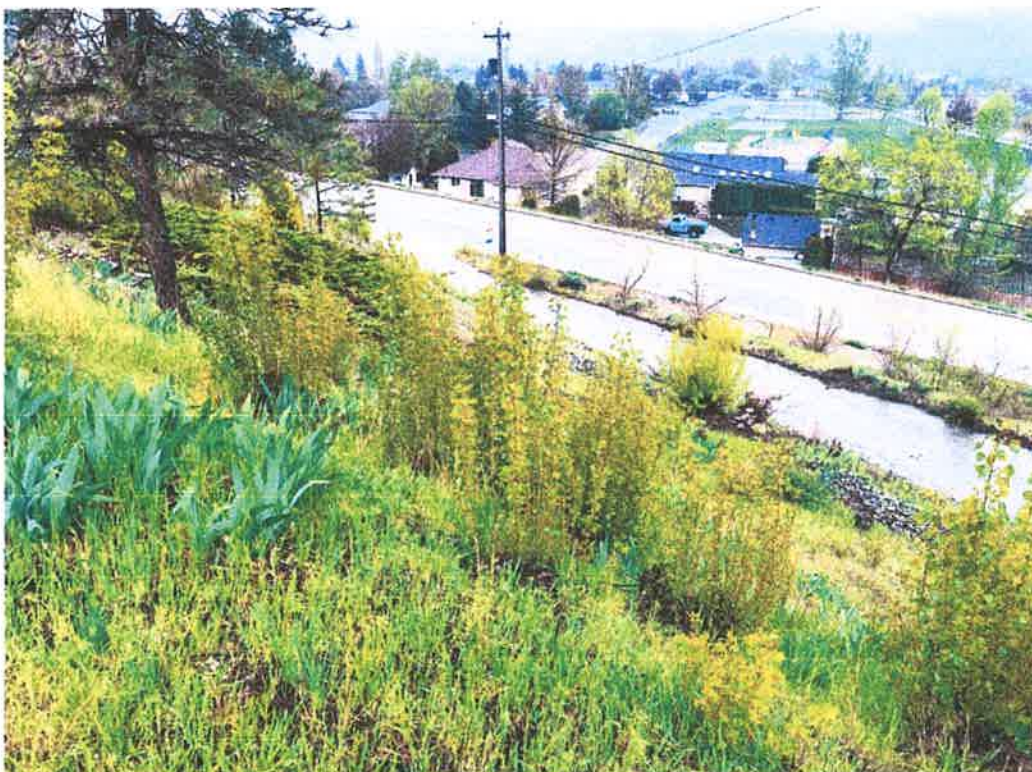
The property is accessible by a driveway that extends from Forsyth Drive at the east corner of the lot up to the northwest corner of the property. The driveway is composed of fill, presumably from the excavation of the terrace. The side slopes of the driveway are approximately 43° (See Photo No. 4).

Photo No. 4 – Driveway access with slope below potential building site.
