Greater West Bench Geotechnical Review

December 22, 2021

191010

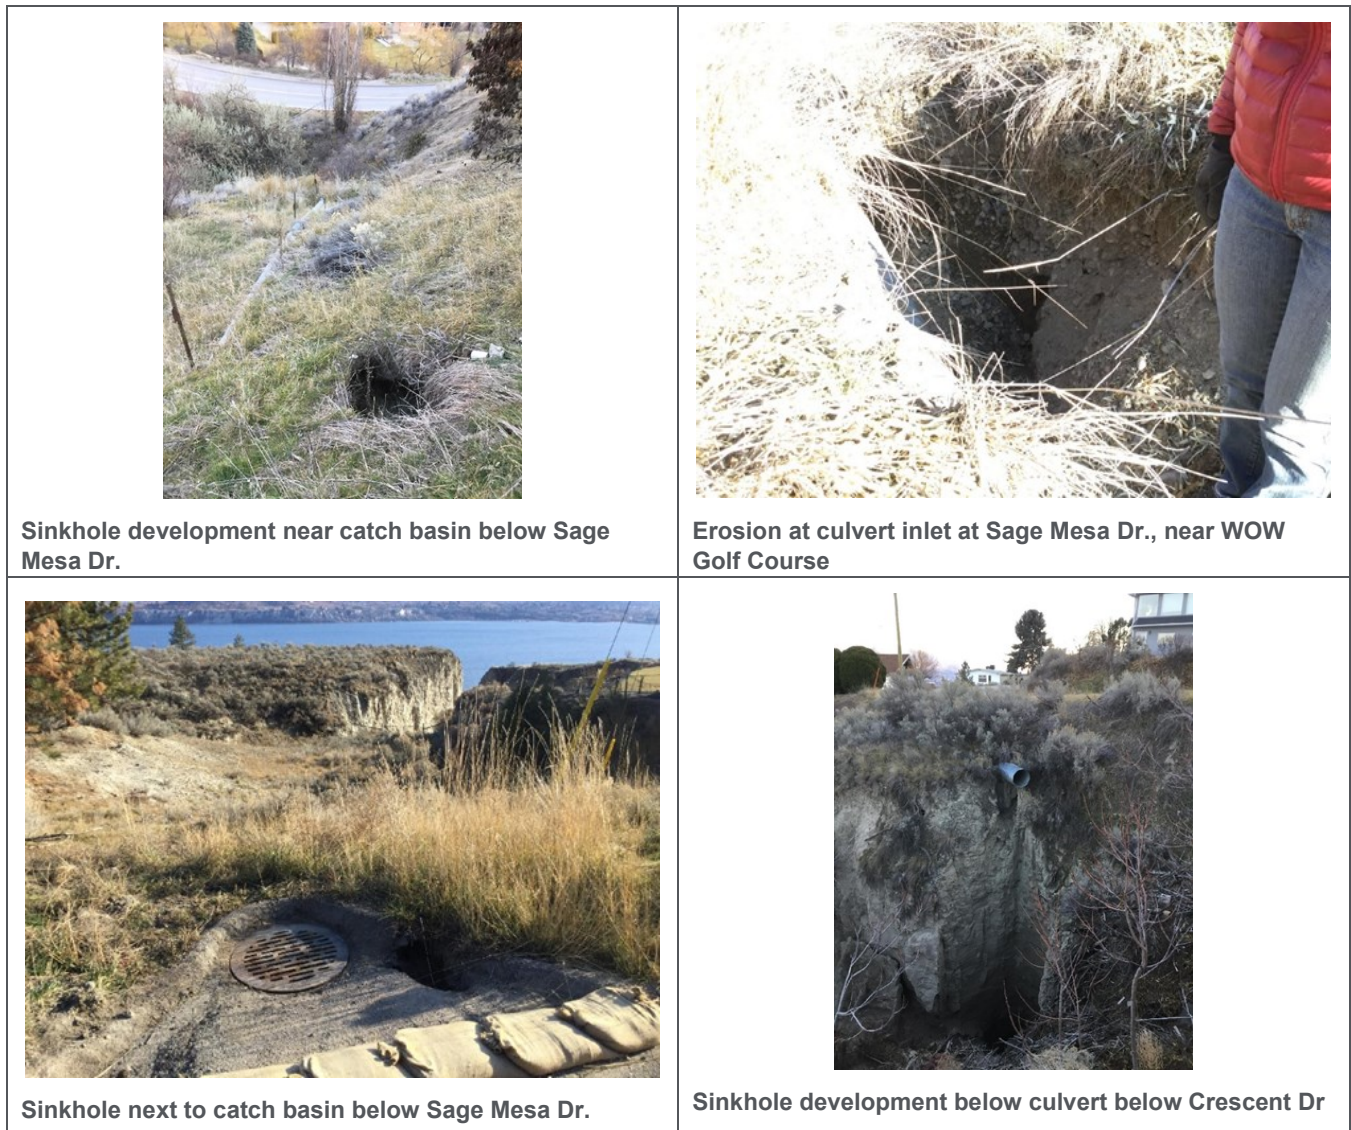
During the field review, several instances of soil erosion (i.e., piping) were observed and considered to be associated with storm drainage. Figure 4.3.a shows photographs of several examples of sinkhole development and erosion.

Figure 4.3.a Photographs of Example Sinkholes and Erosion Features Associated with Stormwater Management in the GWB Study Area

There is a clear connection between concentrated stormwater runoff and soil stability issues. As a result, further investigation of existing erosion issues is required, and development of an integrated Stormwater Management Plan (SWMP) for the area is recommended.

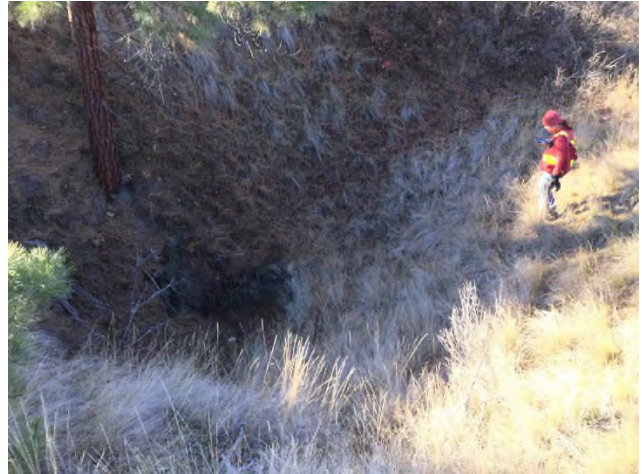
Photo 2 Large (pre-existing) sinkhole in Sage Mesa area

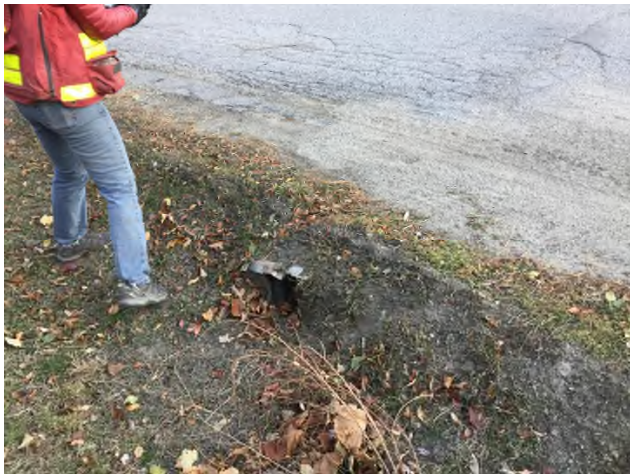
Photo 3 Damaged culvert inlet (Sage Mesa)

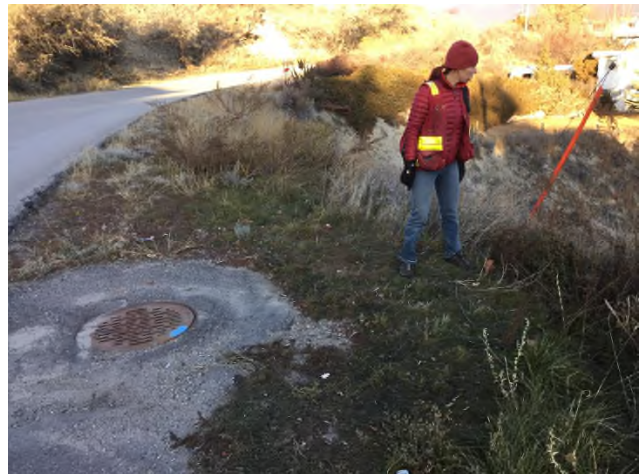
Photo 4 Catch basin above Sage Mesa Road at top of steep embankment (showing signs of instability)

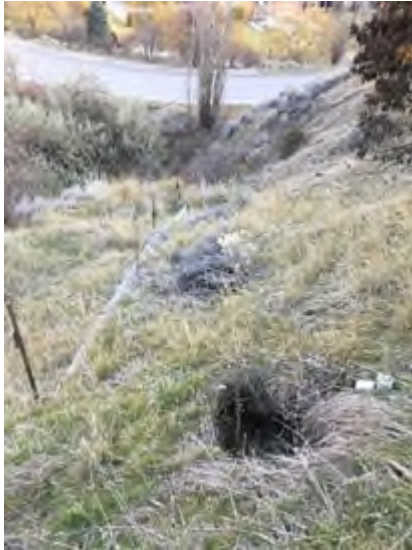
Photo 5 Sinkhole and tension crack near catch basin (see Photo 4)

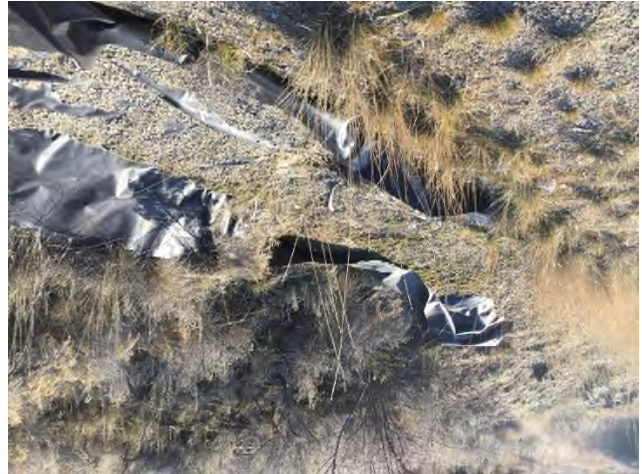
Photo 6 Ditch line maintenance measures in disrepair, on Sage Mesa Rd above WOW Golf Course

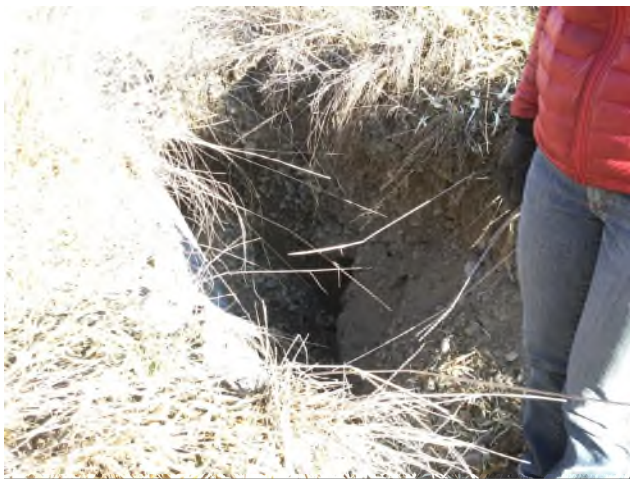
Photo 7 Erosion at Culvert Inlet at Sage Mesa Rd crossing (near WOW GC)

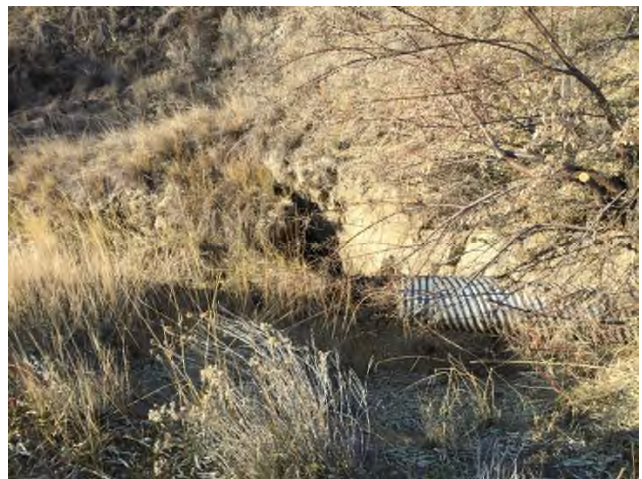
Photo 8 Erosion at culvert outlet at Sage Mesa Rd crossing (near WOW GC)

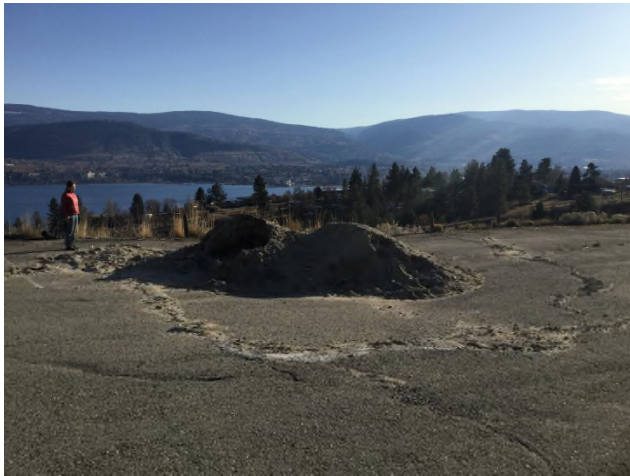
Photo 9 Large sinkhole forming in parking lot (WOW GC)

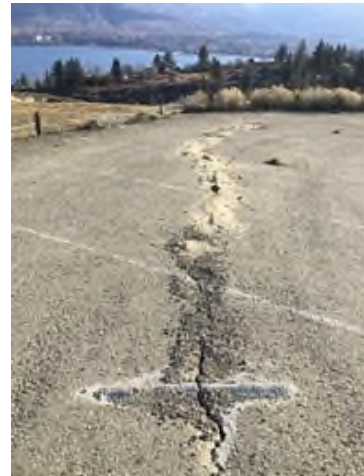
Photo 10 Pavement cracking at WOW GC

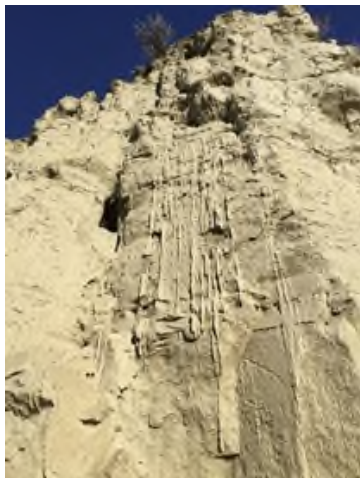
Photo 11 Silt Bluff at north end of study area – showing “wax like” flow of saturated silt

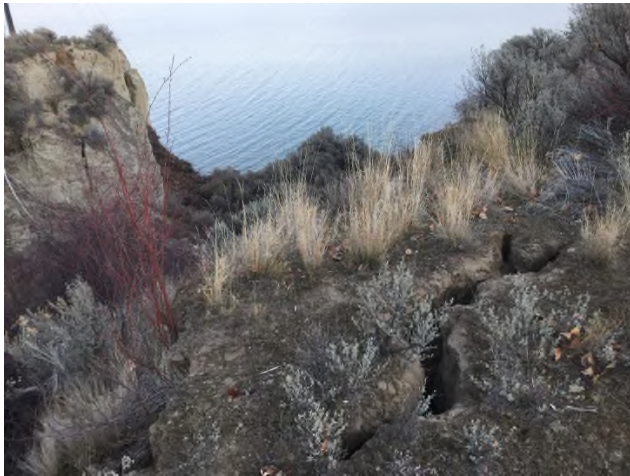
Photo 13 Tension crack at gully edge (Sage Mesa)

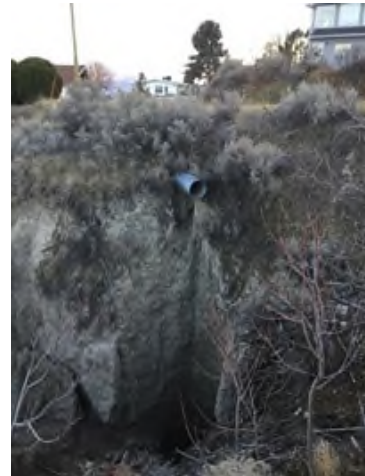
Photo 14 Massive sinkhole at culvert outlet (adj to Photo 13 Sage Mesa)

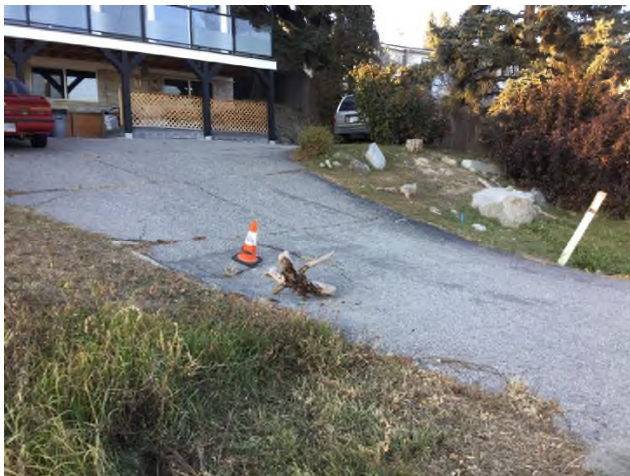
Photo 15 Small sinkhole in driveway (Sage Mesa)

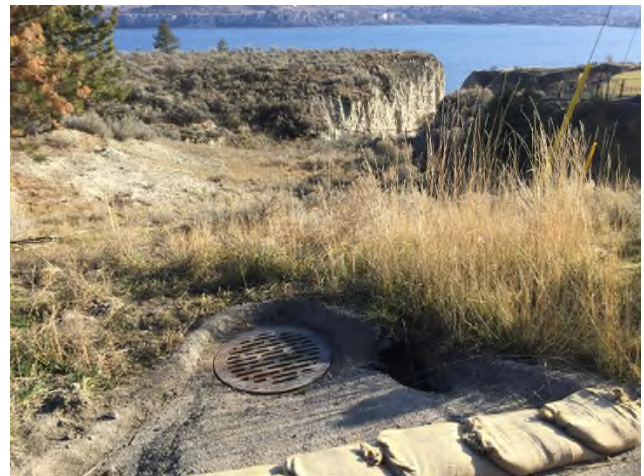
Photo 16 Sinkhole next to catch basin, with sandbags blocking runoff

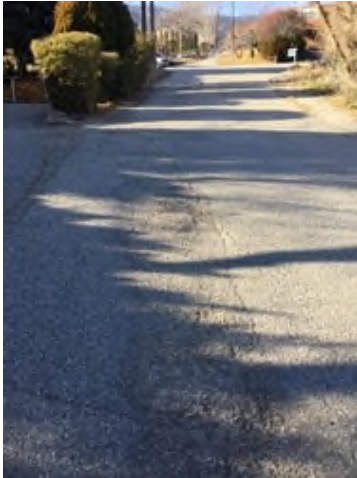
Photo 17 Depressions in road (end of Duchess Dr)

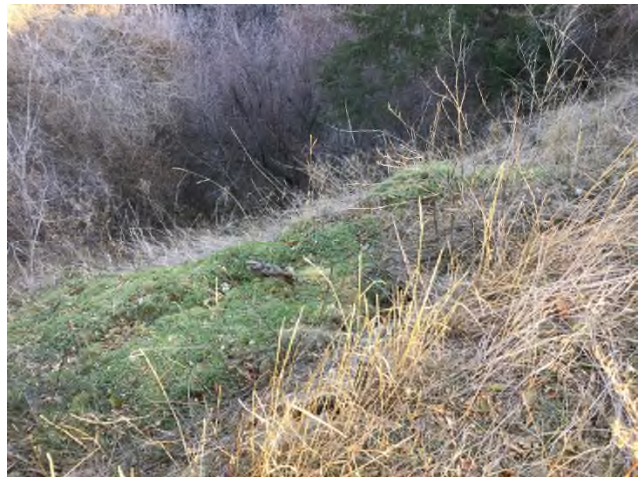
Photo 20 Tension cracks and landslide activity along crest of gully (Newton Dr and Duchess Dr.)

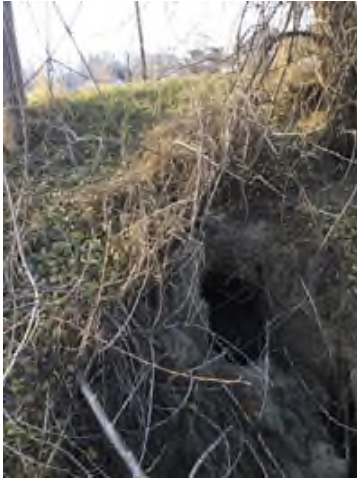
Photo 21 Sinkholes at gully crest (Newton Dr and Duchess Dr)

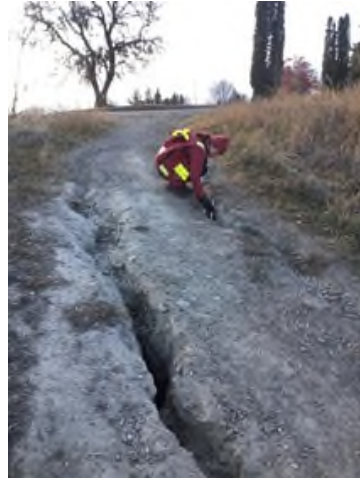
Photo 22 Subsurface erosion and deep cavity on access to KVR at Newton Road

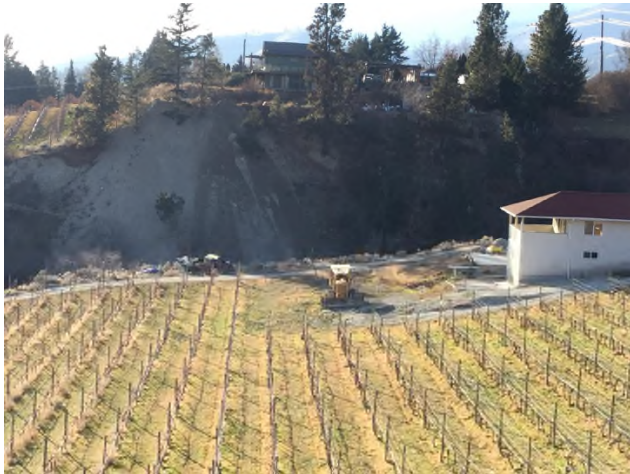
Photo 23 Fill dumping and shallow instability along gully slope (end of Moorpark Dr.)

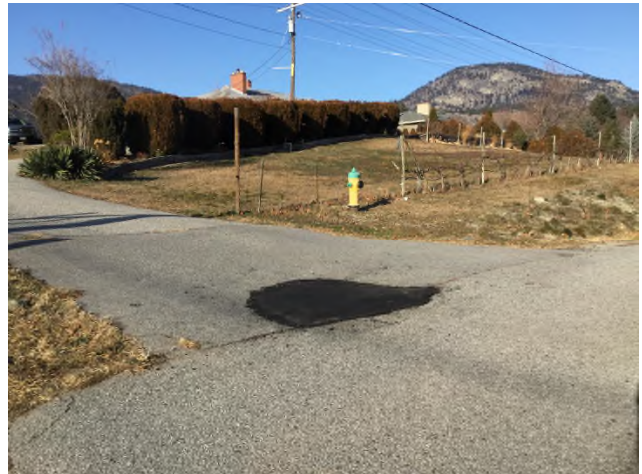
Photo 24 Recent (2019) sinkhole repair due to leaking water valve (Sparton Road)

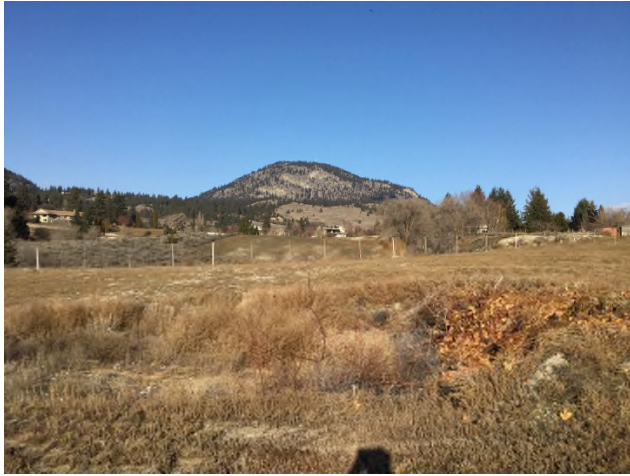
Photo 25 Partly infilled sinkhole on private property (off Sparton Road)

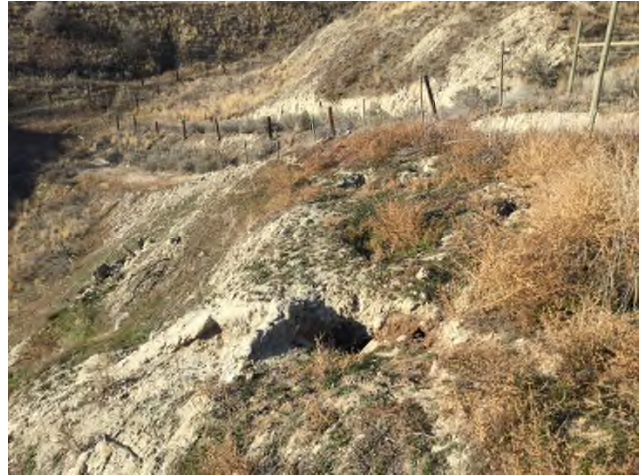
Photo 26 Sinkhole visible within gully (off Sparton Road)
