# Lot 16 – KAP1190 – Spiller Road Environmental Assessment

Makonis Consulting Ltd  
West Kelowna, B.C.

**Makonis Project No: 2018-106**

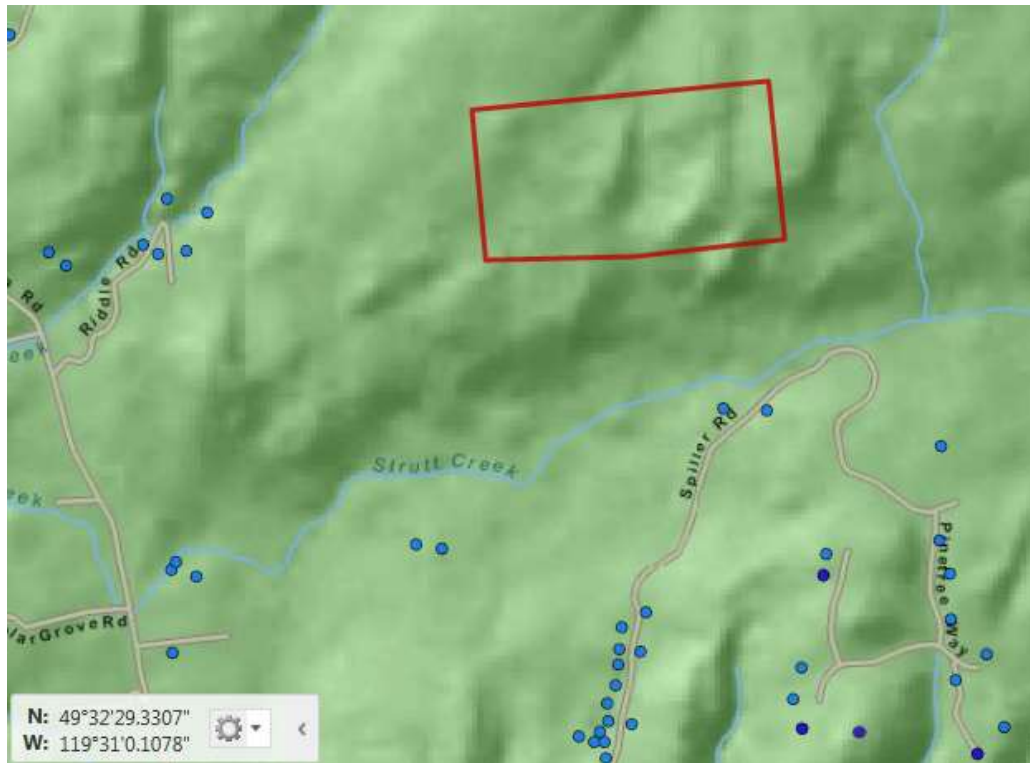
Image 1: Water wells (light blue) and groundwater points (dark blue) for the subject region.

According to BCiMap (accessed March 15, 2018), there are no water wells located on or immediately adjacent to the property. No groundwater observation points or points of well diversion were noted for the subject area.

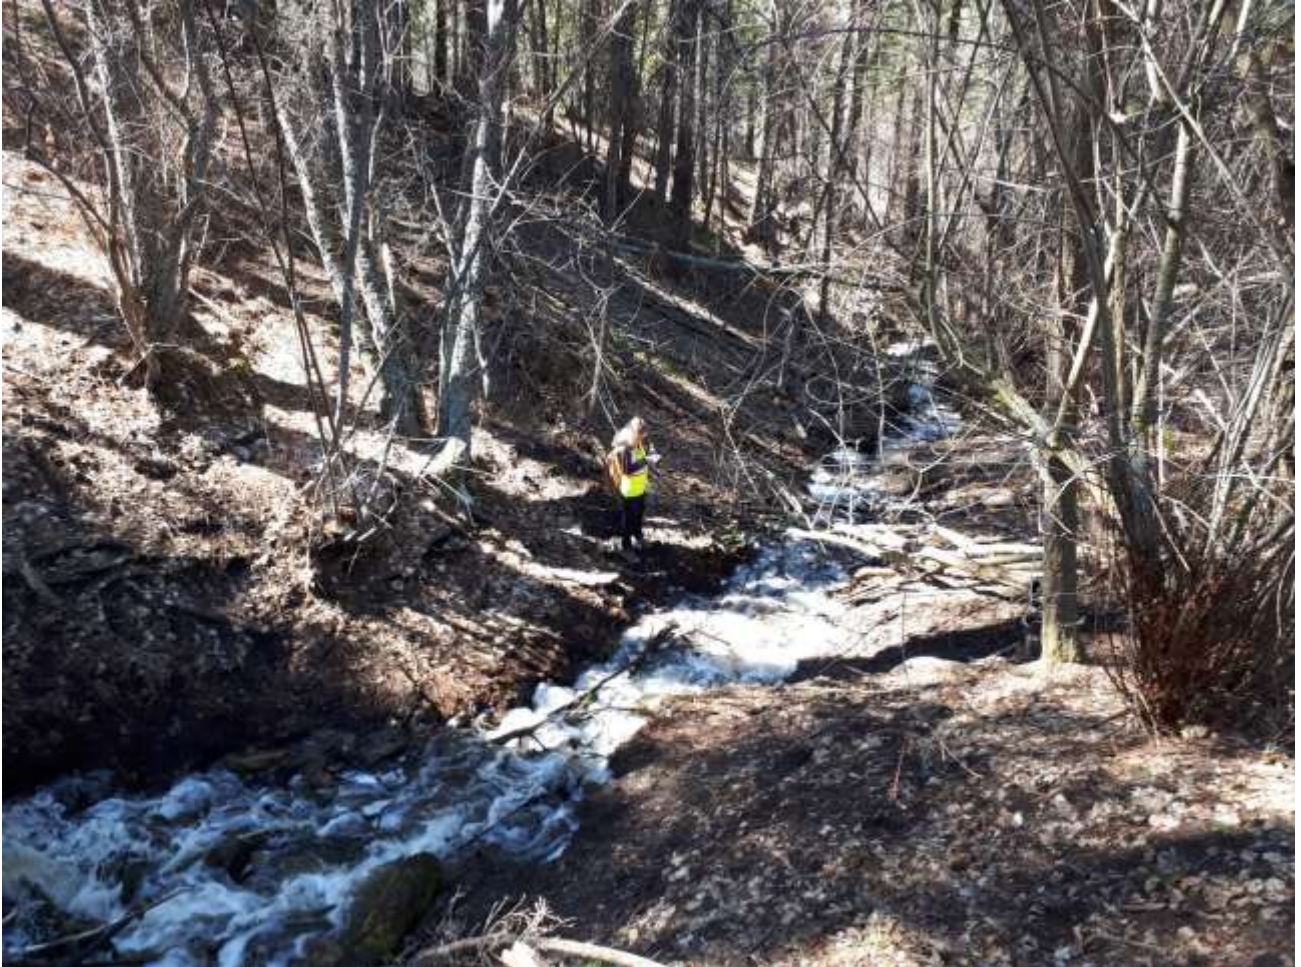
**Photo 1: Looking west downstream at Strutt Creek. This picture is below the proposed access route as shown on proposal.**

- a. A further assessment should take place if the access to this site is proposed to cross Strutt Creek, to ensure the creek is protected accordingly and applicable permits are sought.

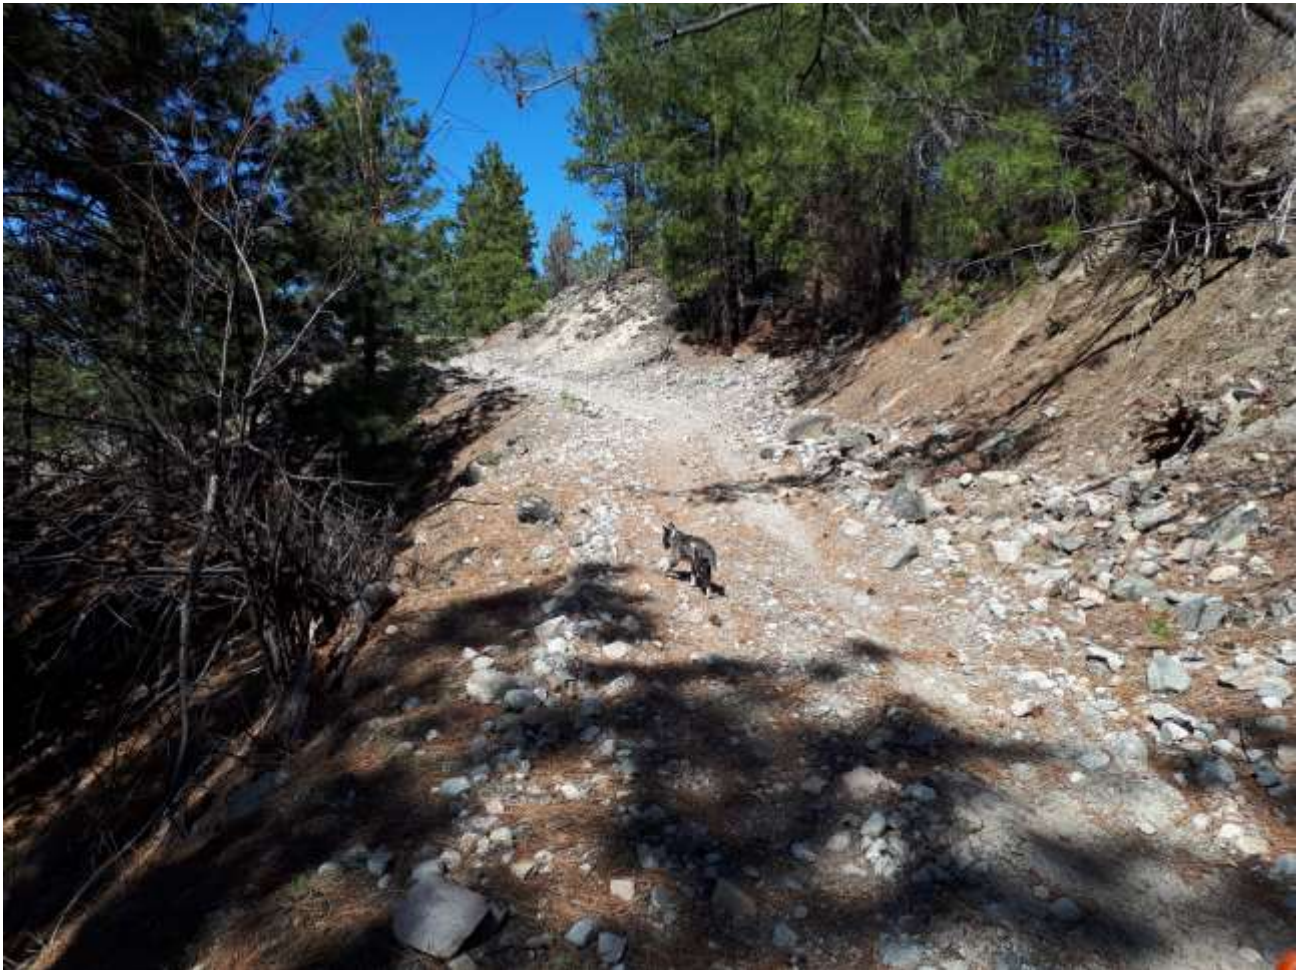
**Photo 2: Looking north at existing access road entering the proposed subject property. Note the tills seen with road cut and spoil sluffing onto road.**

- b. be leak-free and in good working condition
  - c. have a spill – containment kit present.
9. Any exposed soils for prolonged periods or for overwintering, shall be covered. Covering may include tarping, or hydromulch (without seed mixture) and must be maintained.
10. Road cuts and fills will require restoration to native site conditions. Plans will be required once the final engineer plans are finalized to design restoration accordingly. The exception to this will be rock cuts are to be left as is.
11. Subdivision – Spiller access construction should be monitored in accordance to this report and subsequent upcoming future reports and approvals.

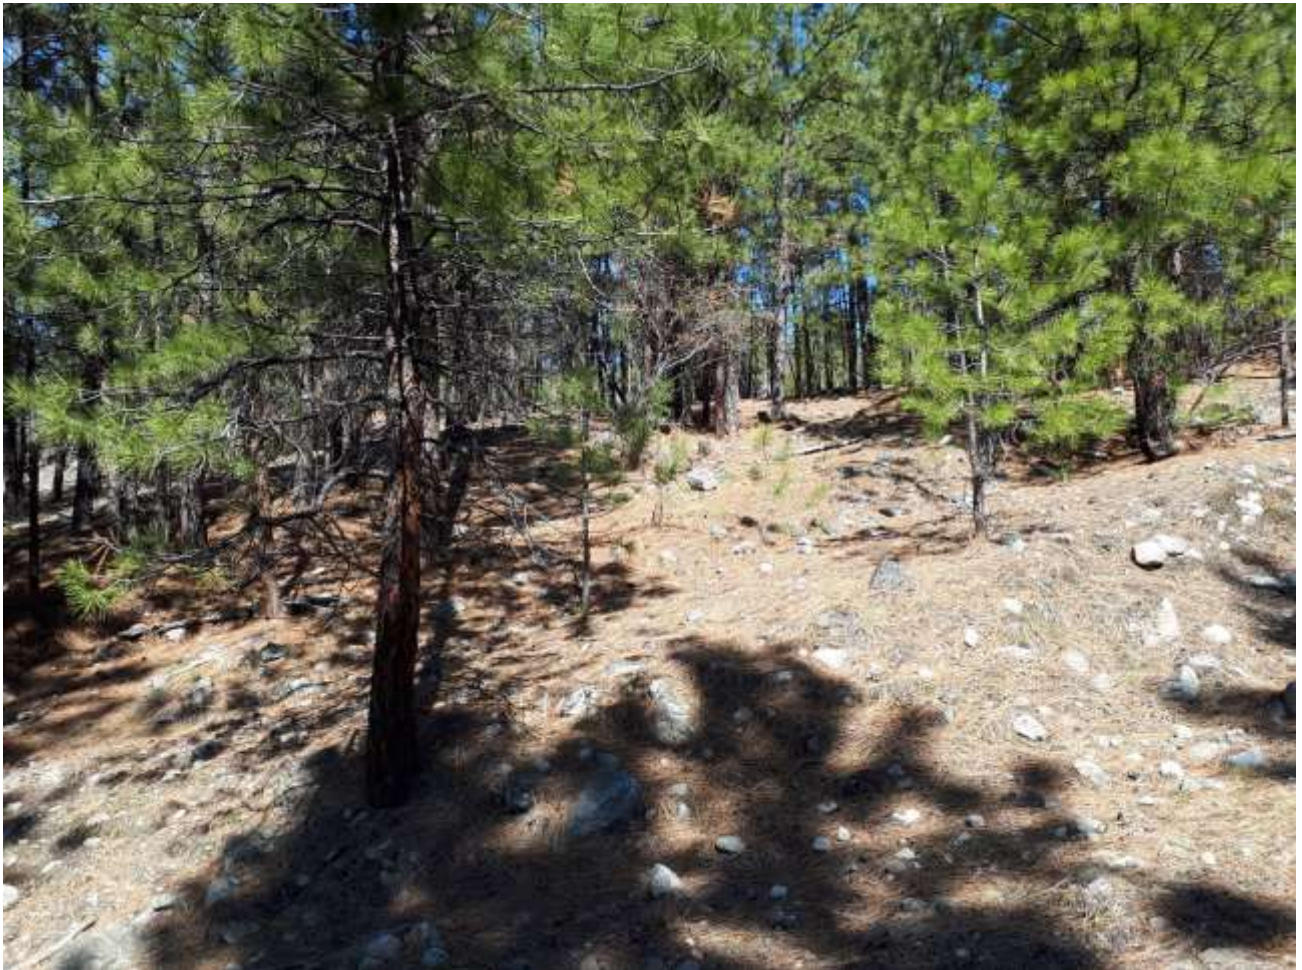
**Photo 3: Looking north-east approximately on Lot 1 at a young stand of pine. This was common throughout most of the subject property as a result of historic logging.**

A road network on the lower portions of the subject property is presumed to have been established sometime ago. Historical logging was evident with older stumps seen throughout the area. Leaving a younger stand of Ponderosa pine and Douglas-fir. Several older veteran trees were noted, however these were infrequent. The 1:20,000 South Okanagan Terrestrial Mapping indicating Old Growth Forest was not seen on the subject property, nor along the proposed access from Spiller Road.

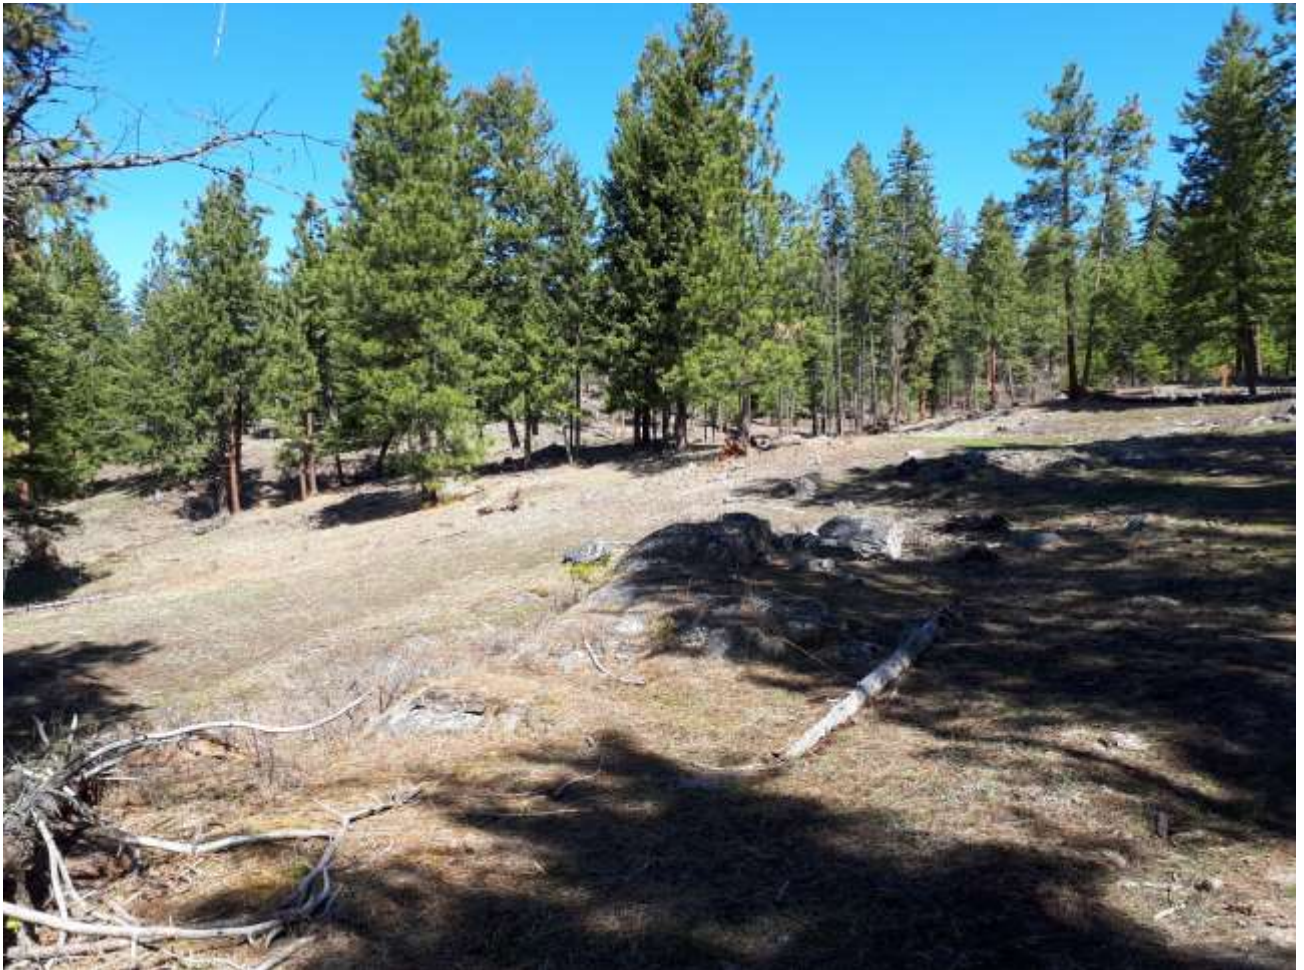
Photo 4: looking north near Lots 4,5 and 6 in approximate location of road alignment.

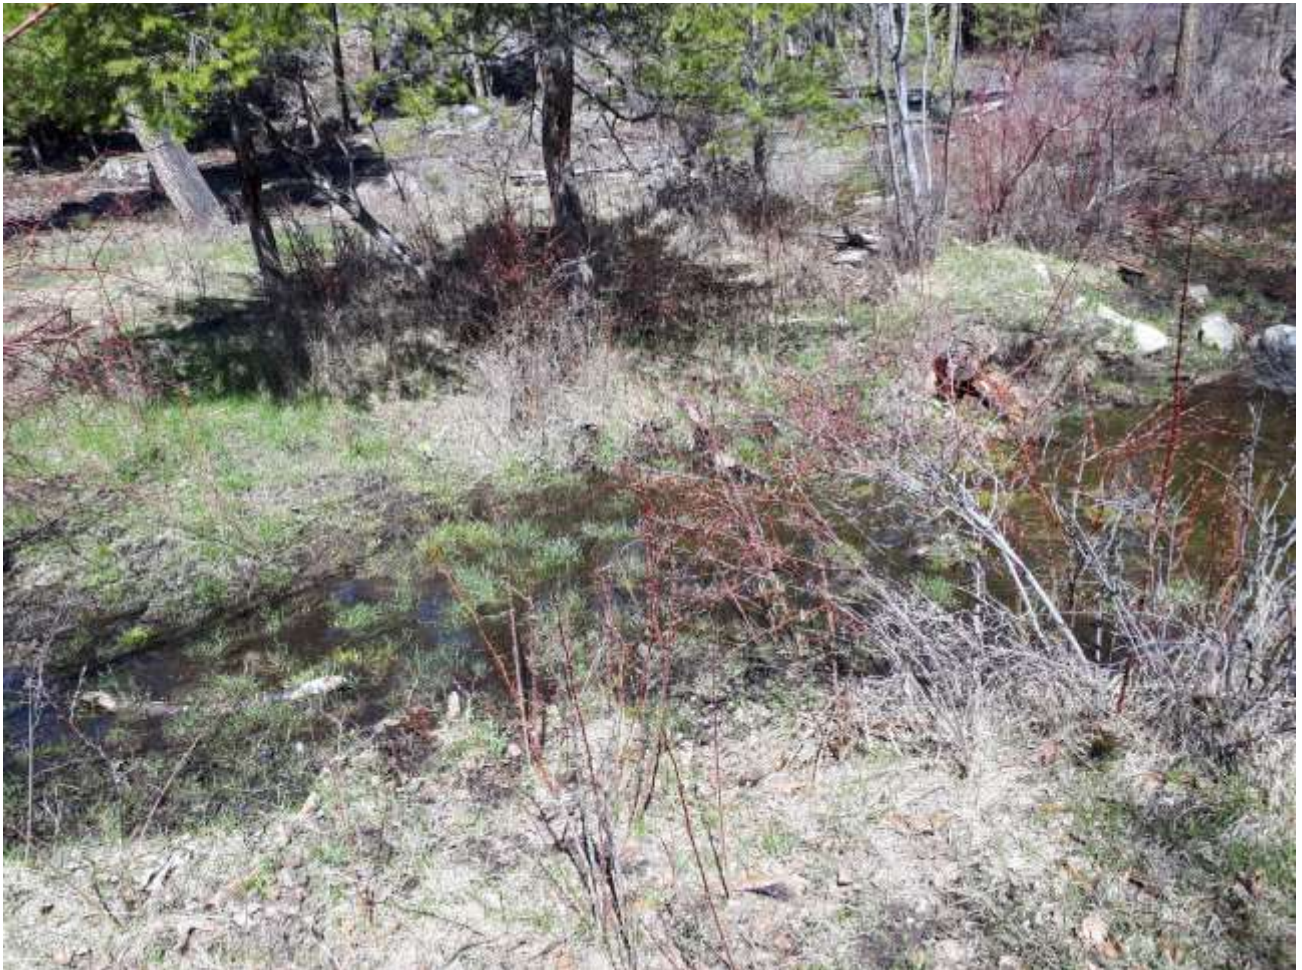
**Photo 5: Wetland on Lot 5.**

3. Additional setback will be placed on the wetlands – ponds on Lots 5 and 6 of 10-meters. These setbacks are also to be a “No Build – No Disturb” area placed on title.

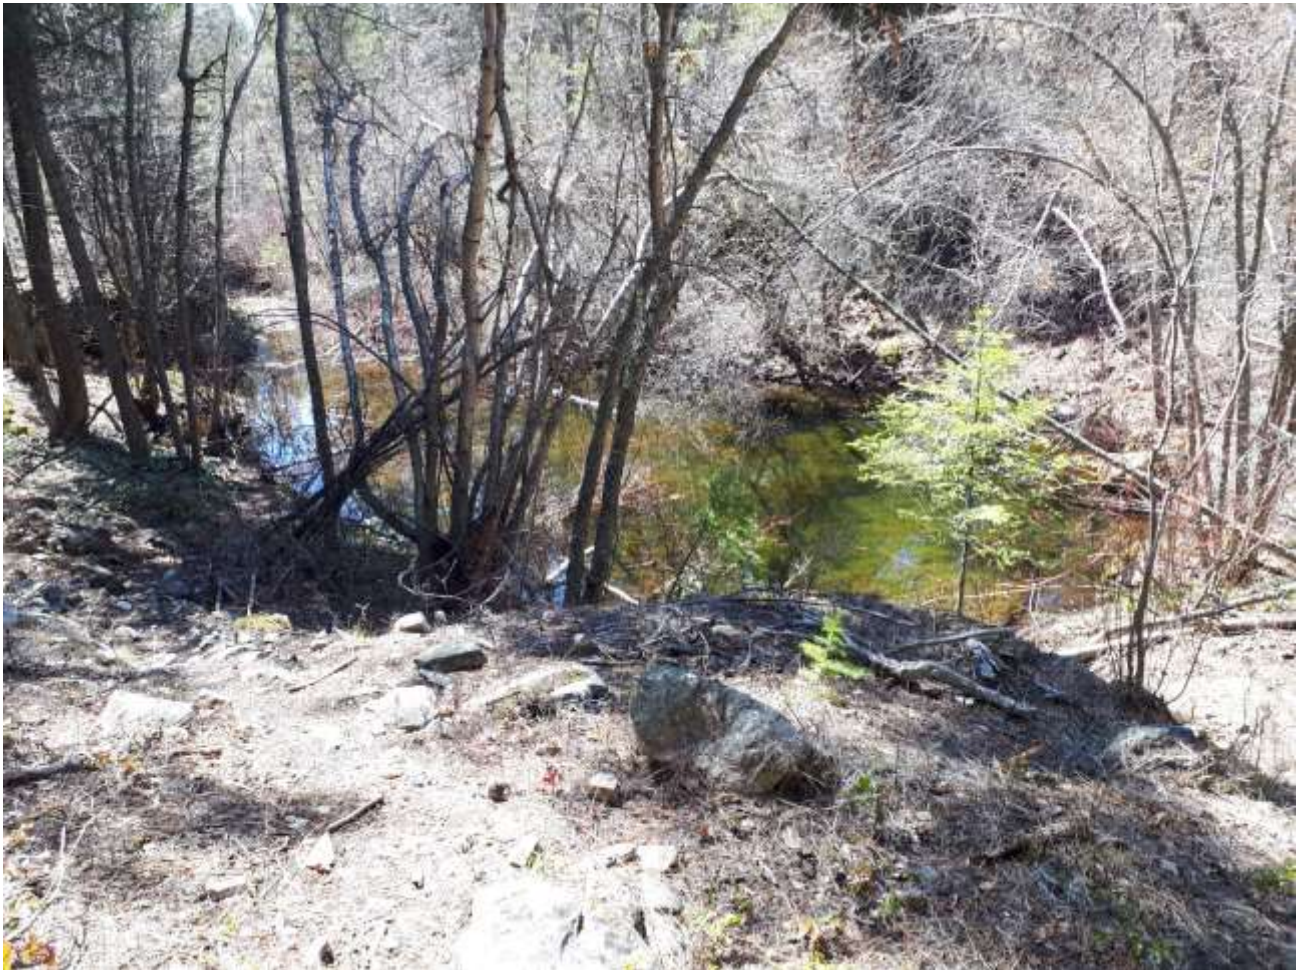
**Photo 6: Pond located on top ends of Lots 5 and 6.**

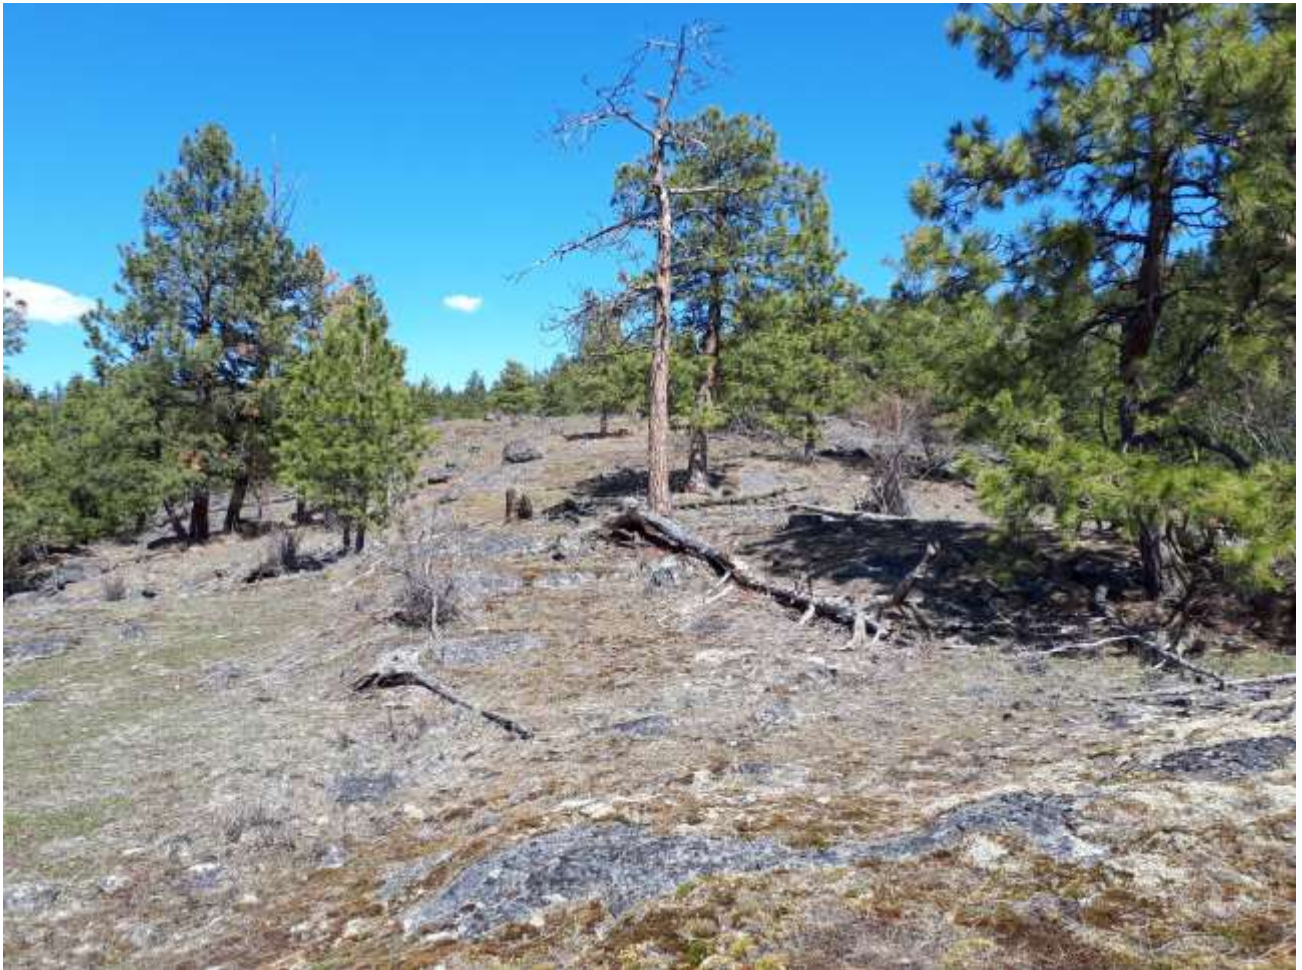
**Photo 7: Rock outcrop, ESA1, located on Lot 6 and 7.**

- Restore disturbed crossing areas to native vegetation
2. Subdivision and future development should maintain and conserve areas within the subject designated as ESA-1 values. No building or crossing should occur in these areas. A “No Disturb – No Build” covenant will be placed on title.

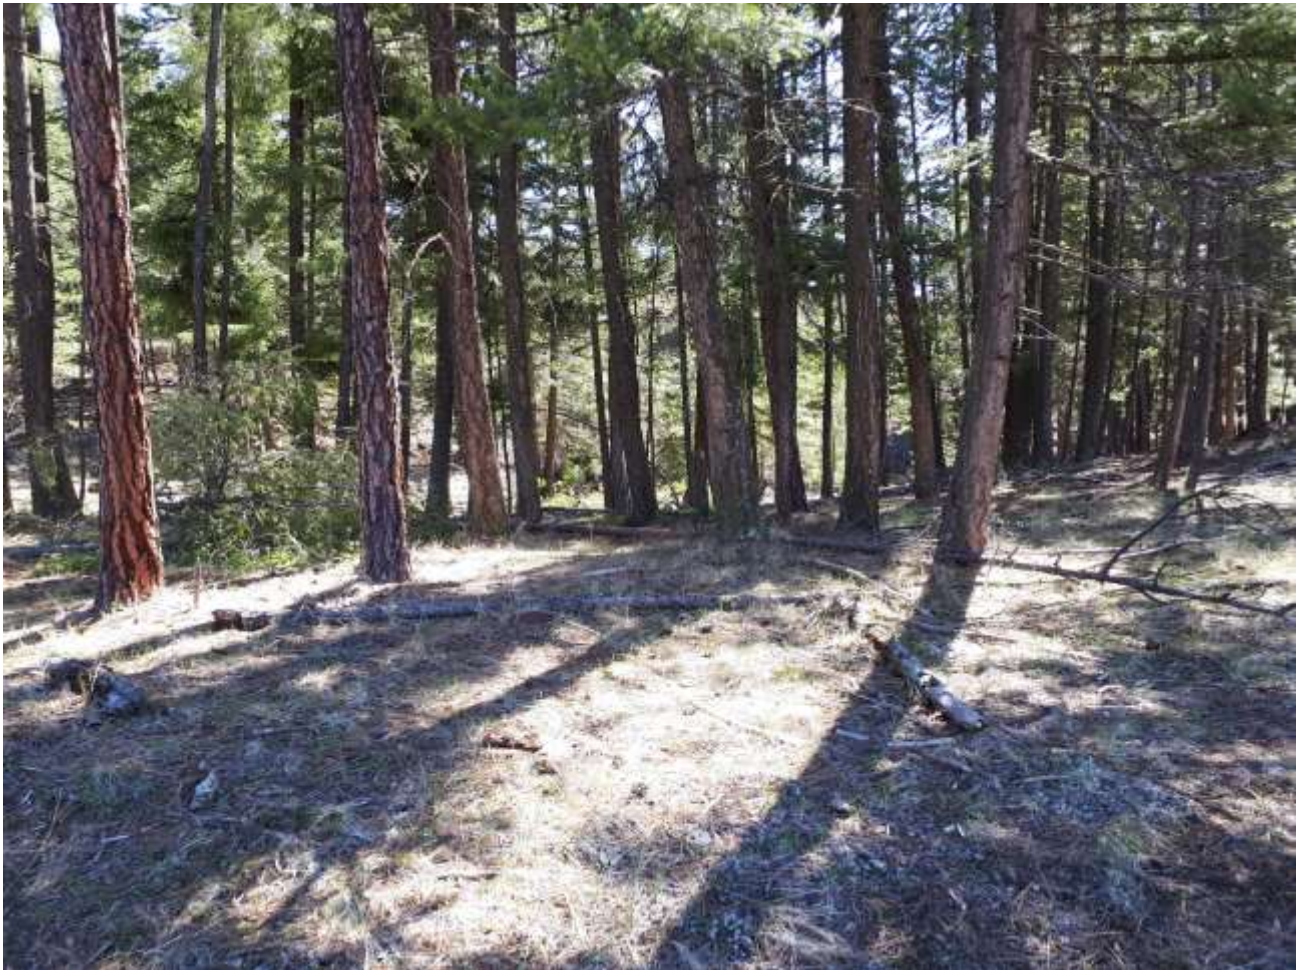
**Photo 8: Forested area on Lot 3, ESA2.**
