MEMORANDUM

File: RGC-3076

Subject: *New Dock Hydrotechnical Report
6771 Indian Rock Road, Naramata, BC*

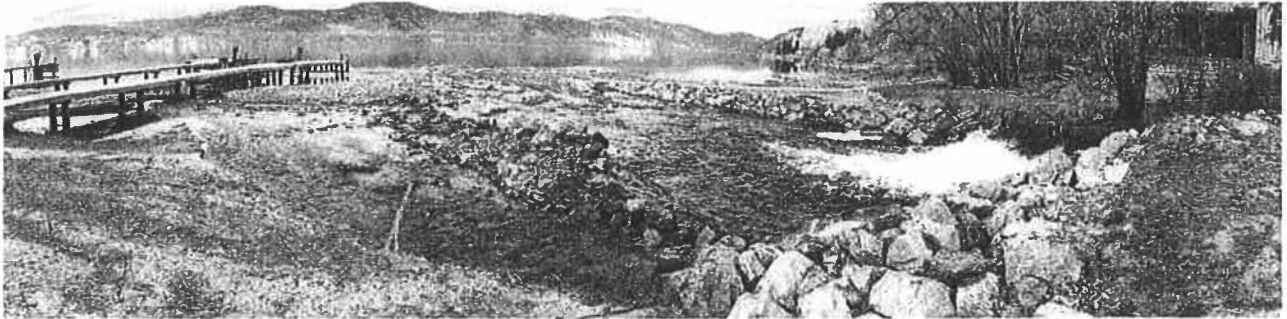
Photo No. 1: Chute Creek delta with existing Mortifee dock. (April 10, 2020)

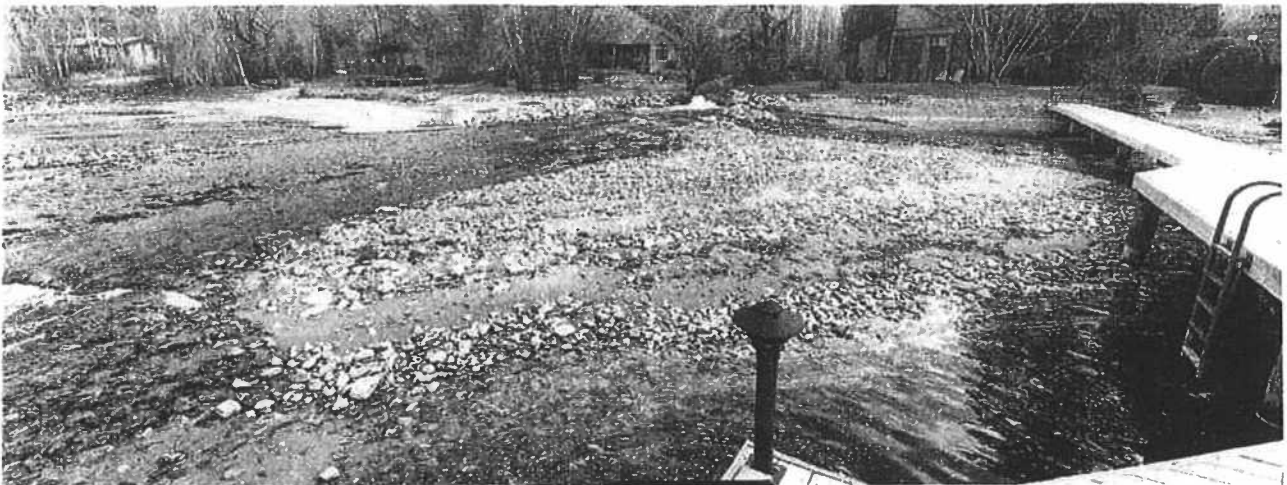
The average elevation across much of the delta is about 342 m. Photo No. 2, taken at a low lake level in spring 2020, shows approximately where the 342 m contour is situated on the delta with a portion of the delta extending under the present dock.

Photo No. 2: View of Chute Creek delta from end of existing Mortifee dock. (April 10, 2020)
