February 15, 2023  
Job 23.004

Re: **Preliminary Geotechnical Hazard Assessment  
Proposed House  
4535 Mill Road  
Naramata, BC**

RENE DOUCETTE  
GEOTECHNICAL INVESTIGATION  
PROPOSED HOUSE  
4535 MILL ROAD  
NARAMATA, BC

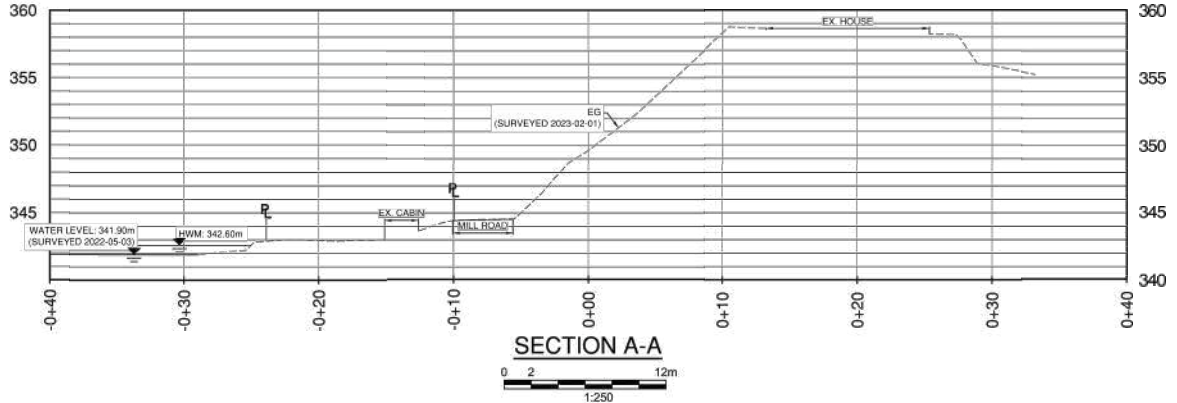
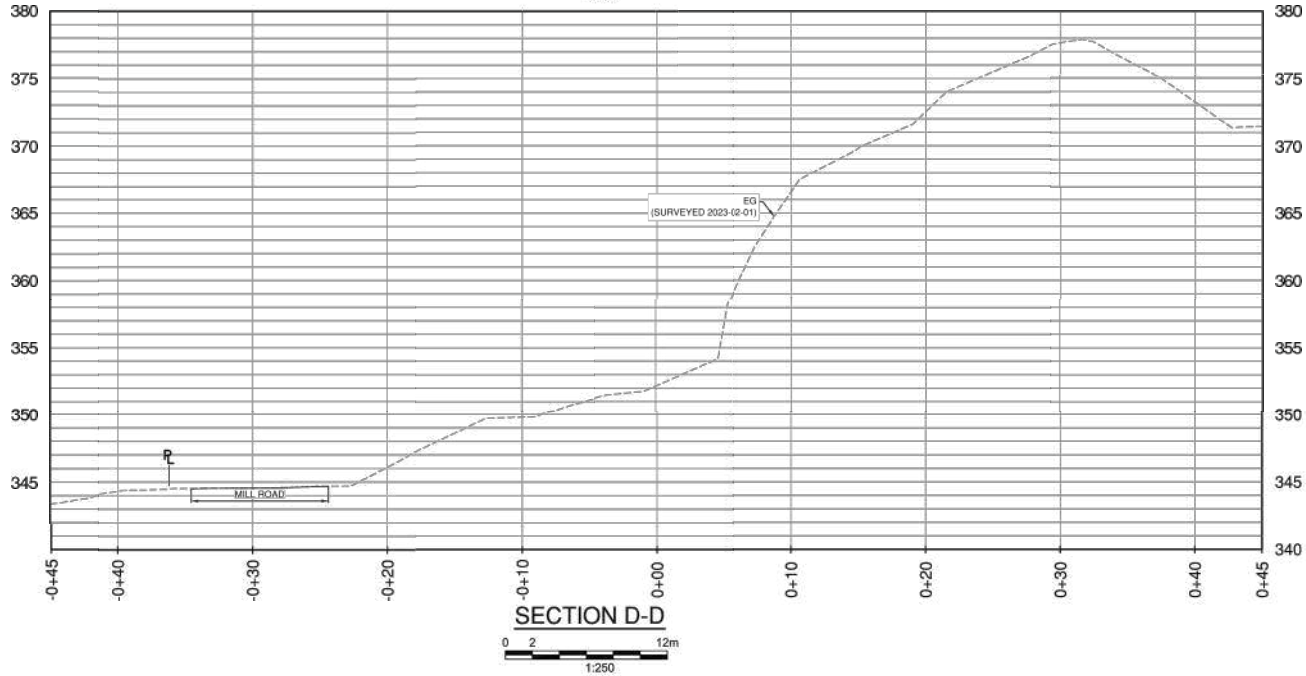
**SITE PLAN  
&  
SLOPE SECTIONS**

Using the cross-sections prepared by JFI Drafting and Design (Drawing 23.004-2) ITSL has completed preliminary slope stability analysis for the sections described as A-A, B-B and C-C. To evaluate the stability of the slopes to the immediate north of the building area, ITSL completed both static and seismic analyses using the commercially available software, Slide2 (by Rocscience).

Section D-D was prepared to evaluate the distance between the steeper slope and the subject property.
