PROPOSED WILLOW BEACH DEVELOPMENT, RDOS, BC

PRELIMINARY HYDROGEOLOGY ASSESSMENT

Prepared By:
Ecoscape Environmental Consultants Ltd.

January 26, 2021

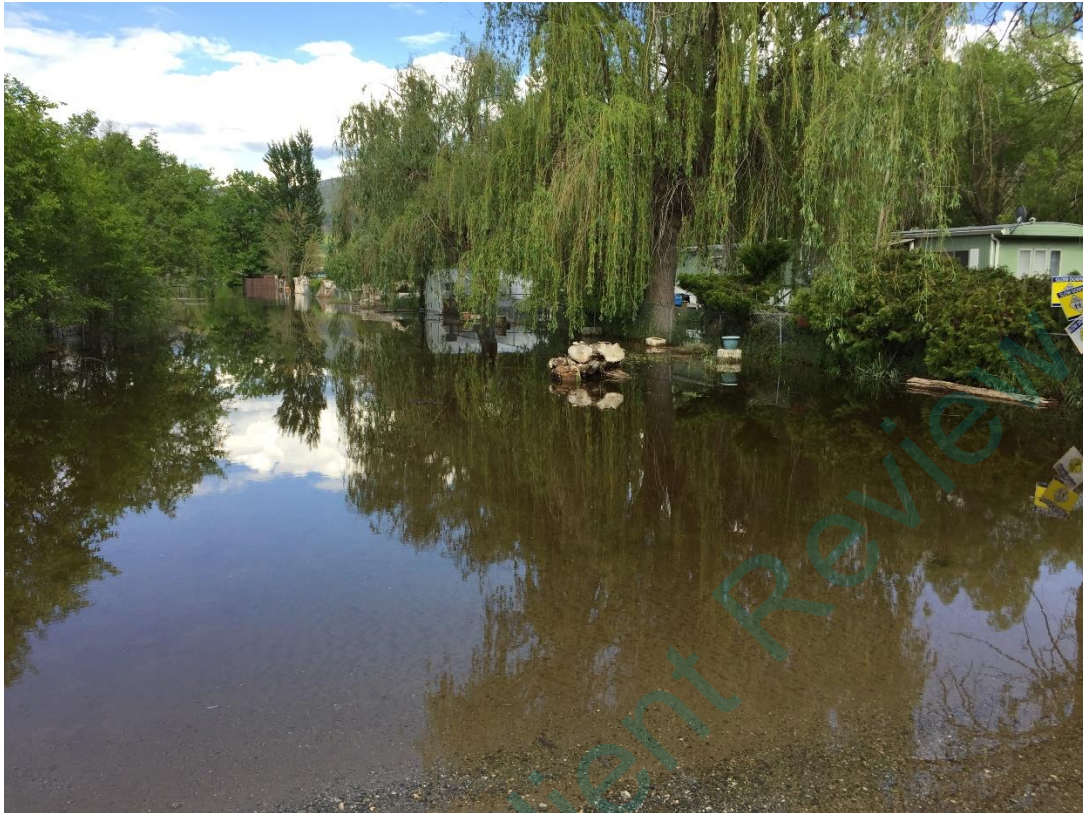
Photo 1: Site wide flooding observed on May 20, 2018.

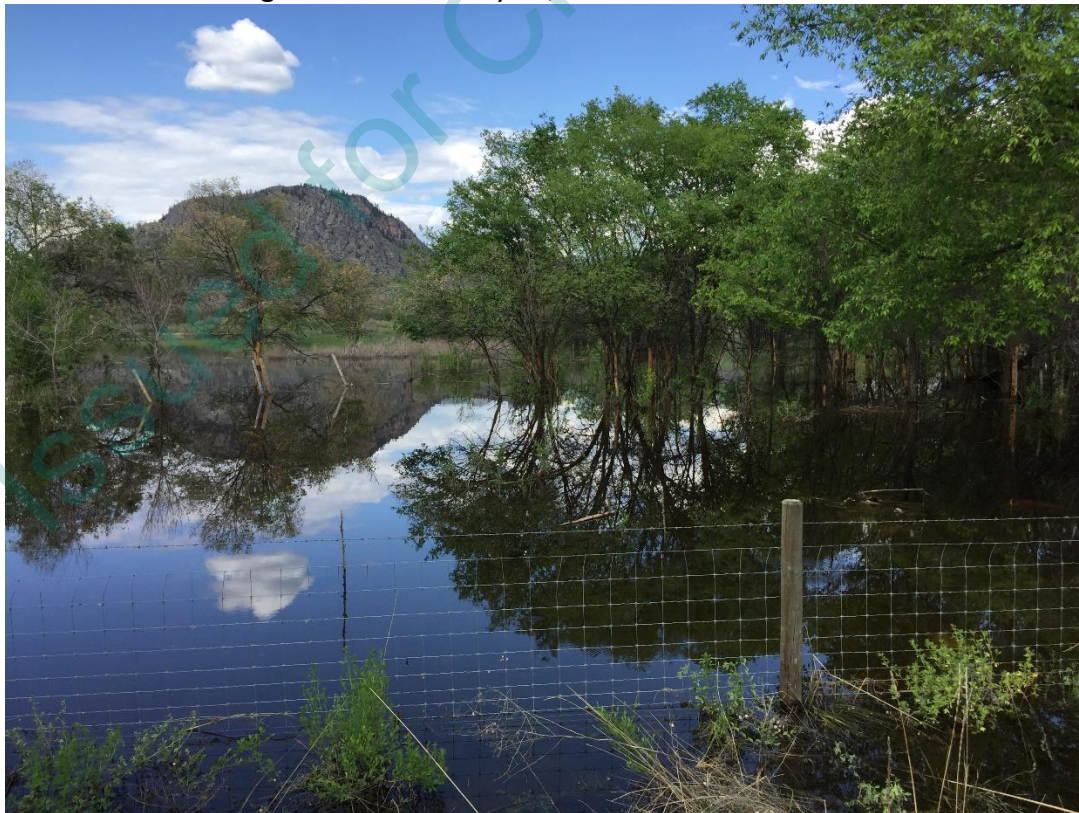
Photo 2: Site wide flooding observed on May 20, 2018.

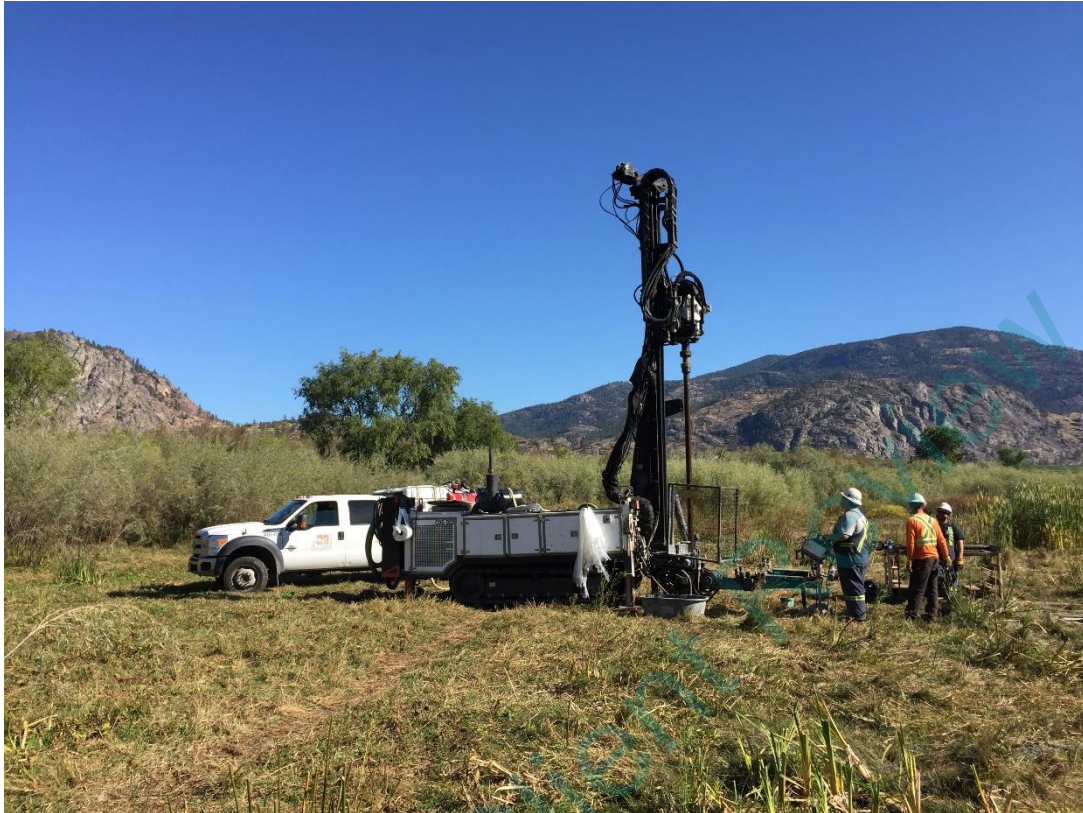
Photo 3: Drilling monitoring wells at the Site using a sonic drill rig (October 2, 2017).

The boreholes were drilled on October 2 to 4, 2017 by Mudbay Drilling using a track-mounted Sonic DB320 drill rig. This type of drilling applies a high-frequency vibration coupled with a downward hydraulic pressure to advance a rotating casing. A continuous core of the encountered sediments was collected within an inner core tube, and was made available for retrieval at the ground surface. Boreholes were advanced to depths ranging from 3.66 m to 31.09 mbgs. Borehole logs were prepared for each drilling location, containing descriptions of soil type, colour, texture, and moisture content, along with other observations. Copies of the borehole logs are included in Appendix D.

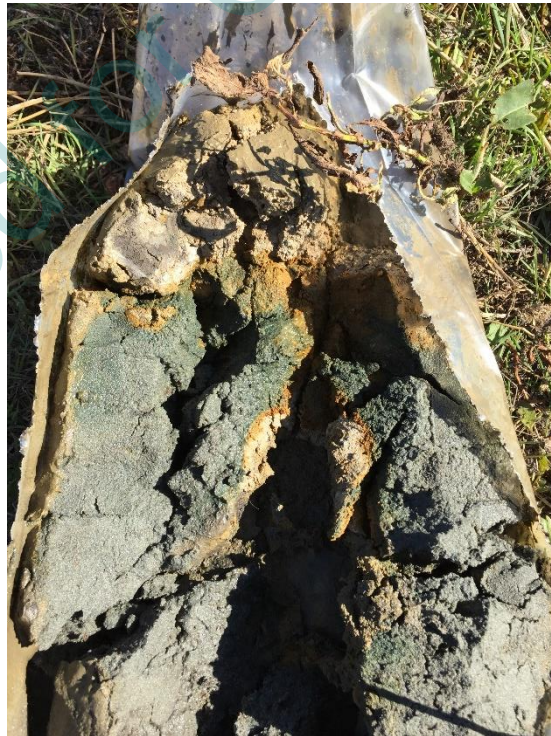
Photo 4: Typical mottling and gleying observed in shallow soils (October 2, 2017).

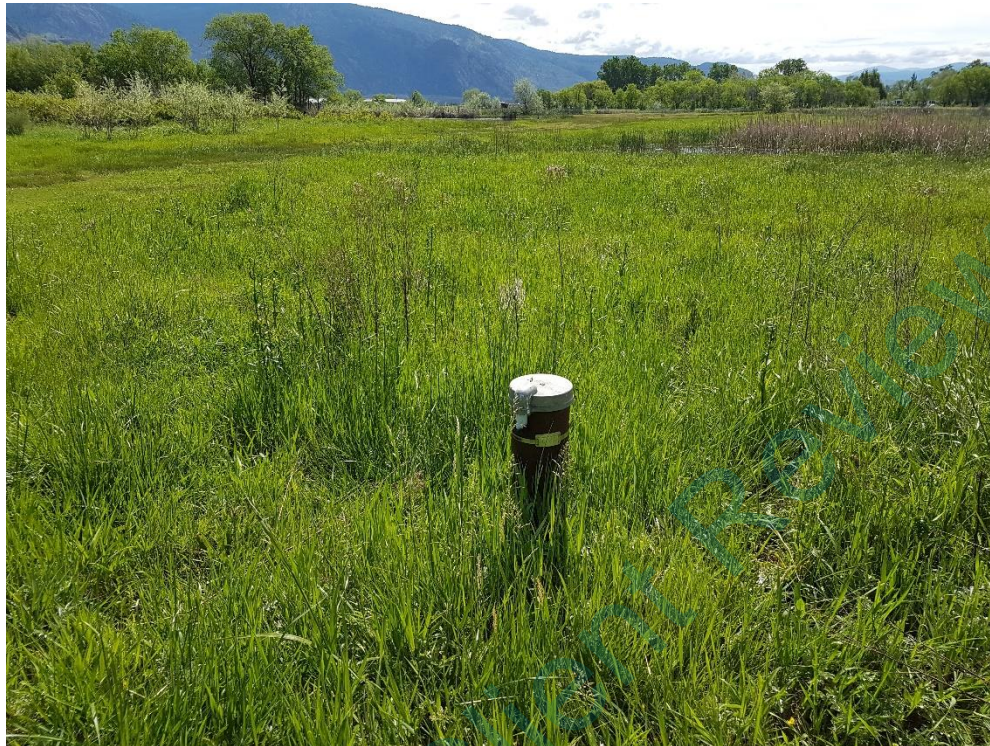
Photo 7: Looking at an existing test well on the Site (May 25, 2017).

Based on WRA mapping, seven (7) wells exist on the Site, as described in Table 1. The first four (4) wells listed in the table are test wells installed by Golder in 2007 (i.e., TW07-1 to TW07-4). Well Tag No. 83816 supplies water to the mobile home park, and the remaining two wells were not observed on the Site.

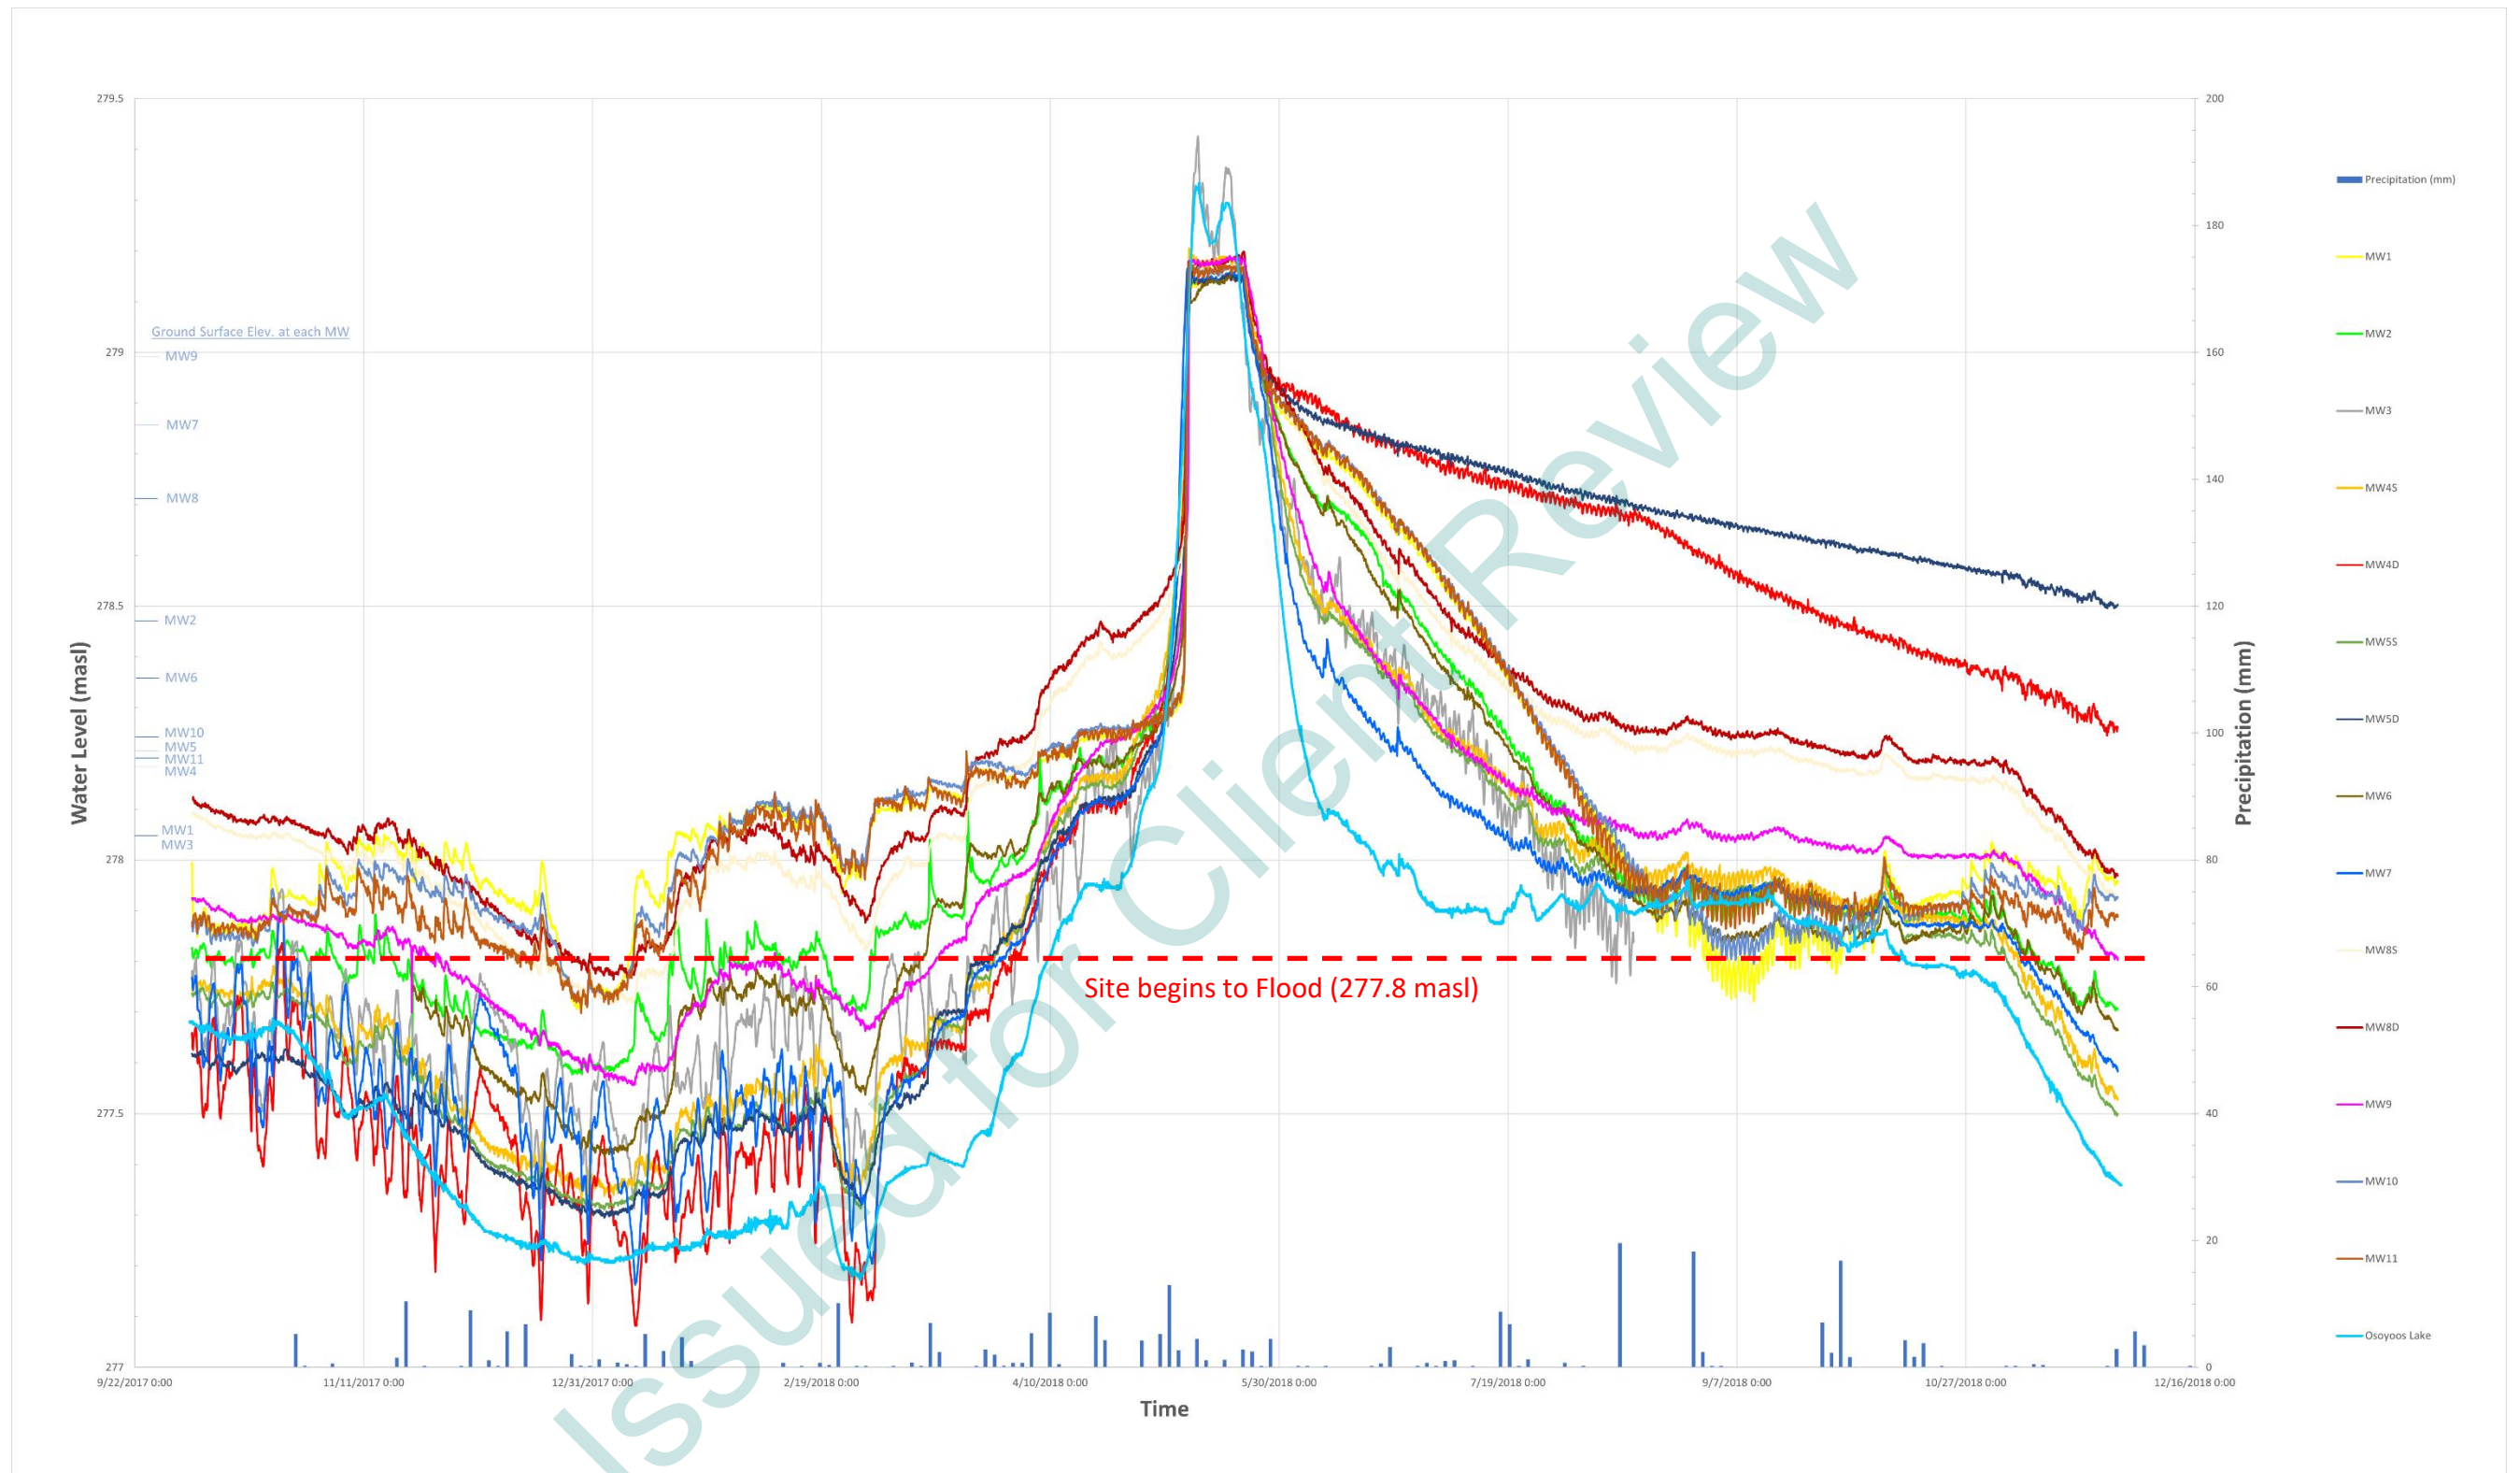
Project: Preliminary Hydrogeology Assessment			
Title: Groundwater Levels over 2018			
Client: Infinity Properties			Figure No: 5
Location: RDOS			Project No: 17-2013.01
Date: January 12, 2021	Dwn by: MPS	Ckd by: LR	Scale: N/A
