Kaleden Fire District

FIRESMART COMMUNITY ASSESSMENT REPORT

January 2019

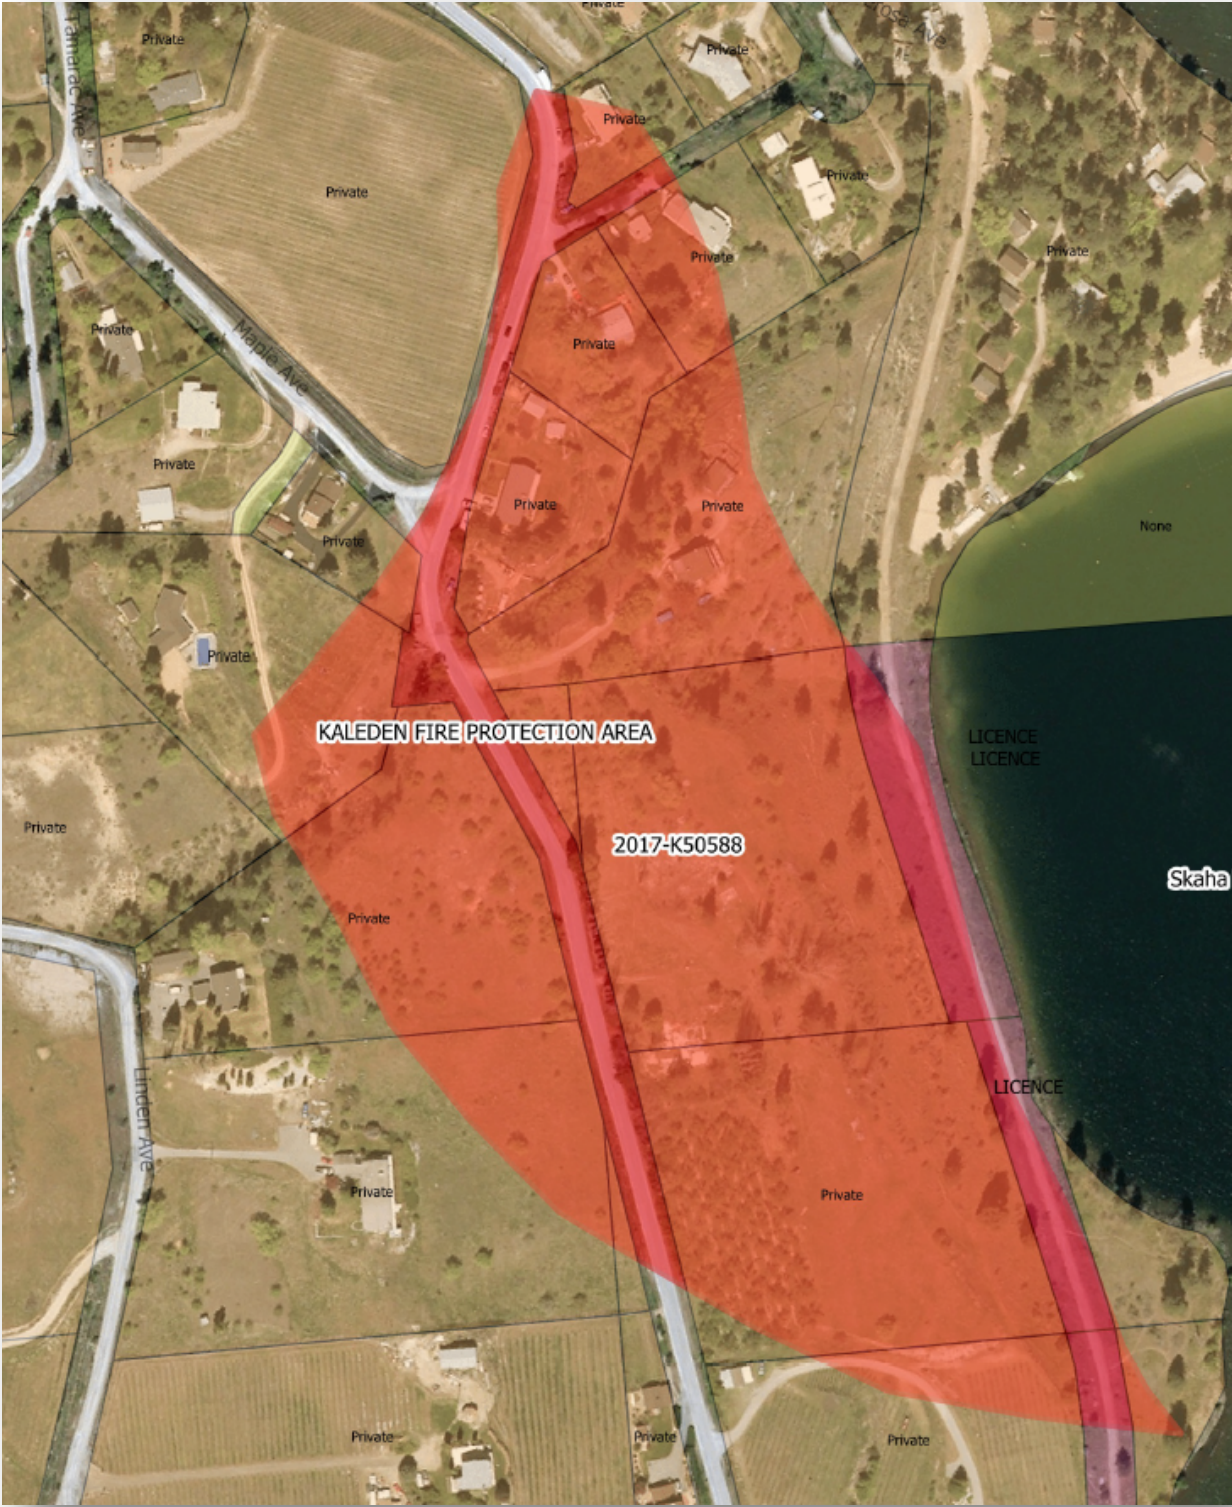
The 2017 Kaleden fire ignited on July 4 and destroyed one home, several outbuildings and damaged additional property. An evacuation order was made for 18 properties with an additional 165 properties on evacuation alert. Ignition occurred sometime after 3:30PM on July 4 and the fire quickly grew to 6.5 ha before containment the following day. The final fire perimeter from the BCWS fire history dataset is presented in Figure 11.

The Kaleden fire was a wind-driven fire incident. Hourly wind data from the Environment Canada (2018) weather station at the Penticton airport (Figure 12) indicates that winds were northerly for most of the day prior to the fire, and that a shift to strong southerly winds occurred sometime after 1:00PM. By 8:00PM that night winds subsided and shifted back to northerly. No official fire cause has been released.

Figure 11 The July 4, 2017 Kaleden fire burned 6.5 ha and destroyed one home.

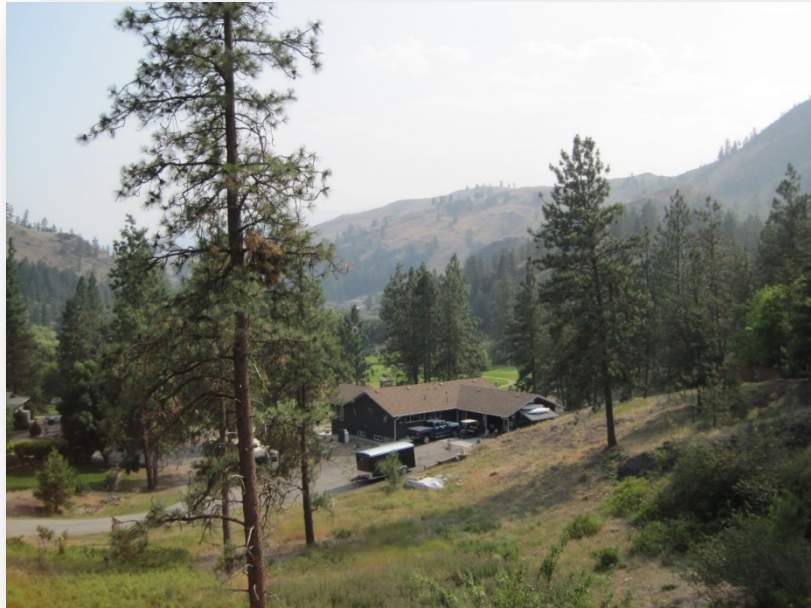
To be clear, *this proviso applies only to well-spaced and pruned conifers that won't readily support torching* (i.e. a tree burning completely from bottom to top), such as those depicted in Figure 13. Conifers with ladder fuels that connect surface fuels with canopy fuels, such as various ornamental and native spruce, *present a very real hazard when occupying space in Zone 1 and should be considered for removal*. It should also be reiterated that mature Ponderosa pine can produce a considerable amount of needle litter, and this characteristic may in fact be a more significant hazard (fortunately, one that is easier and significantly less costly to mitigate).

Figure 13 The Ponderosa pines in the foreground provide an example of well-spaced and pruned conifers with a low likelihood of torching.

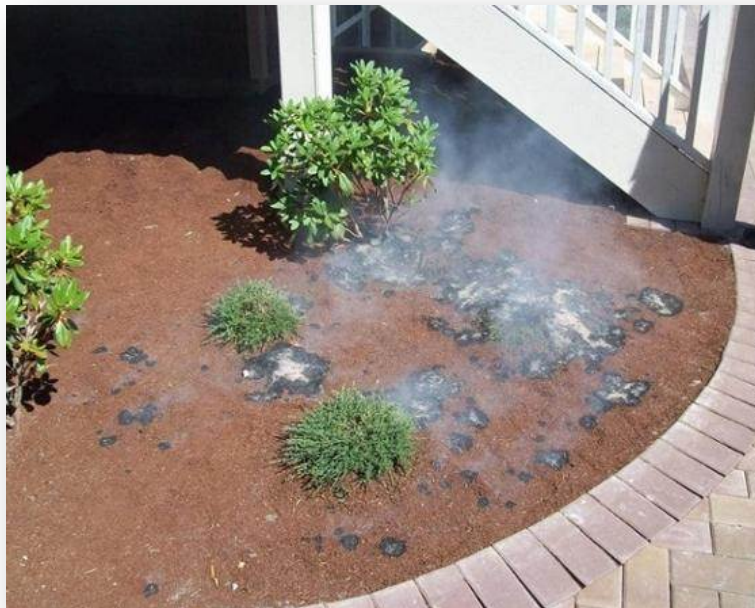
Another popular, low maintenance landscaping strategy that unfortunately presents a home ignition hazard is the use of bark mulch as a ground cover. Kaleden has several examples of bark mulch used in landscaping – and in some cases this is presenting a hazard to the adjacent homes. During the hot summer months, bark mulch will dry out and become extremely receptive to ember ignition and conducive to persistent surface fire spread (Quarles & Smith, 2011). Bark mulch should be viewed as a fuel bed that can effectively transport fire throughout its extent when sufficiently dry (e.g. Figure 16). Homeowners should consider any flammable connections between a bark mulch bed and the house (e.g. wood siding, wood stairs etc.) as a pathway for direct flame contact that could result in the ignition of the home. Through their research, Quarles and Smith (2011) recommend that noncombustible materials (e.g. rock, gravel, concrete, pavers etc.) or ignition-resistant plants (e.g. irrigated lawn) be used within five feet from a structure in place of combustible materials such as bark mulch.

Figure 16 Various types of mulch can be extremely susceptible to ember ignition during a wildfire (FIREsafe Marin, 2013).

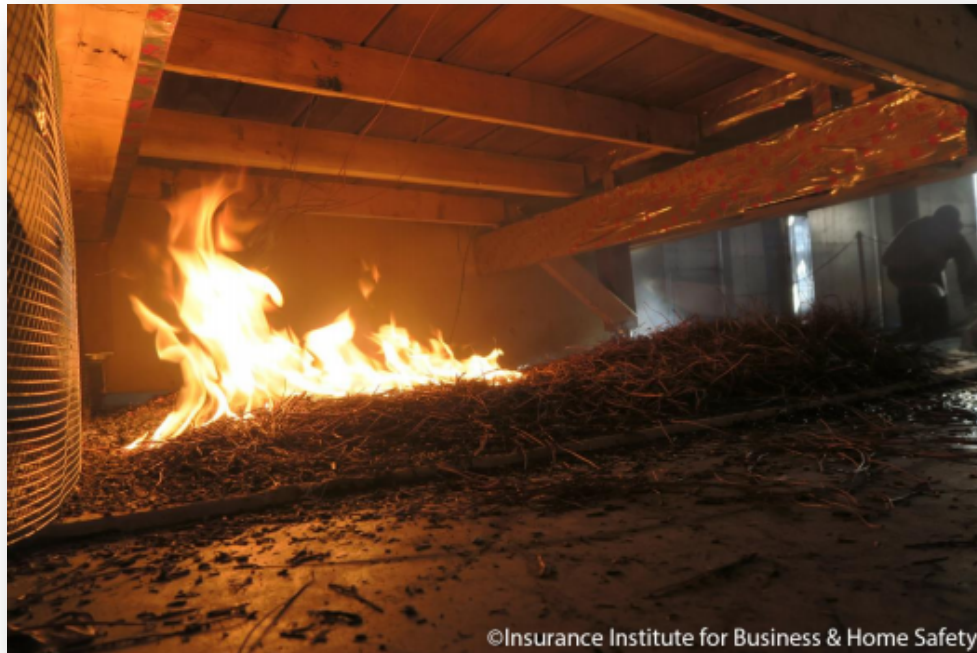
When boards are used for the decking surface, any gaps between boards (referred to as the *between-deck-board gap* in ember ignition research, such as Quarles and Standohar-Alfano [2017]) should be viewed as avenues for organic debris to fall through and accumulate underneath the deck or accumulate on the deck surface. Debris and embers can also accumulate at a between-deck-board gap location above a support joist (Quarles & Standohar-Alfano, 2017). Between-deck-board gaps can also permit embers to fall through and ignite accumulated debris under the deck, potentially resulting in the ignition of the deck and subsequently the house.

Figure 25 This photo was taken during testing by the Insurance Institute for Business & Home Safety. A full-scale home model placed in a burn chamber was subjected to an ember blizzard to test the effect of embers and ember accumulation on structures during a wildfire. Deck boards permitted embers to pass through the between-deck-board-gaps and ignited combustible accumulations under the deck. A deck or porch where the underside is completely open offers no resistance to ember accumulation. [Photo: (Quarles & Standohar-Alfano, 2017)]

If combustible material is to be stored under a deck, this area should be sheathed in 12 mm exterior-grade plywood or screened with 3 mm non-corrosive metal screening to prevent embers from entering the space and igniting the stored material. Areas underneath deck boards should be assessed for debris accumulations and cleaned out as needed.

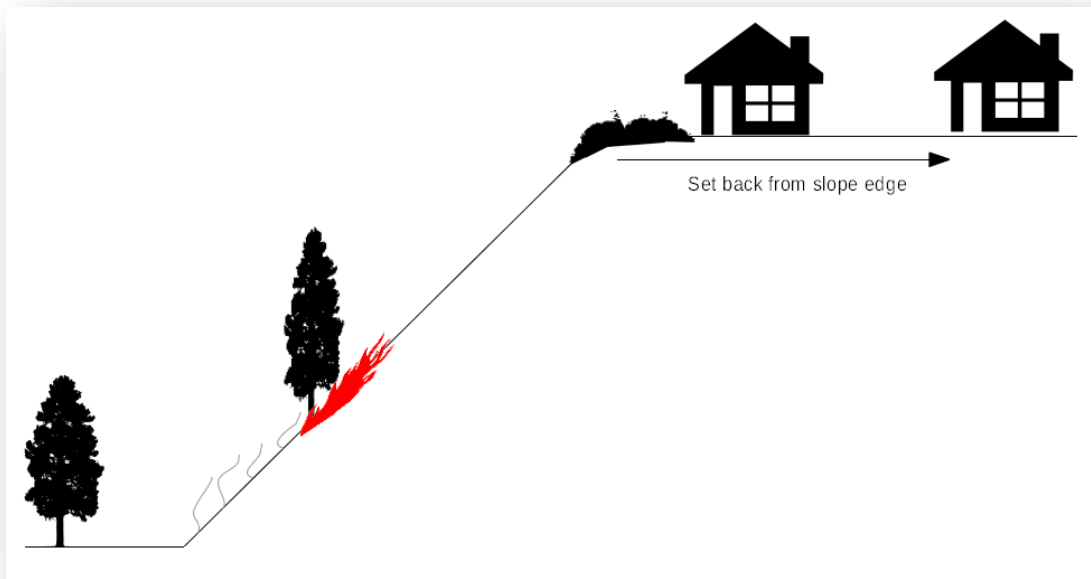
Setback refers to the relative distance between a structure and the crest of a slope (Figure 26). FireSmart Canada recommends a minimum 10 m setback for a single-story house and the setback should be increased proportionally for taller buildings (Partners in Protection, 2003). Existing homes without adequate setback need to mitigate fuel hazards further down the slope below in an effort

to reduce potential fire intensity at the slope crest. Adequate setback becomes negated when flammable vegetation occurs at or near the crest of the slope, as depicted in Figure 23. Finally, a setback assessment must consider any decks or balconies between the crest of the slope and the home.

Figure 26 Set back from slope edge is the degree to which a home is away from the crest of a slope leading up towards the home. In this example, the home on the right has greater set back. The home on the left has less set back and would be subjected to fire as it crested the slope. In this illustration fuel loading attributed to landscaping is also present at the slope crest, further exaserbating the set back issues.

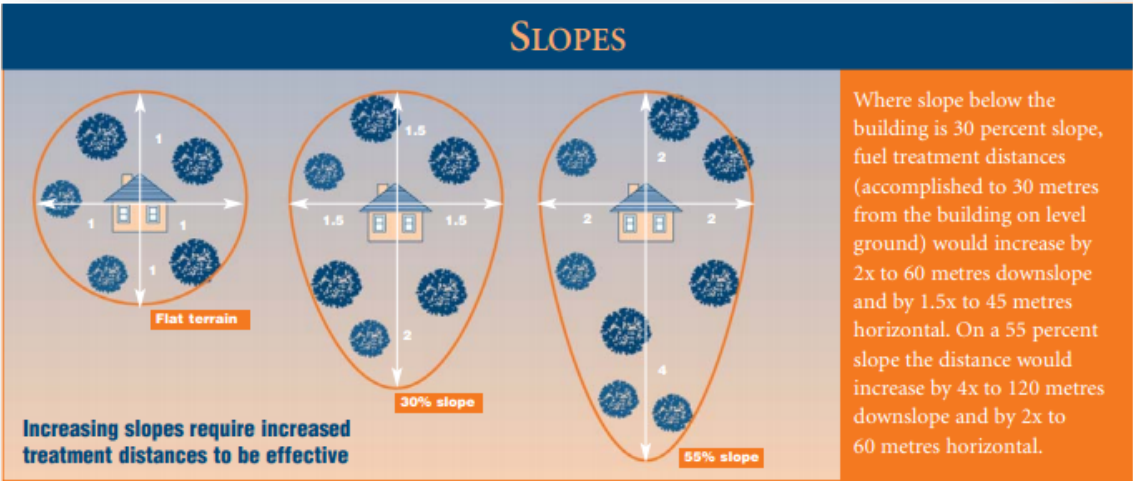
Decks that extend out over a slope require careful assessment. A fuel-laden slope leading up towards a deck could result in direct flame contact or ember accumulation on the deck or stored material under the deck. The underside of the deck may also trap heat from a fire coming upslope towards the structure, further contributing to increased ease of ignition. Figure 27 illustrates an example in Kaleden where the deck and home extend out over the crest of the slope. In this situation, without an effective fuel break below the home, a fire spreading upslope would impact the underside of the deck and home, through direct flame contact, convective heat and ember accumulation. In this case, fuel mitigation efforts need to be carried out down the slope. FireSmart Canada has developed a guideline for expanding the treatment area on slopes below a structure, as illustrated in Figure 28 (Partners in Protection, 2003).

Figure 28 FireSmart Canada recommends expanding the treatment areas downslope from a home to account for the increased rate of spread and associated fire intensity of a fire spreading upslope towards the house (Figure reproduced from the Protecting Your Community from Wildfire manual published by FireSmart Canada and Partners in Protection).

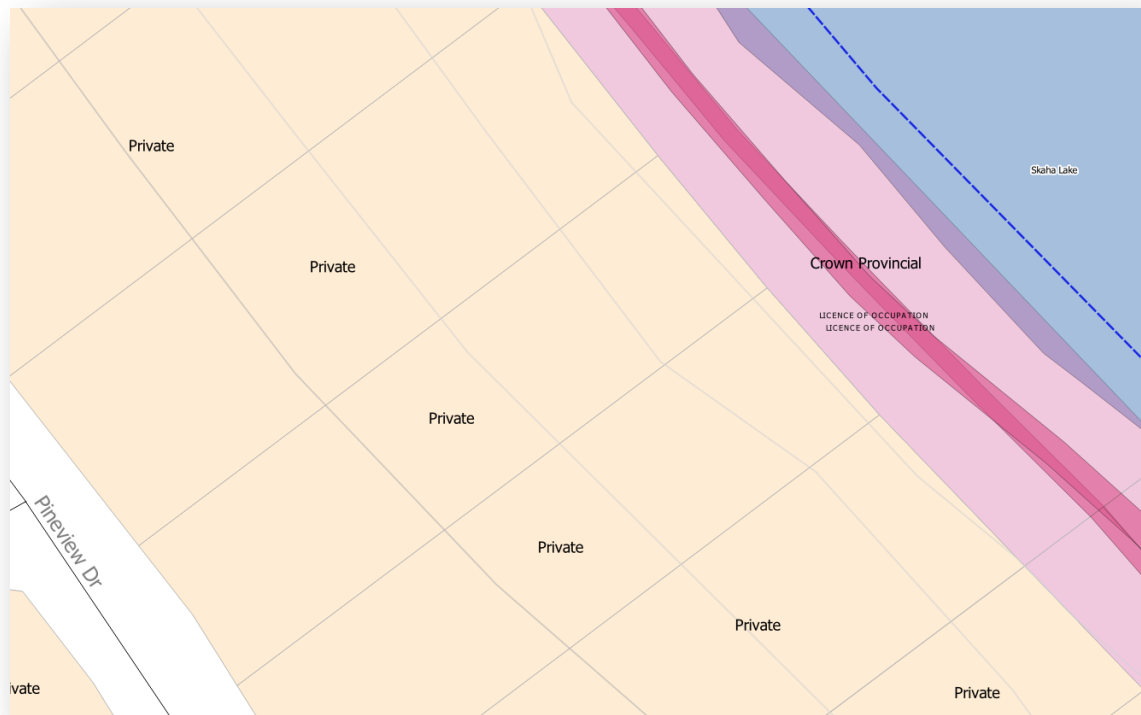
Kaleden has several examples of lot boundaries that extend a significant distance downslope below the homes. A number of properties along Pineview Drive typify this issue, whereby lot boundaries extend downslope to the KVR rail trail or other private lots along the rail trail. In most cases, the lower portions of these lots are unused, in large part due to steep slopes (e.g. Figures 23 and 27). Figure 29 illustrates the land ownership and disposition between a portion of Pineview Drive and Skaha Lake. In this case, lot boundaries extend down to a strip of Crown Provincial land which contains the KVR trail. The trail itself exists under a Crown licence of occupation.

Figure 29 Parcel fabric for a portion of Pineview Drive above the KVR trail.

The strip of Crown Provincial land between the lot boundaries and the lake, as depicted in Figure 29, entails the toe of the slope below the private lots, as illustrated in the approximately corresponding Google Earth image in Figure 30. This situation effectively isolates the bottom of the lots from the trail and shoreline, meaning any fuel reduction efforts by property owners are contingent on bringing fuel upslope to Pineview Drive or treating in situ.

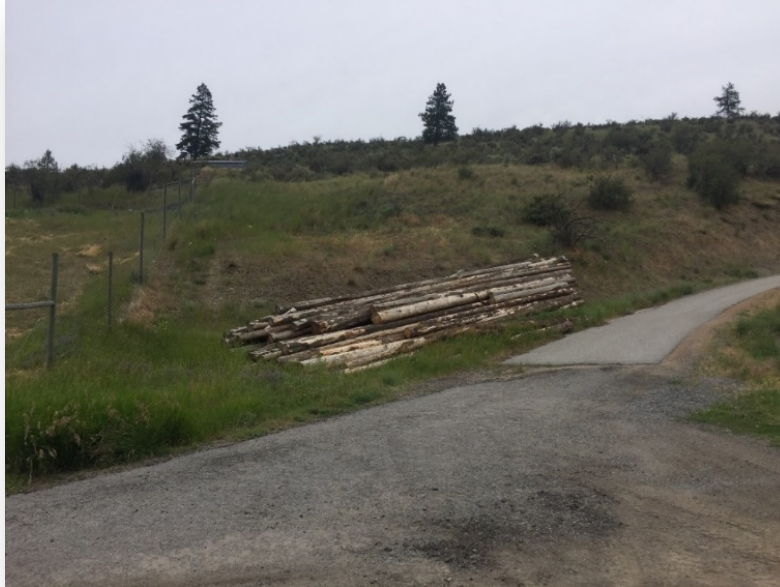
were identified, including the log deck depicted in Figure 32. Admittedly the log deck location was likely chosen for convenience as much as hazard mitigation, but the result is the same.

Figure 32 This deck of unbucked firewood is well away from any structures. Admittedly this was likely the most convenient location to unload these logs, but the benefit of separating firewood from the home during the summer remains.
