September 25, 2023

GFX-1068

Geotechnical and Geohazard Assessment for Existing Swimming Pool – **AMENDED in RED**
2636 Forsyth Drive, Penticton, BC

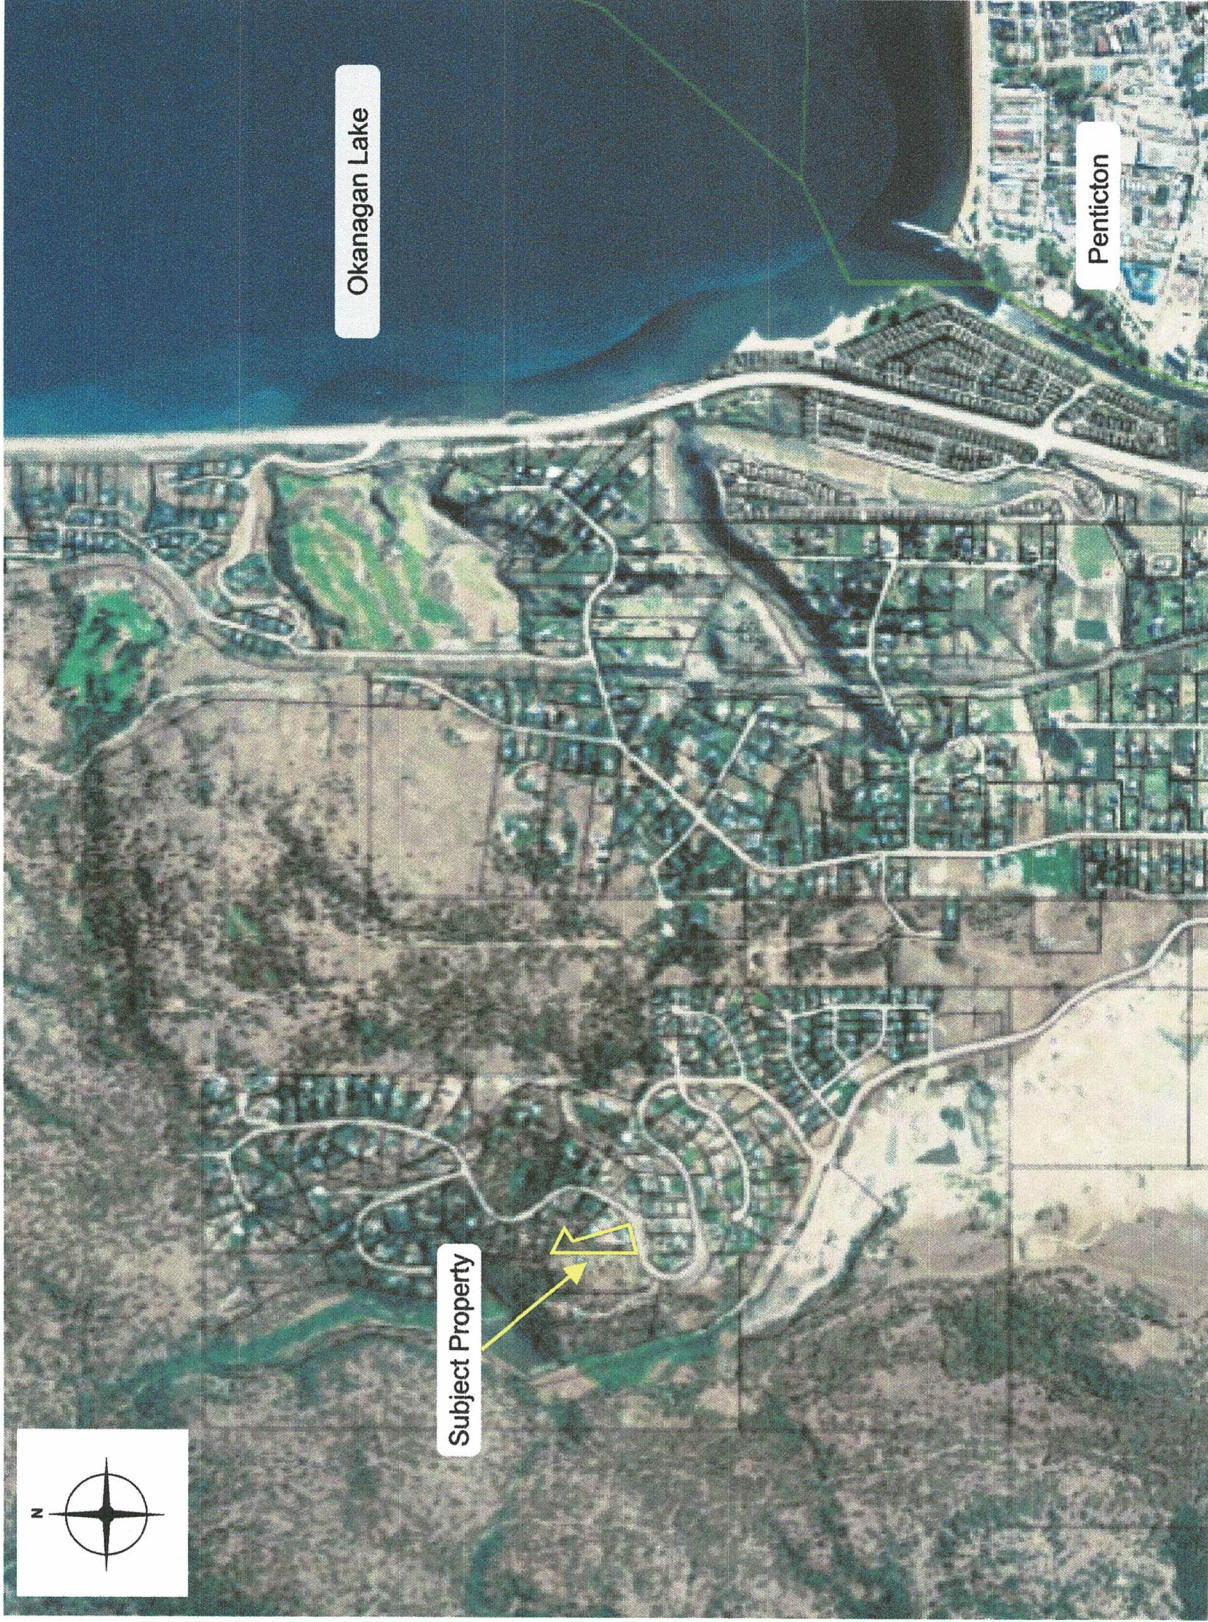
The property at 2636 Forsyth Drive is located in the West Bench area of Penticton. The property is surrounded by residential lots, with access along a driveway from Forsyth Drive. The subject property slopes down to the south with the swimming pool located at the south end of the property (See Photo No. 4), as shown on the attached *Figure 2 – Site Plan*.

Photo No. 4: View looking south from house through swimming pool location.
Forsyth Drive below (2023 07 06).
