May 10, 2022

Our File: RGC-3511

**Subject: Geotechnical Pre-Purchase Assessment
2204 Forsyth Drive, Penticton BC**

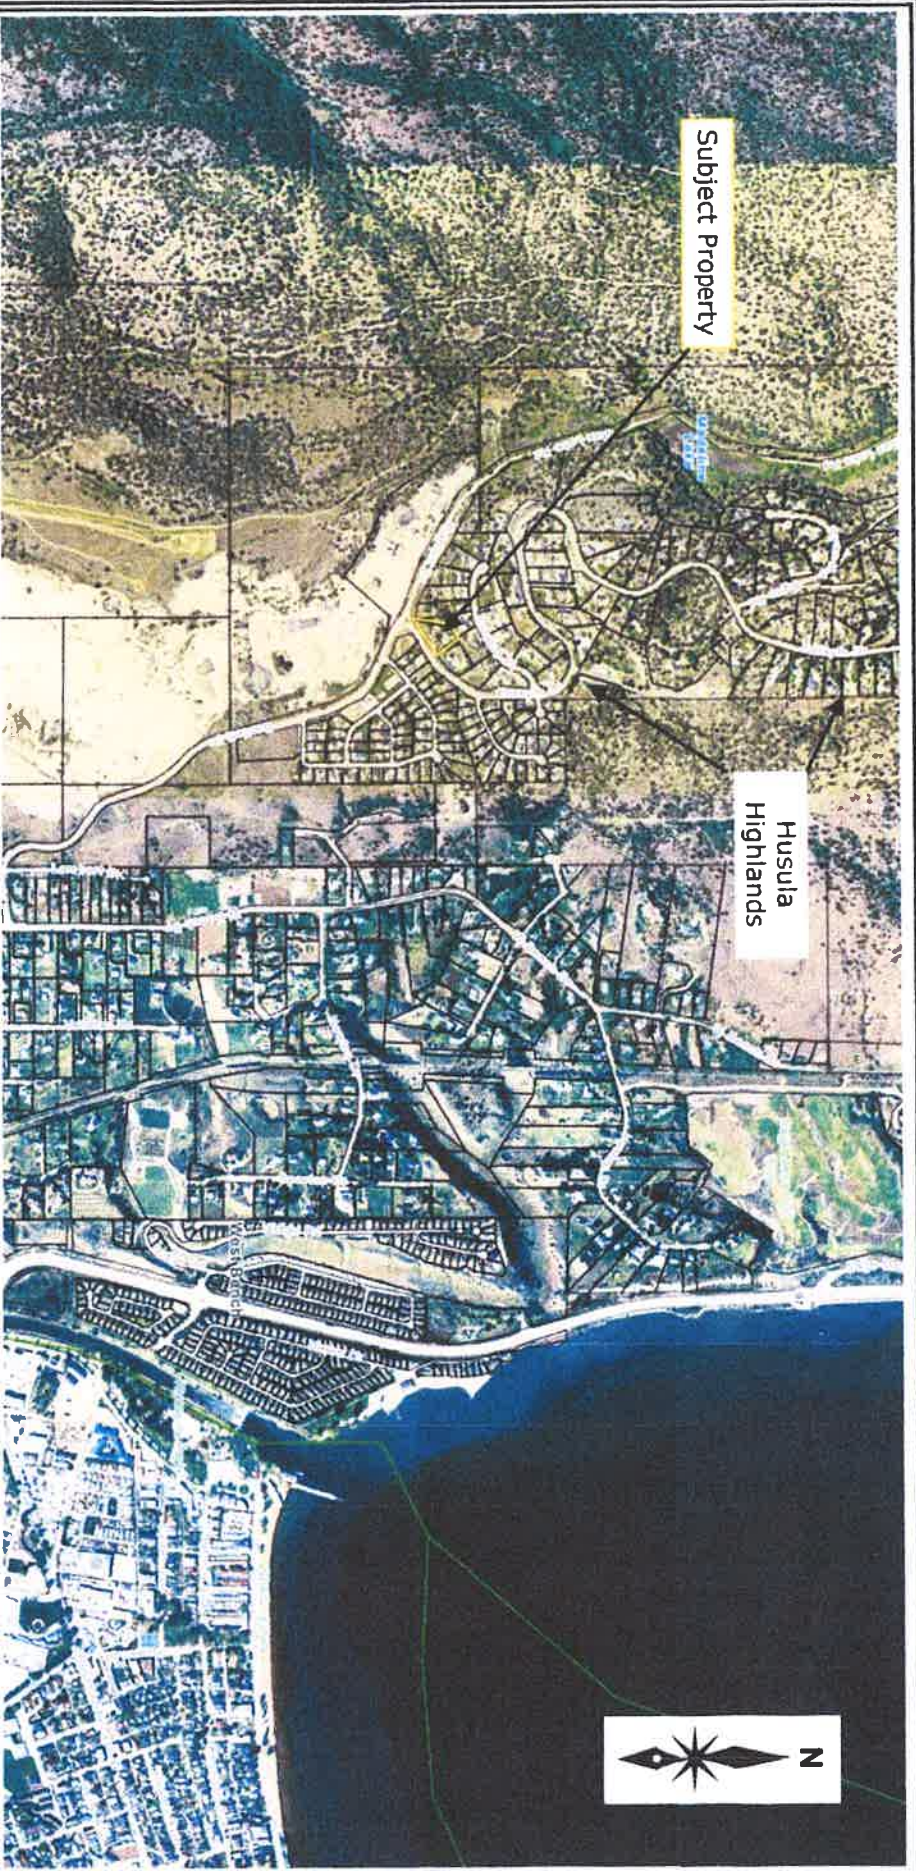
The property is accessible by a driveway that extends from Forsyth Drive at the east corner of the lot up to the northwest corner of the property. The driveway is composed of fill, presumably from the excavation of the terrace. The side slopes of the driveway are approximately 43° (See Photo No. 4).

Photo No. 4 – Driveway access with slope below potential building site.
